The essence of InfraCore Inside[®]

A brief introduction

InfraCore Inside looks and feels like a sandwich structure, but it has a more direct descent from beams, in fact multi-beam plates.

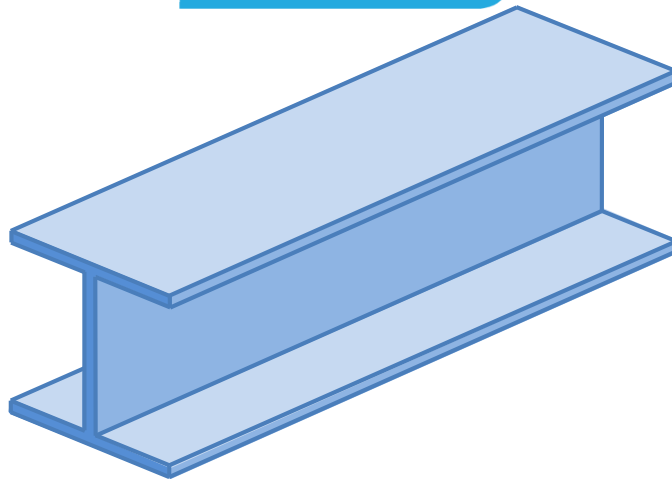
Steel beam:

Two flanges, connected by a web

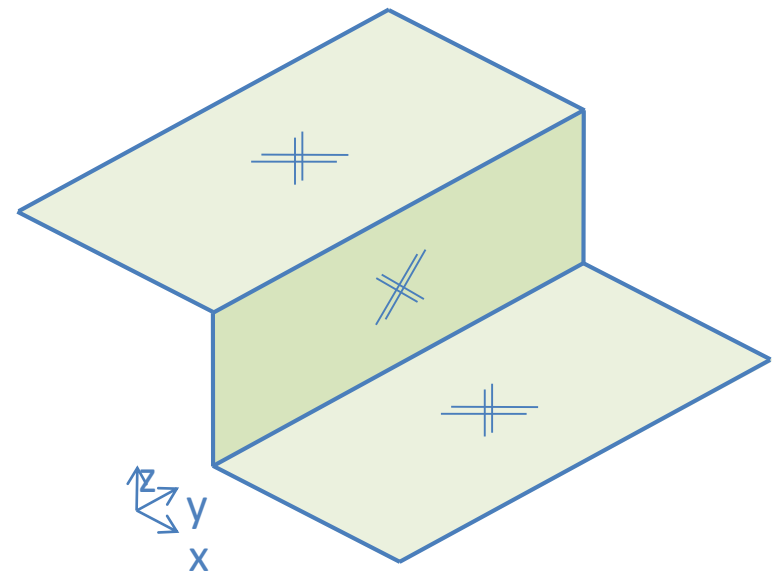
Glass Fibre Fabric beam:

Two flanges, connected by a web
One layer of $\pm 45^\circ$ fabric

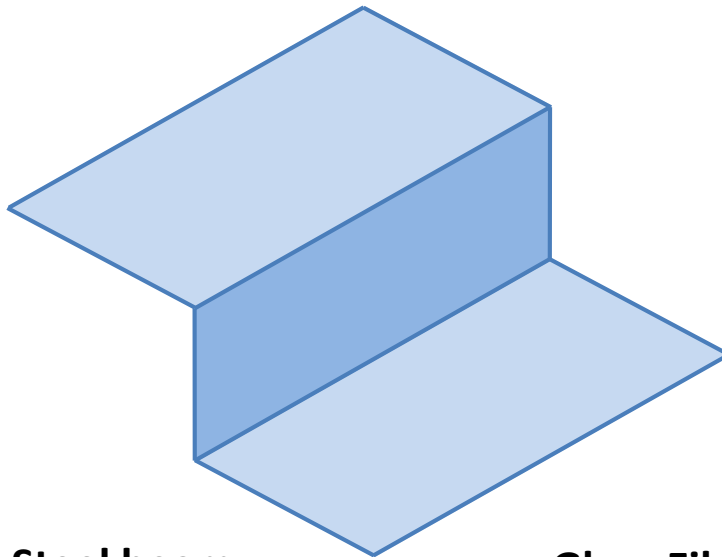
Steel beam:

Two flanges, connected by a web

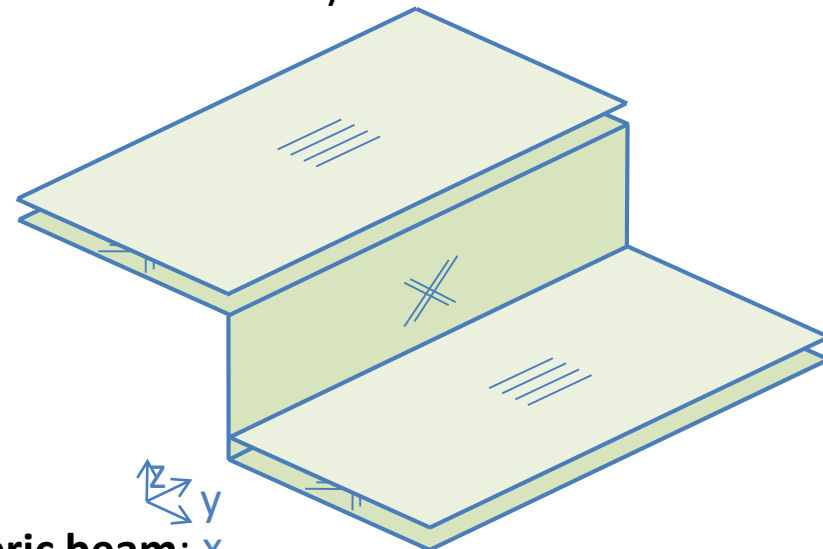
Glass Fibre Fabric beam:

Two flanges, connected by a web
One layer of $\pm 45^\circ$ fabric + one layer of 0° fabric on flanges

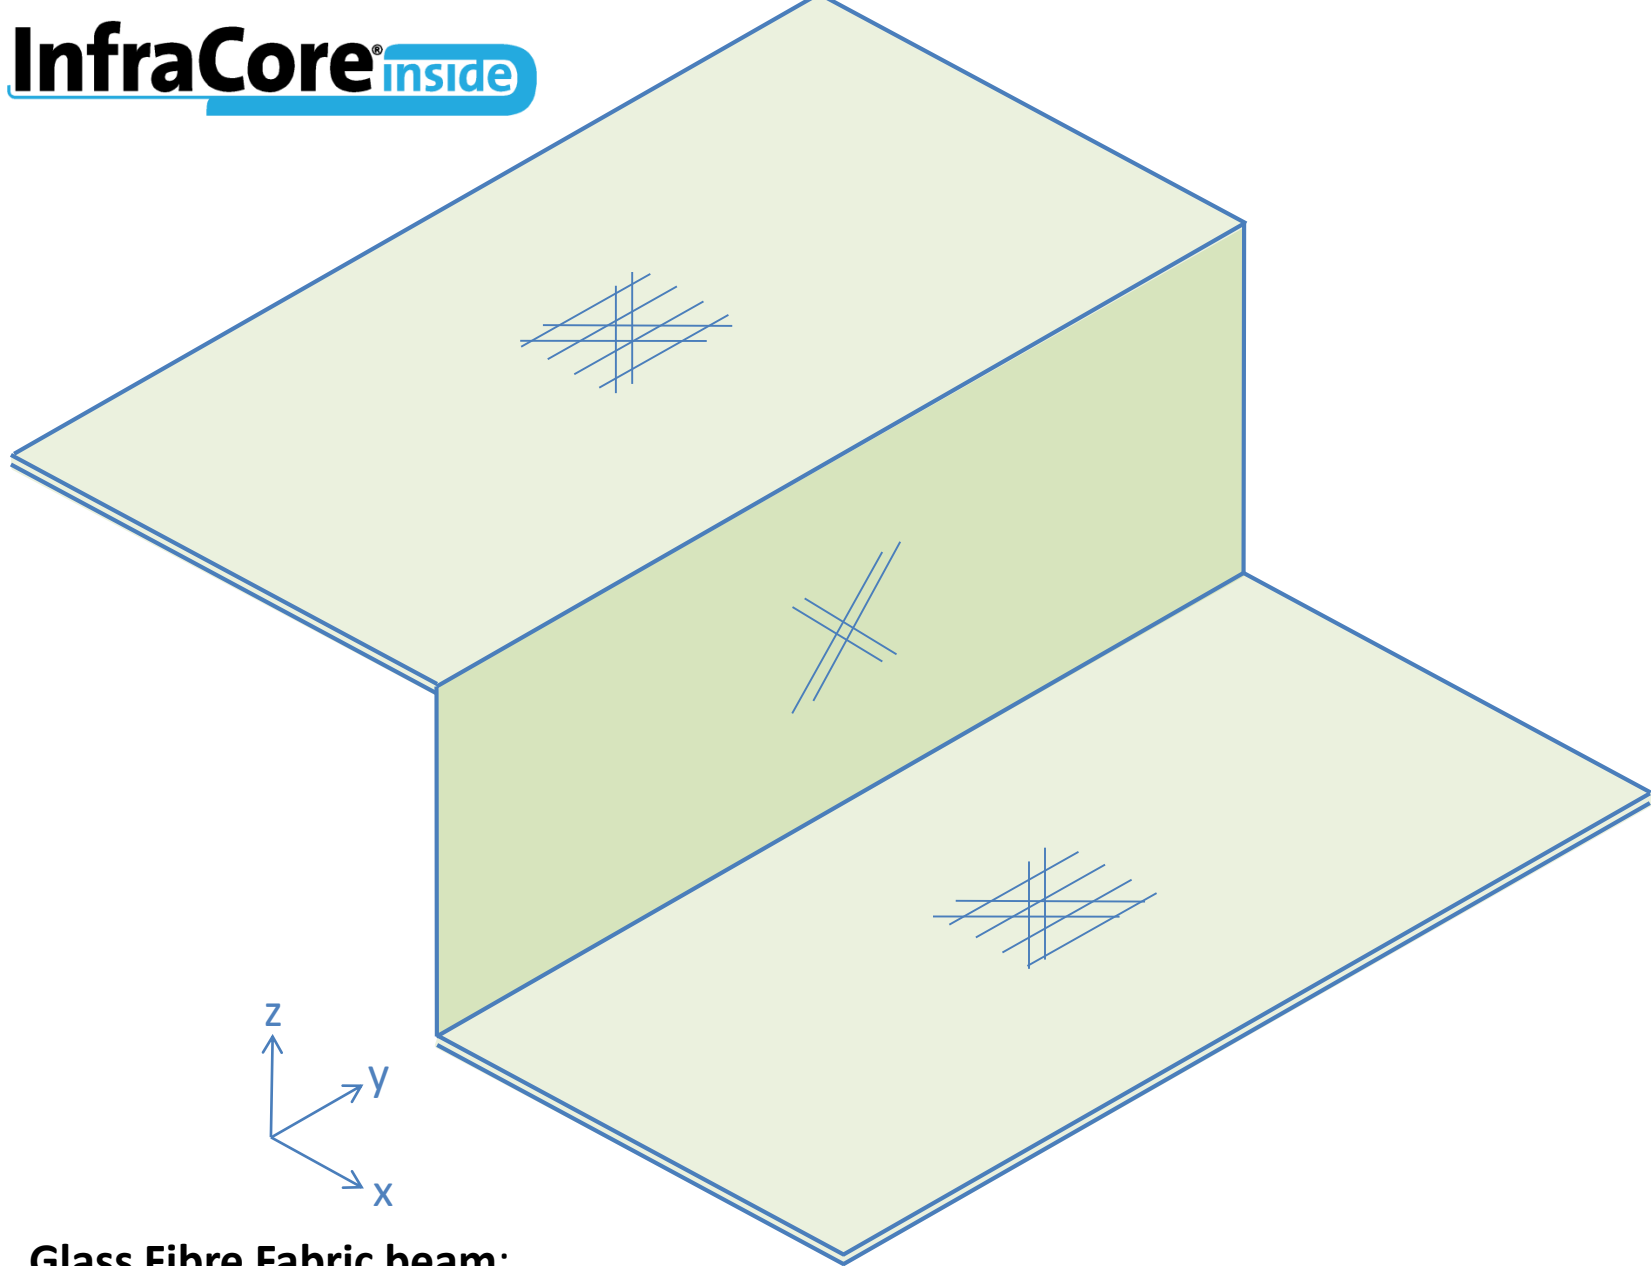
Glass Fibre Fabric beam:

Two flanges, connected by a web

Flanges 0°/ ±45° fabric, web ±45° fabric

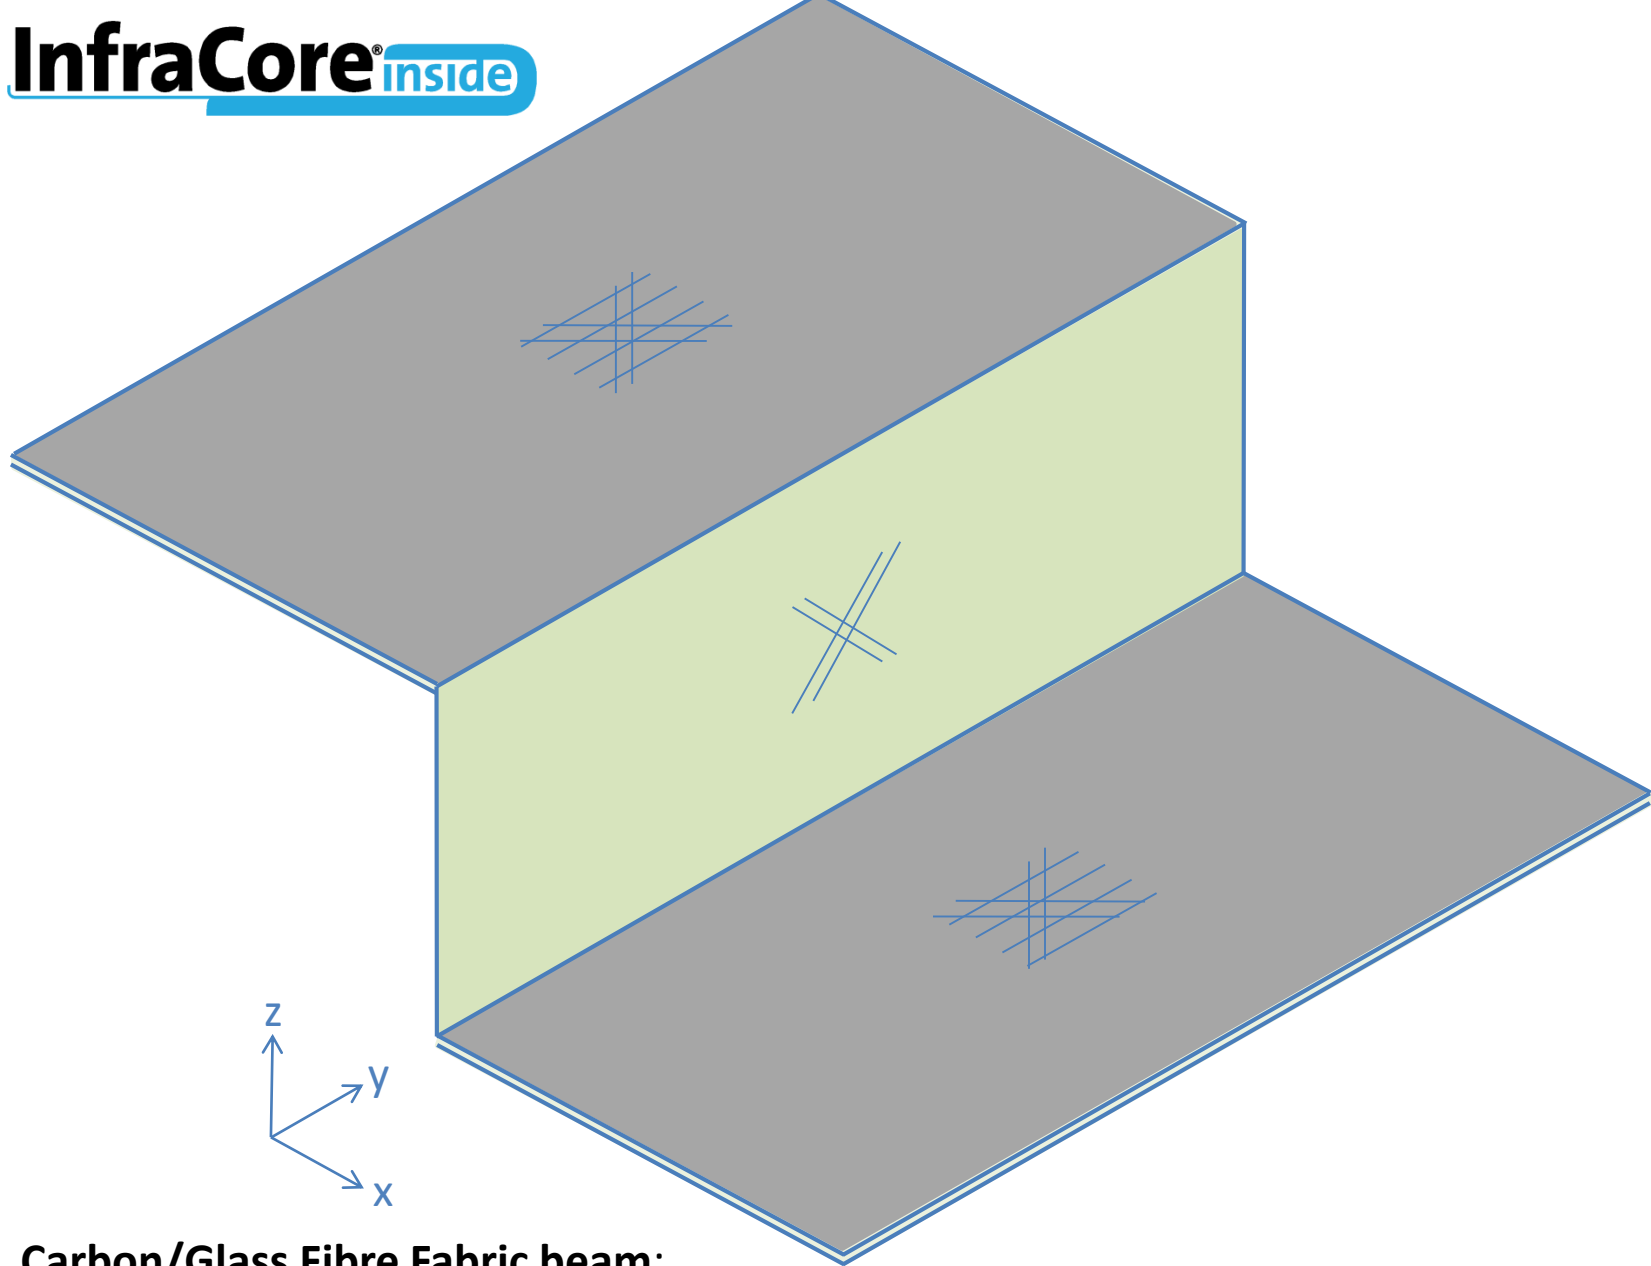
Carbon/Glass Fibre Fabric beam:

Two flanges, connected by a web

Flanges 0° carbon/ ±45° glass fabric, web ±45° glass fabric

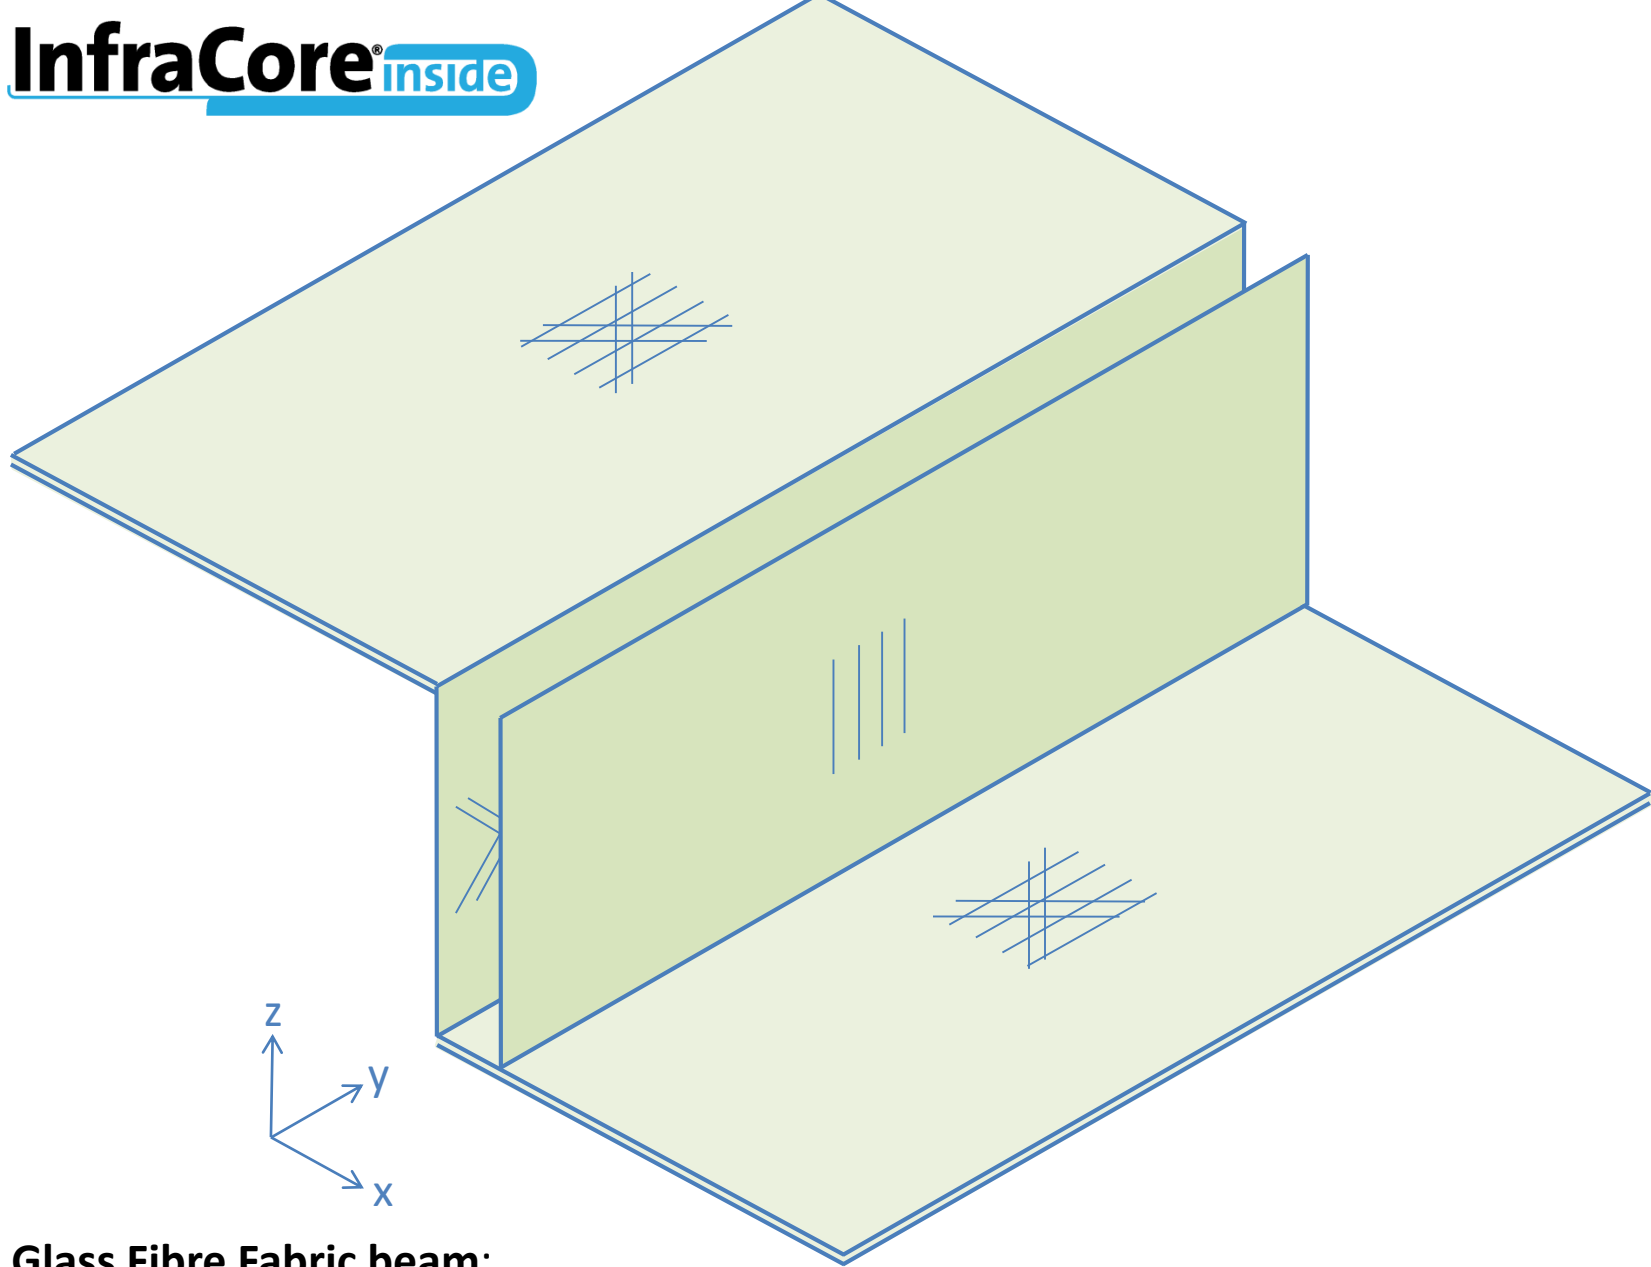
Glass Fibre Fabric beam:

Two flanges, connected by a web

Flanges 0°/ ±45° fabric, web ±45° fabric + one layer of 90° fabric

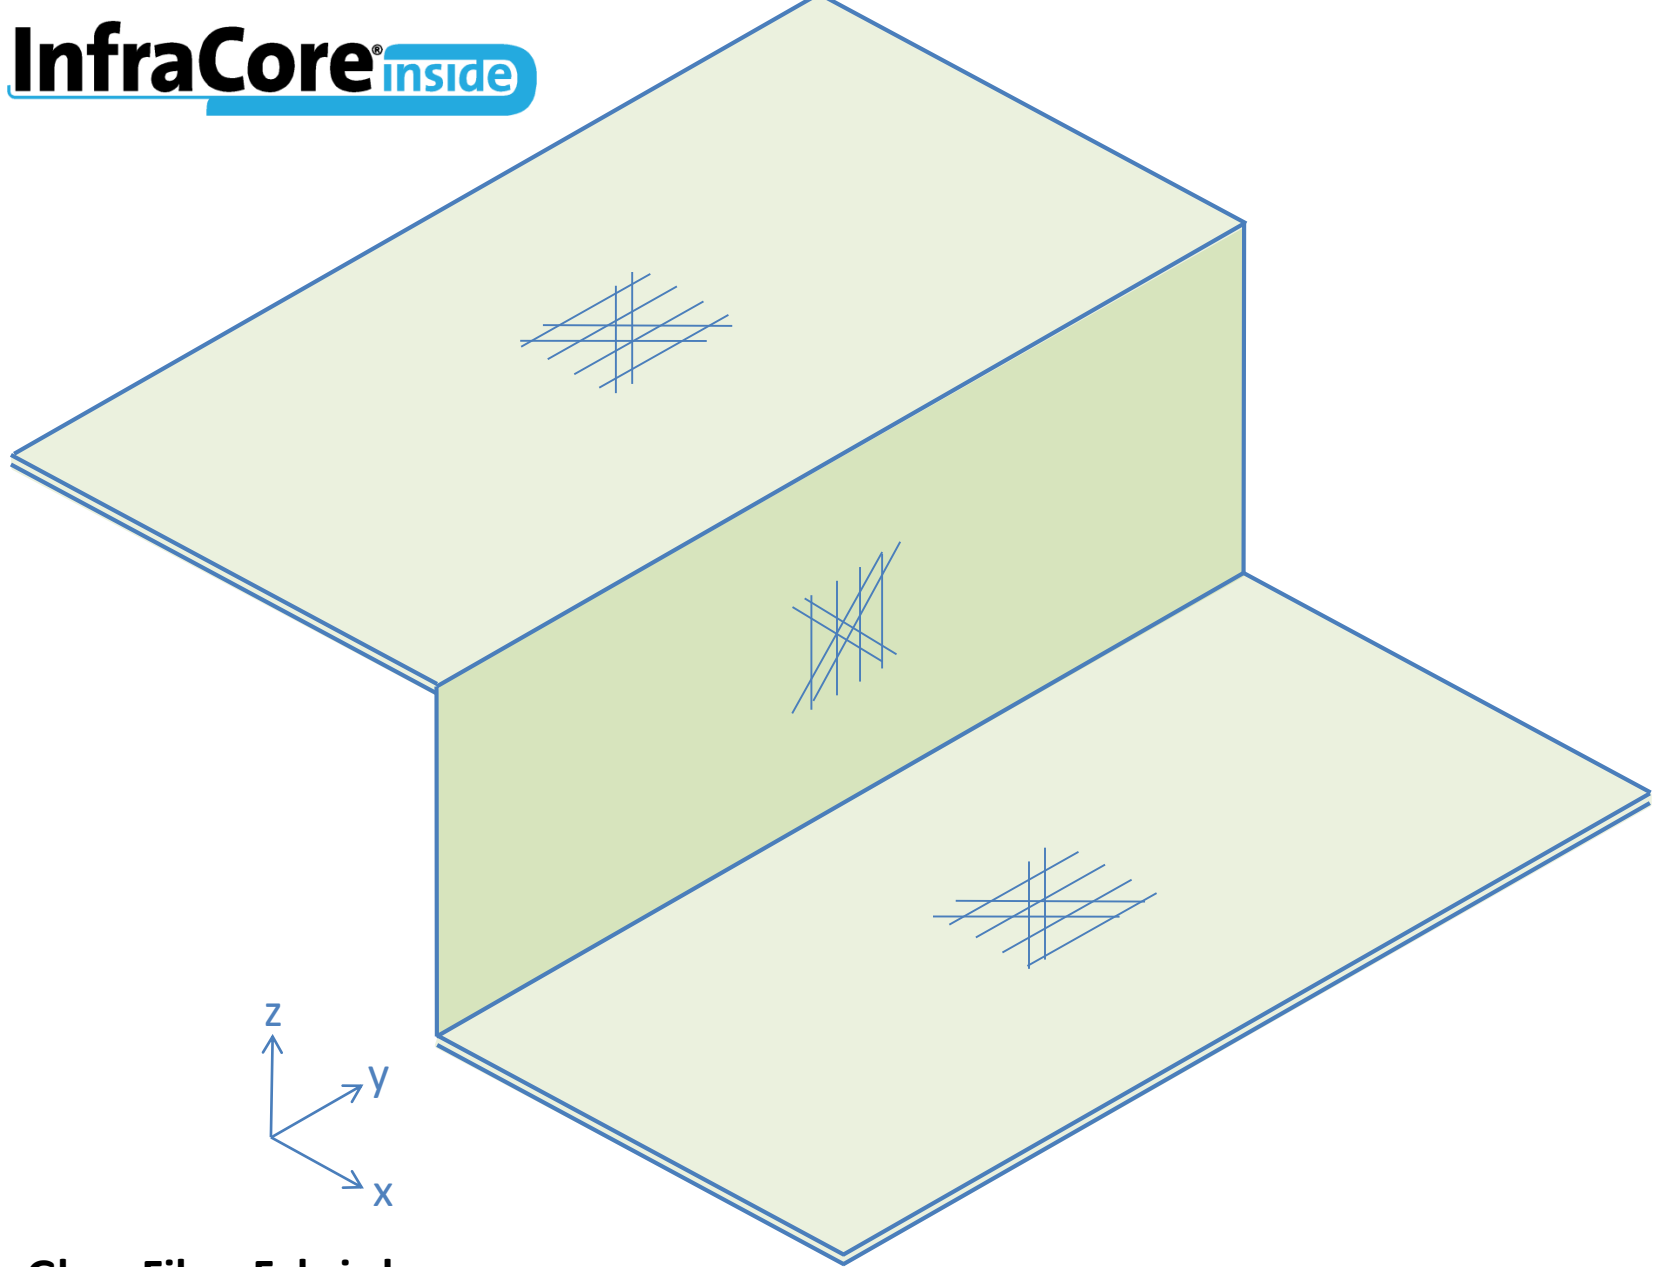
Glass Fibre Fabric beam:

Two flanges, connected by a web

Flanges $0^\circ / \pm 45^\circ$ fabric, web $90^\circ / \pm 45^\circ$ fabric

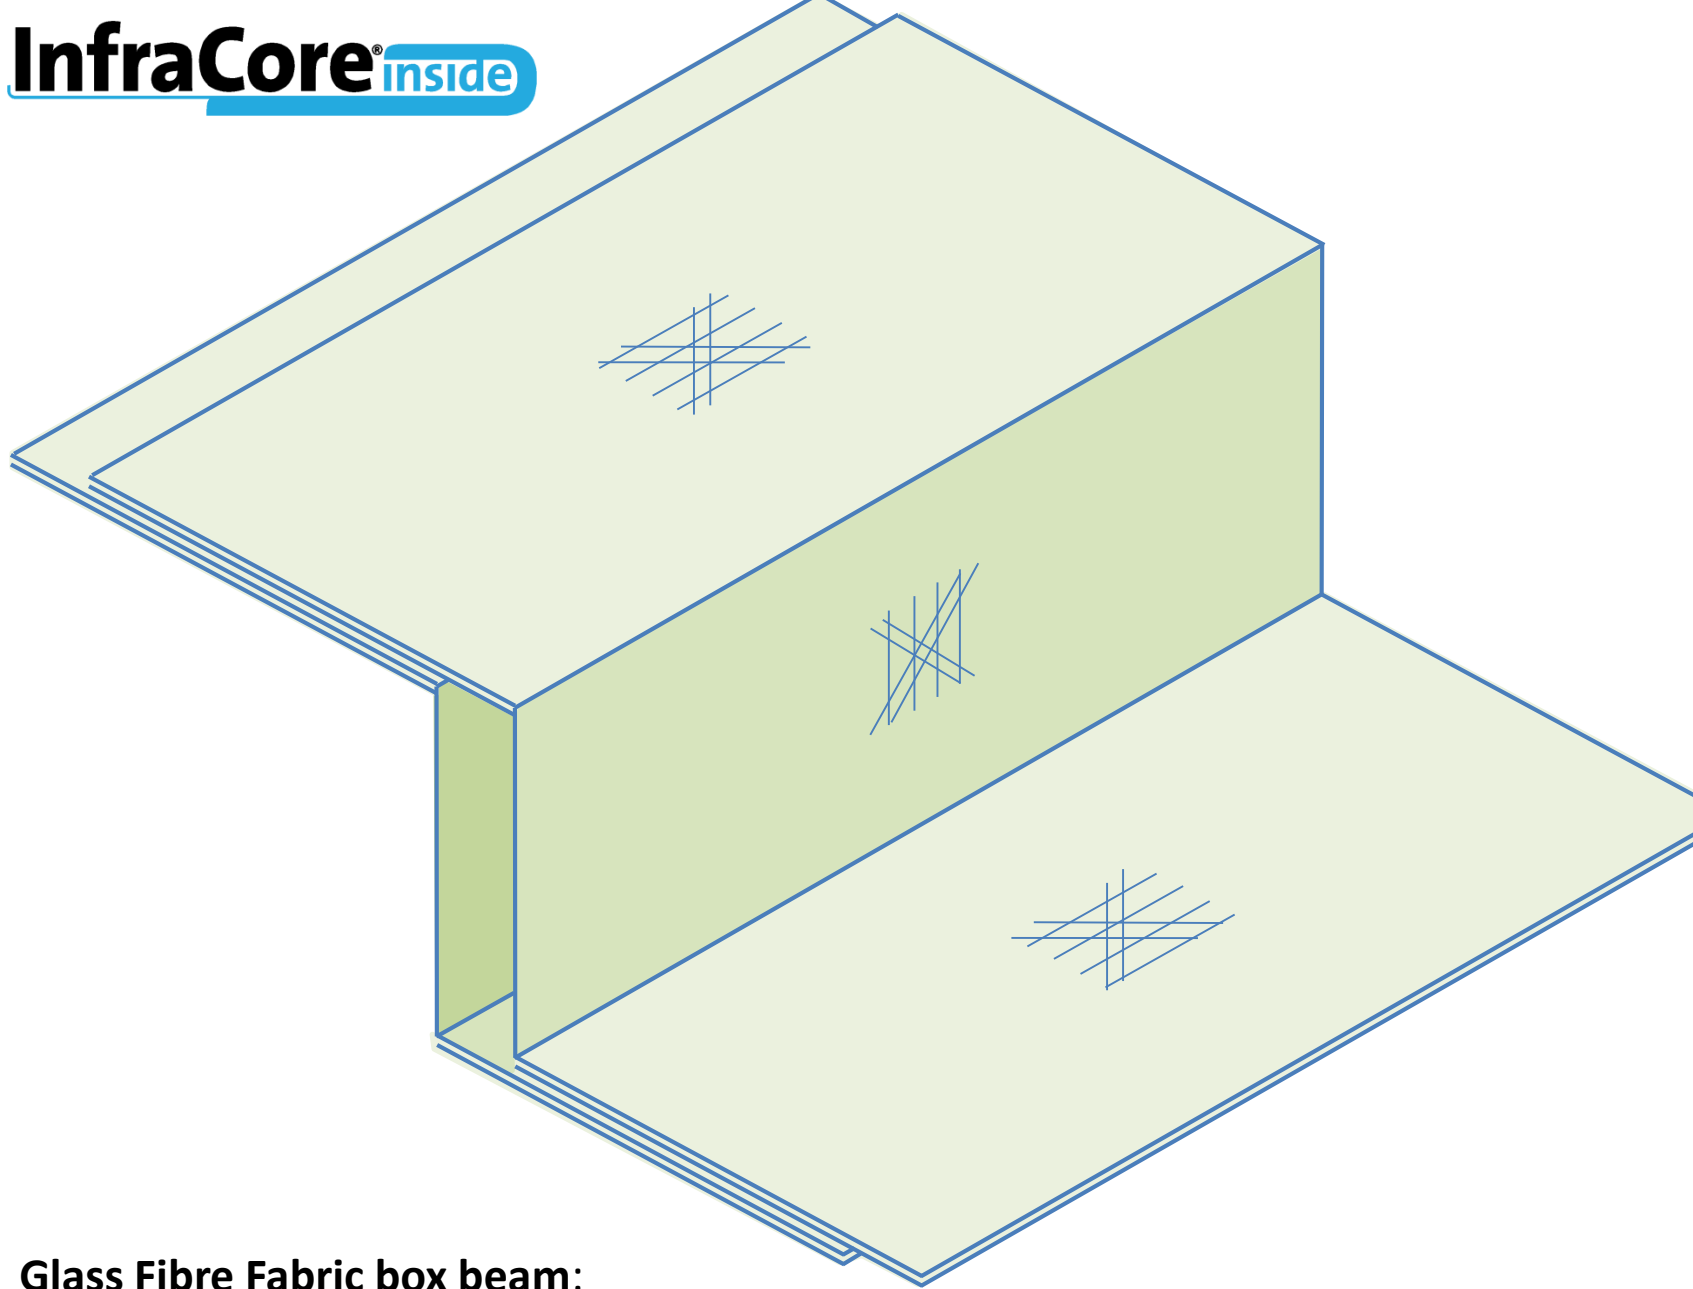
Glass Fibre Fabric box beam:

Flanges, connected by webs

Flanges 0°/ ±45° fabric, webs 90°/±45° fabric

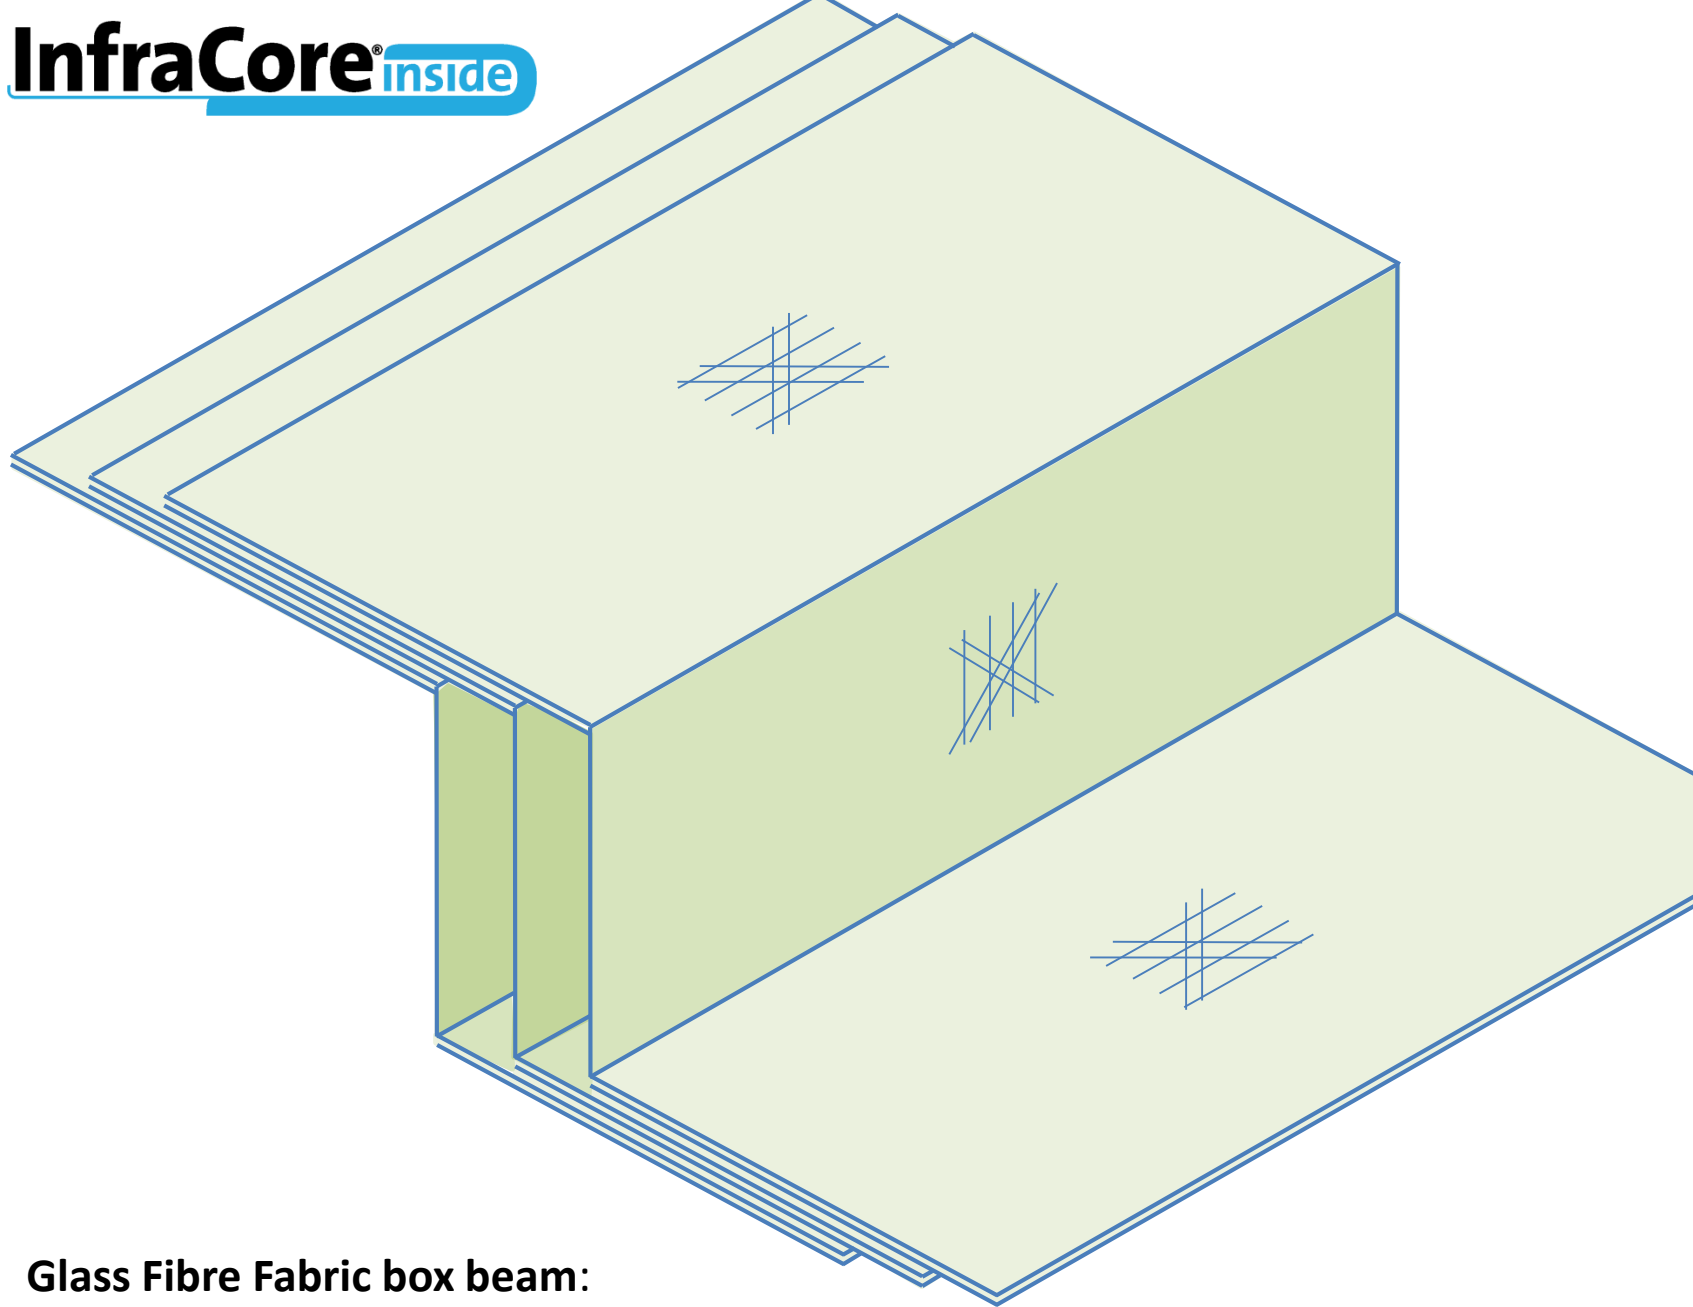
Glass Fibre Fabric box beam:

Flanges, connected by webs

Flanges 0°/ ±45° fabric, webs 90°/±45° fabric

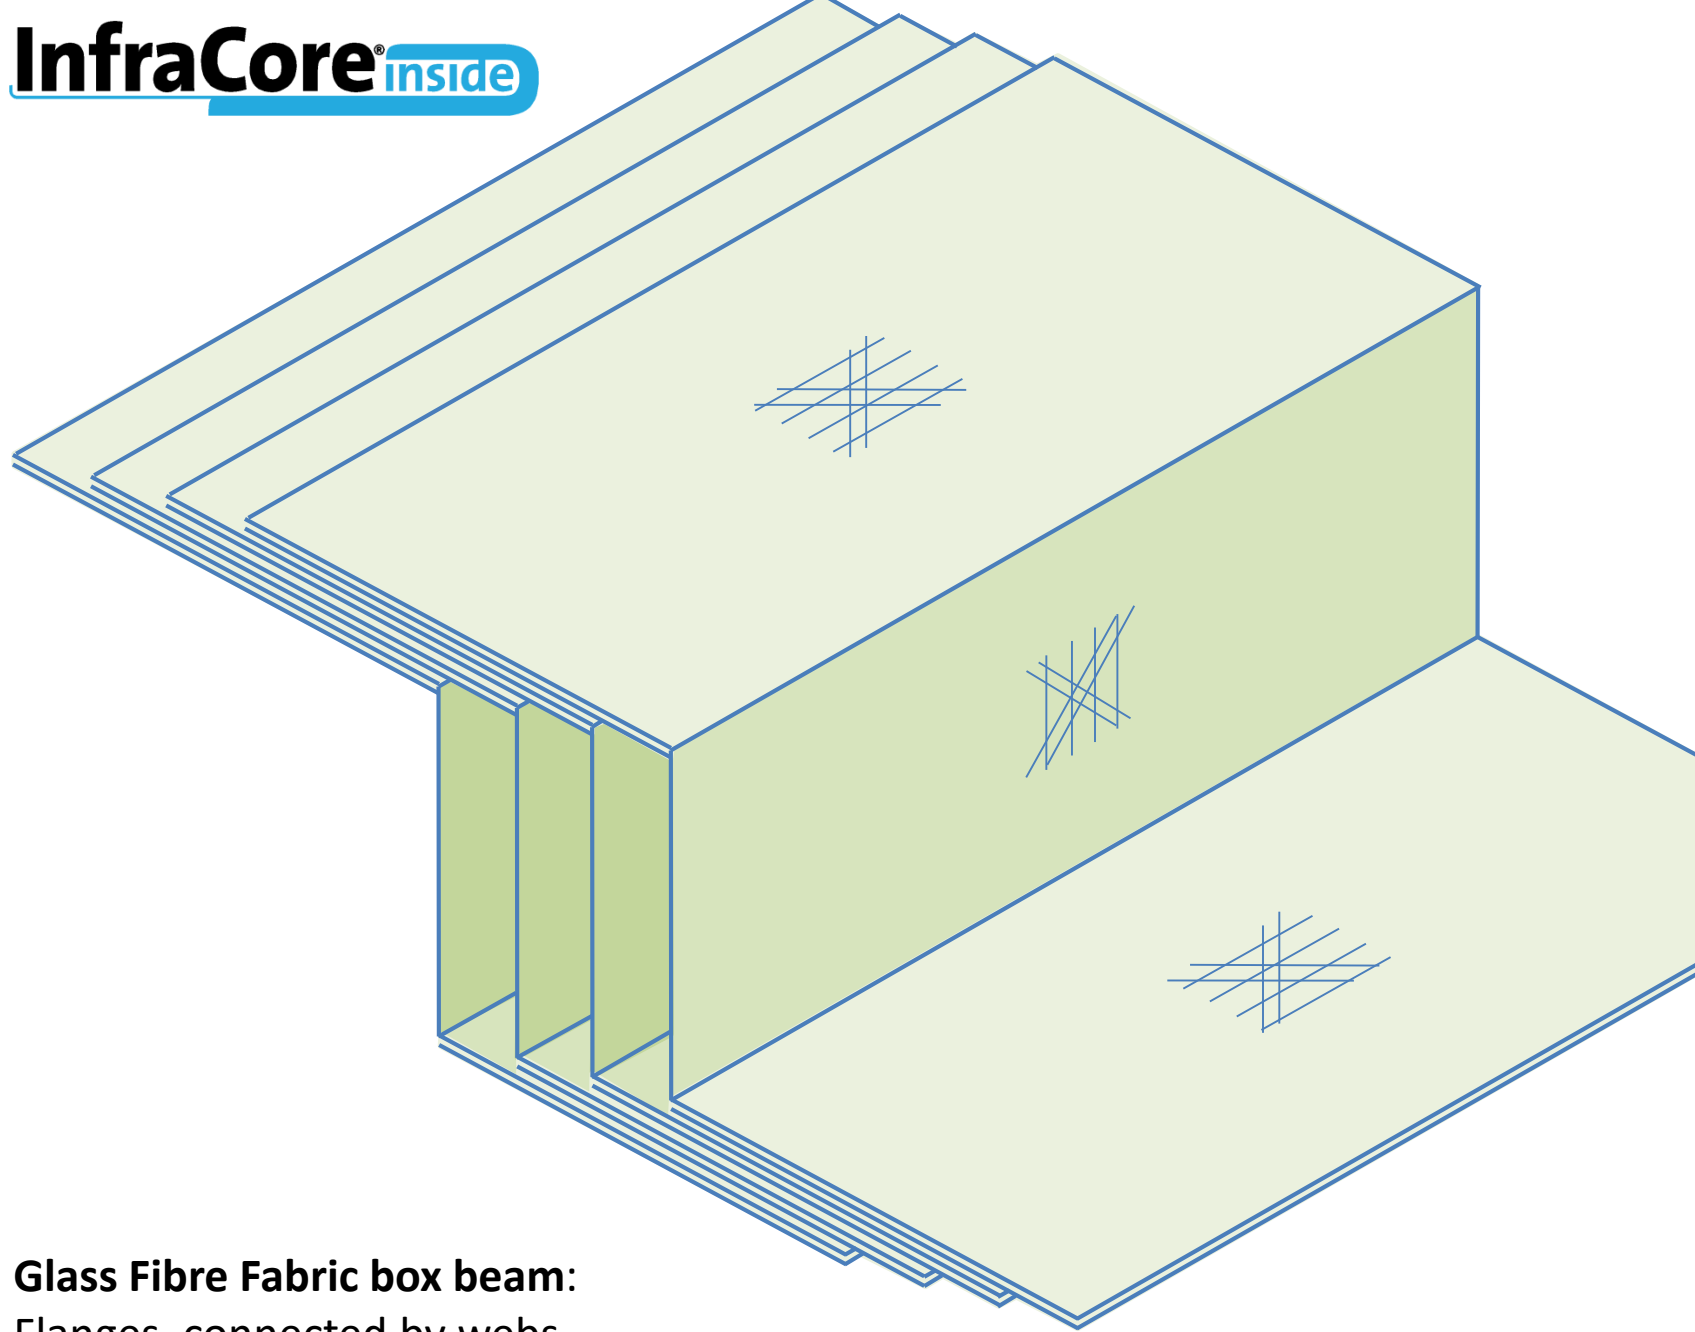
Glass Fibre Fabric box beam:

Flanges, connected by webs

Flanges 0°/ ±45° fabric, webs 90°/±45° fabric

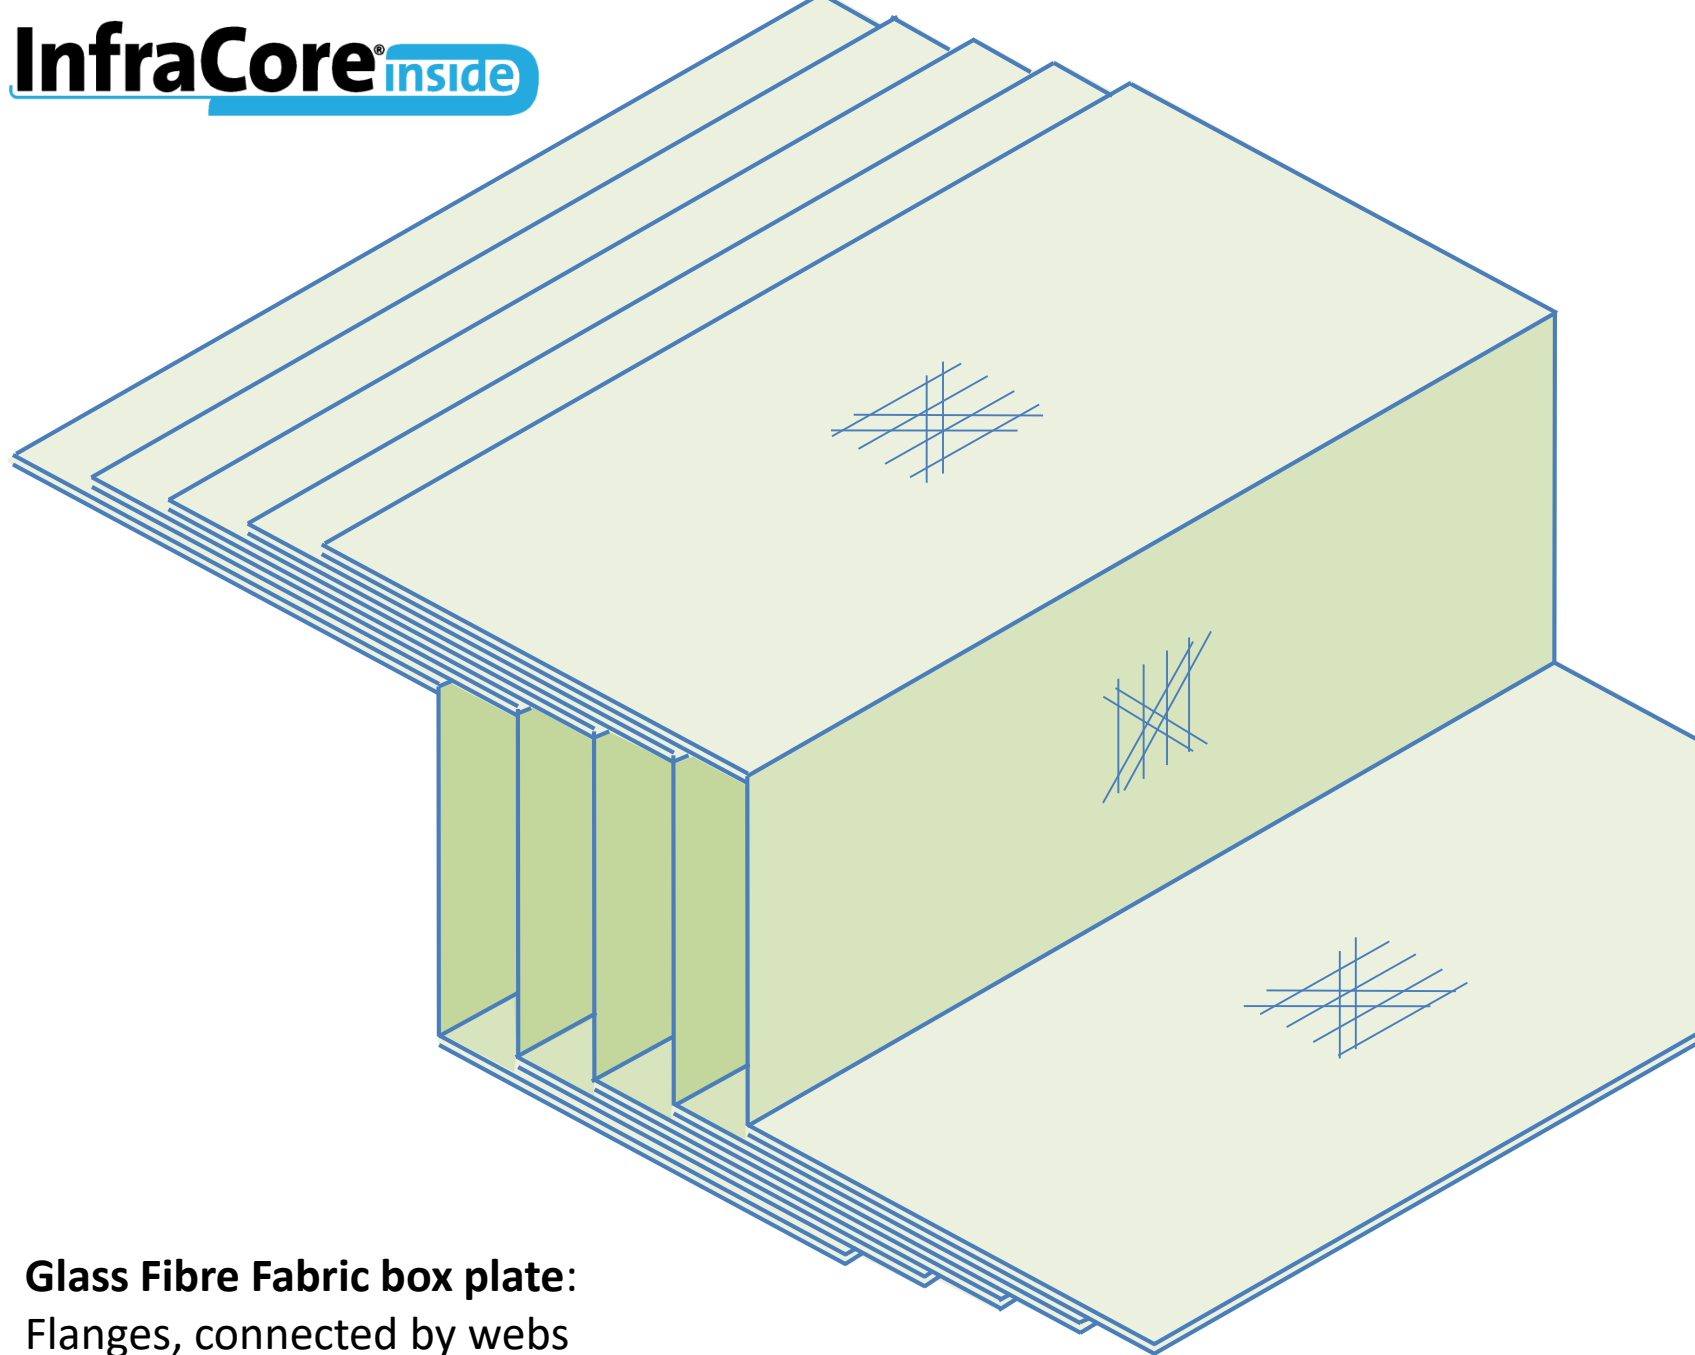
Glass Fibre Fabric box plate:

Flanges, connected by webs

Flanges 0°/ ±45° fabric, web 90°/±45° fabric

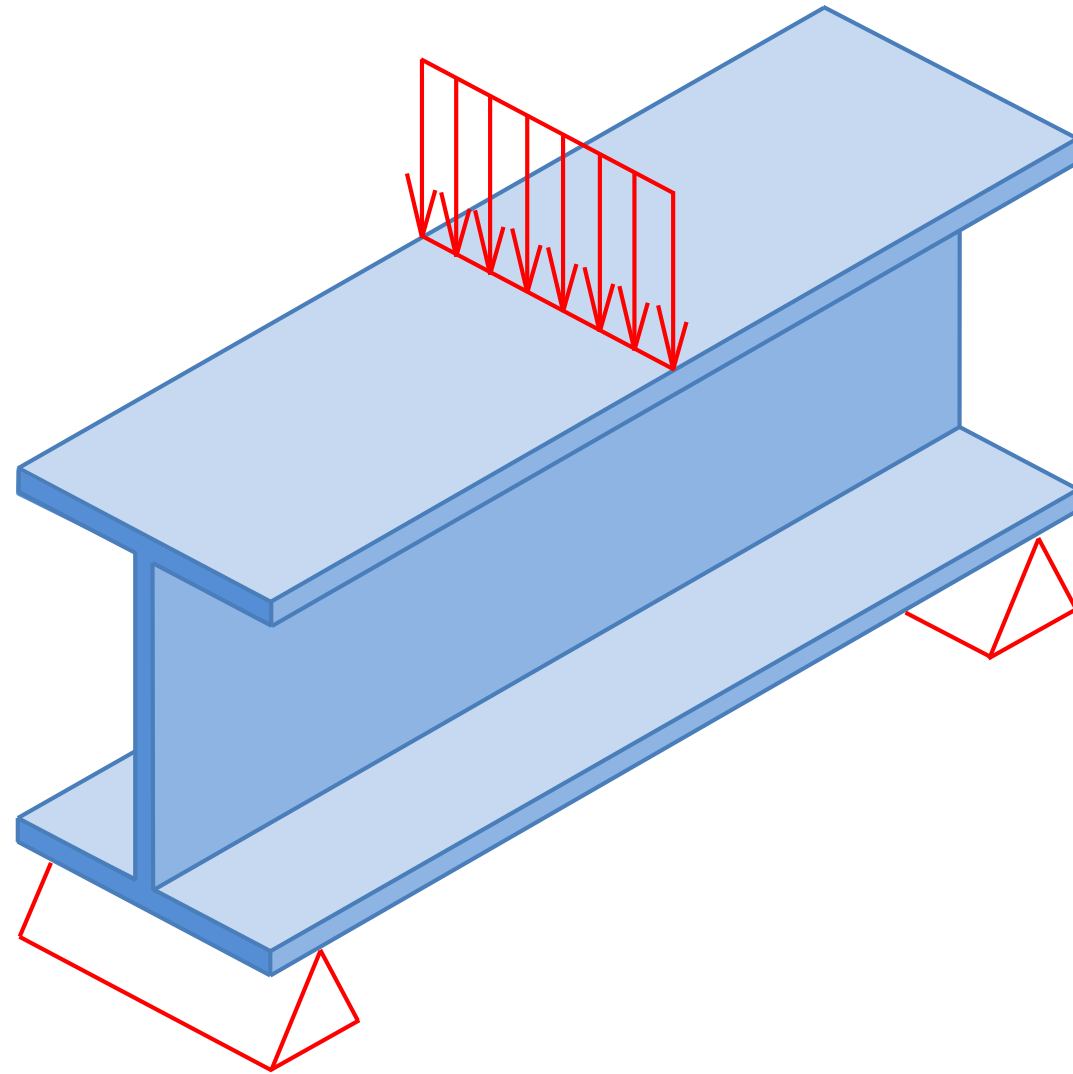
Steel beam
Loaded in three-point bending

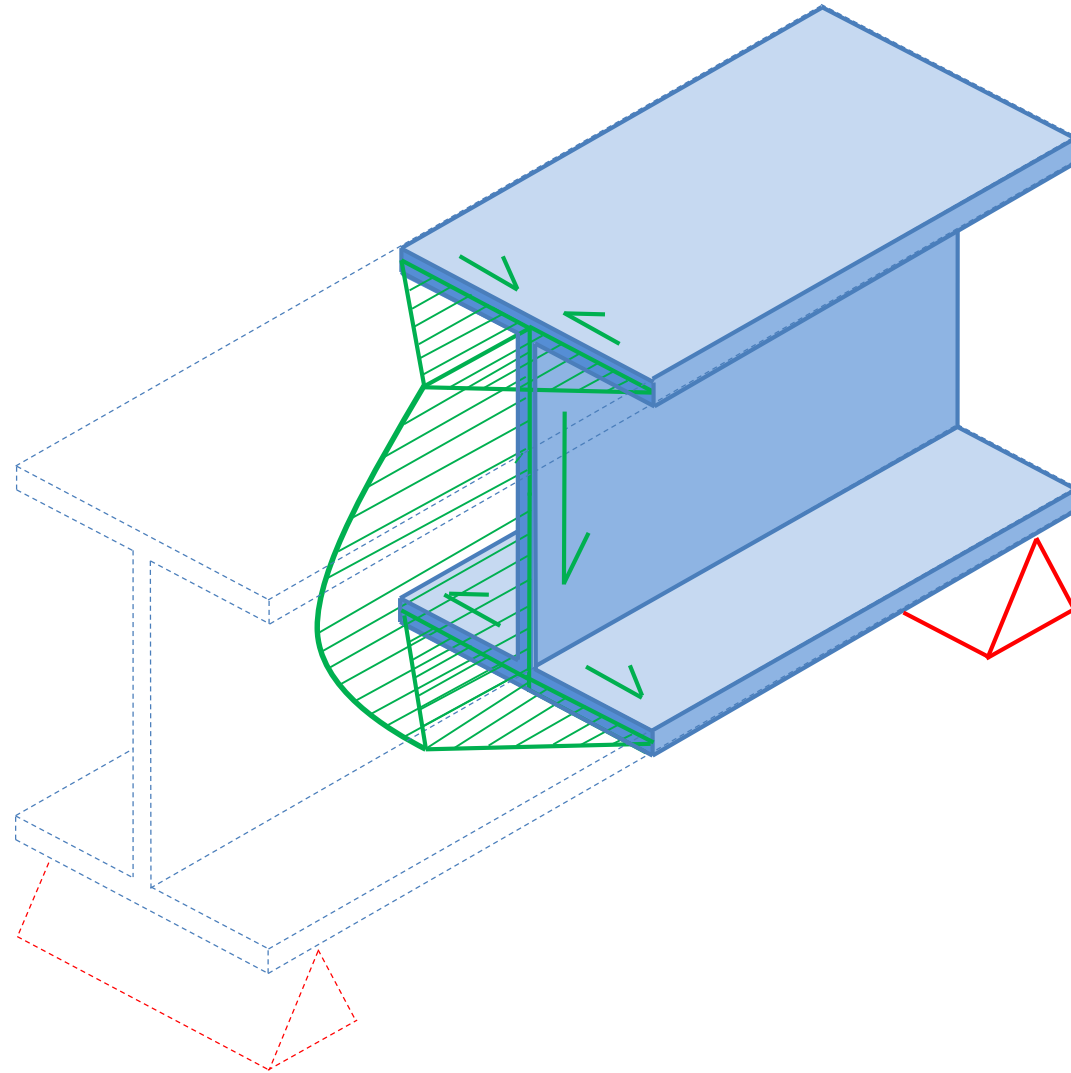
Steel beam

Loaded in three-point bending

Shear load distribution on cross section
