The essence of InfraCore Inside[®]

A brief introduction

InfraCore Inside looks and feels like a sandwich structure, but it has a more direct descent from beams, in fact multi-beam plates.

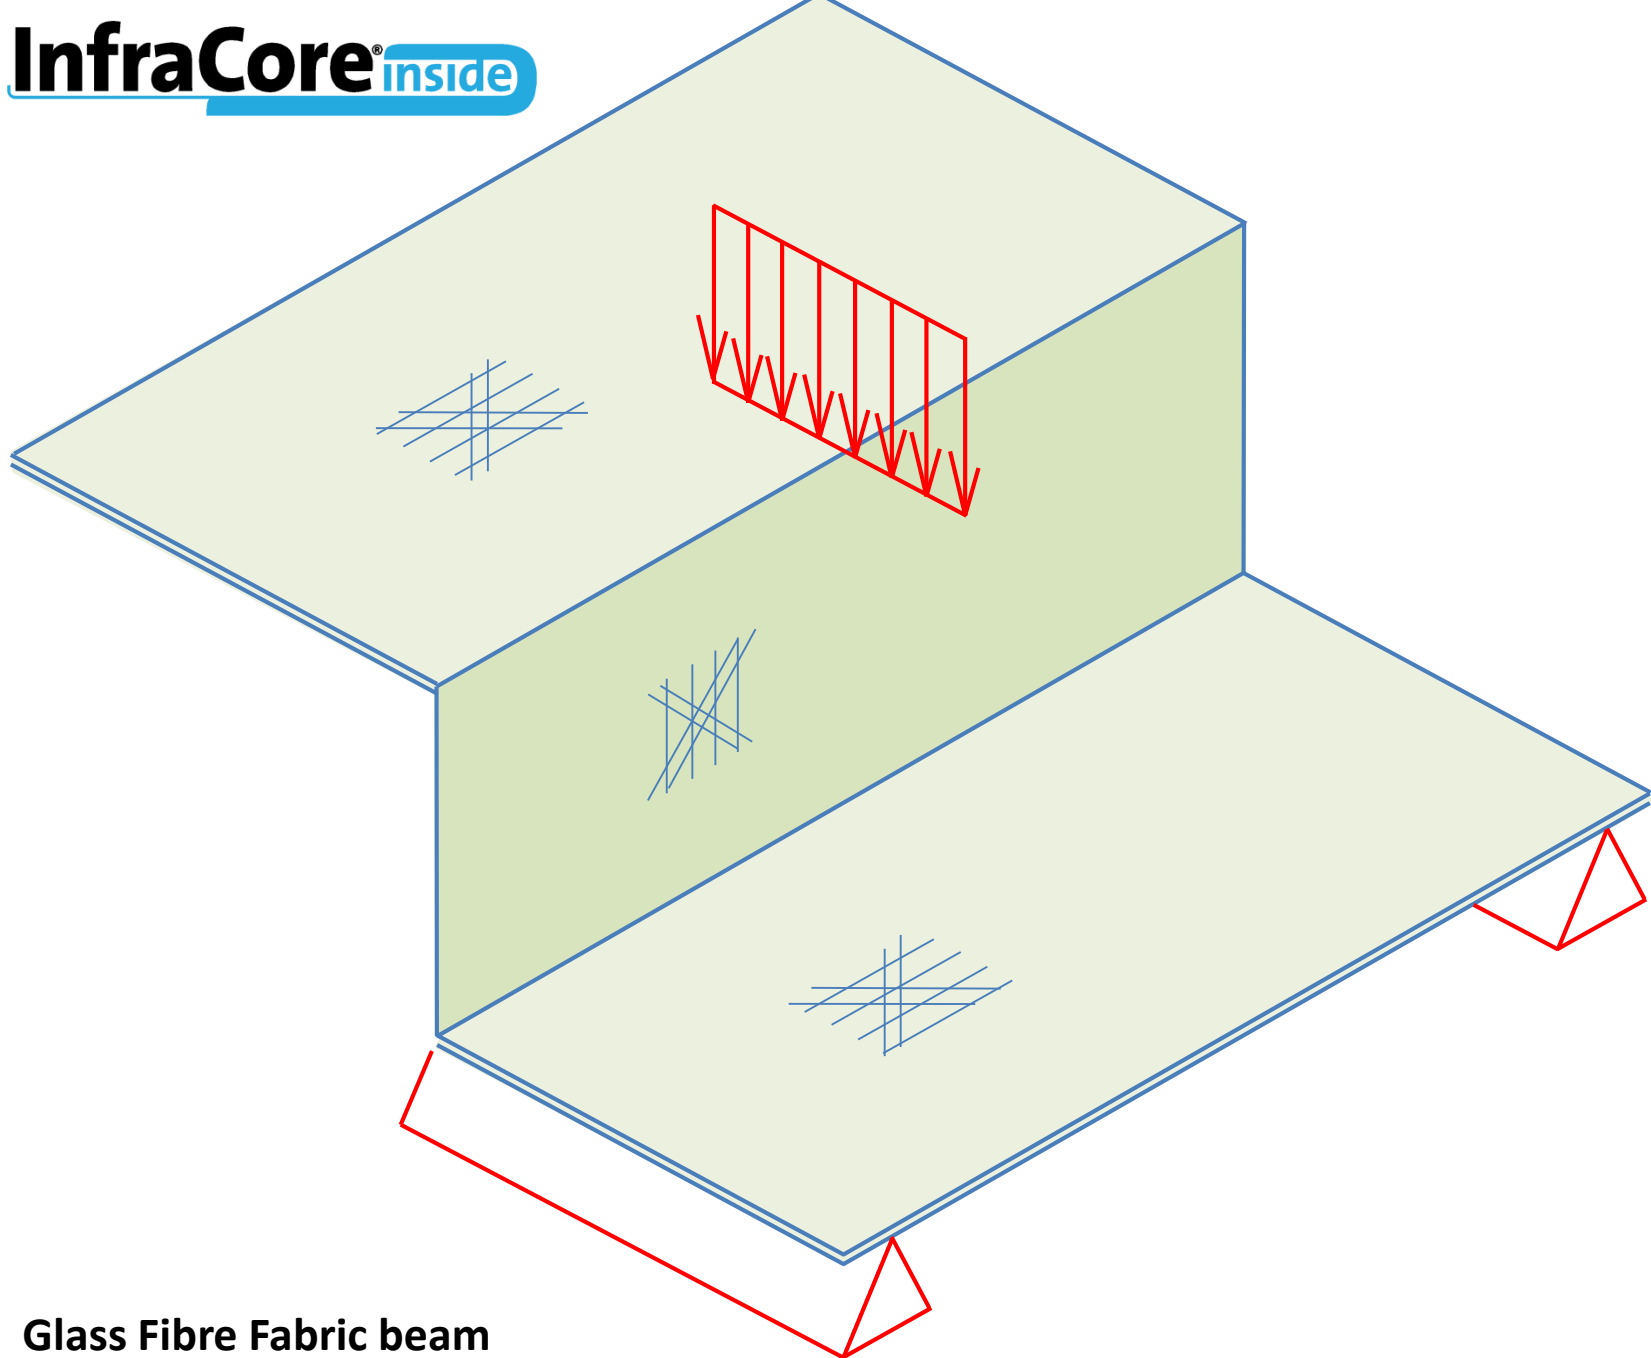
Glass Fibre Fabric beam
Loaded in three-point bending

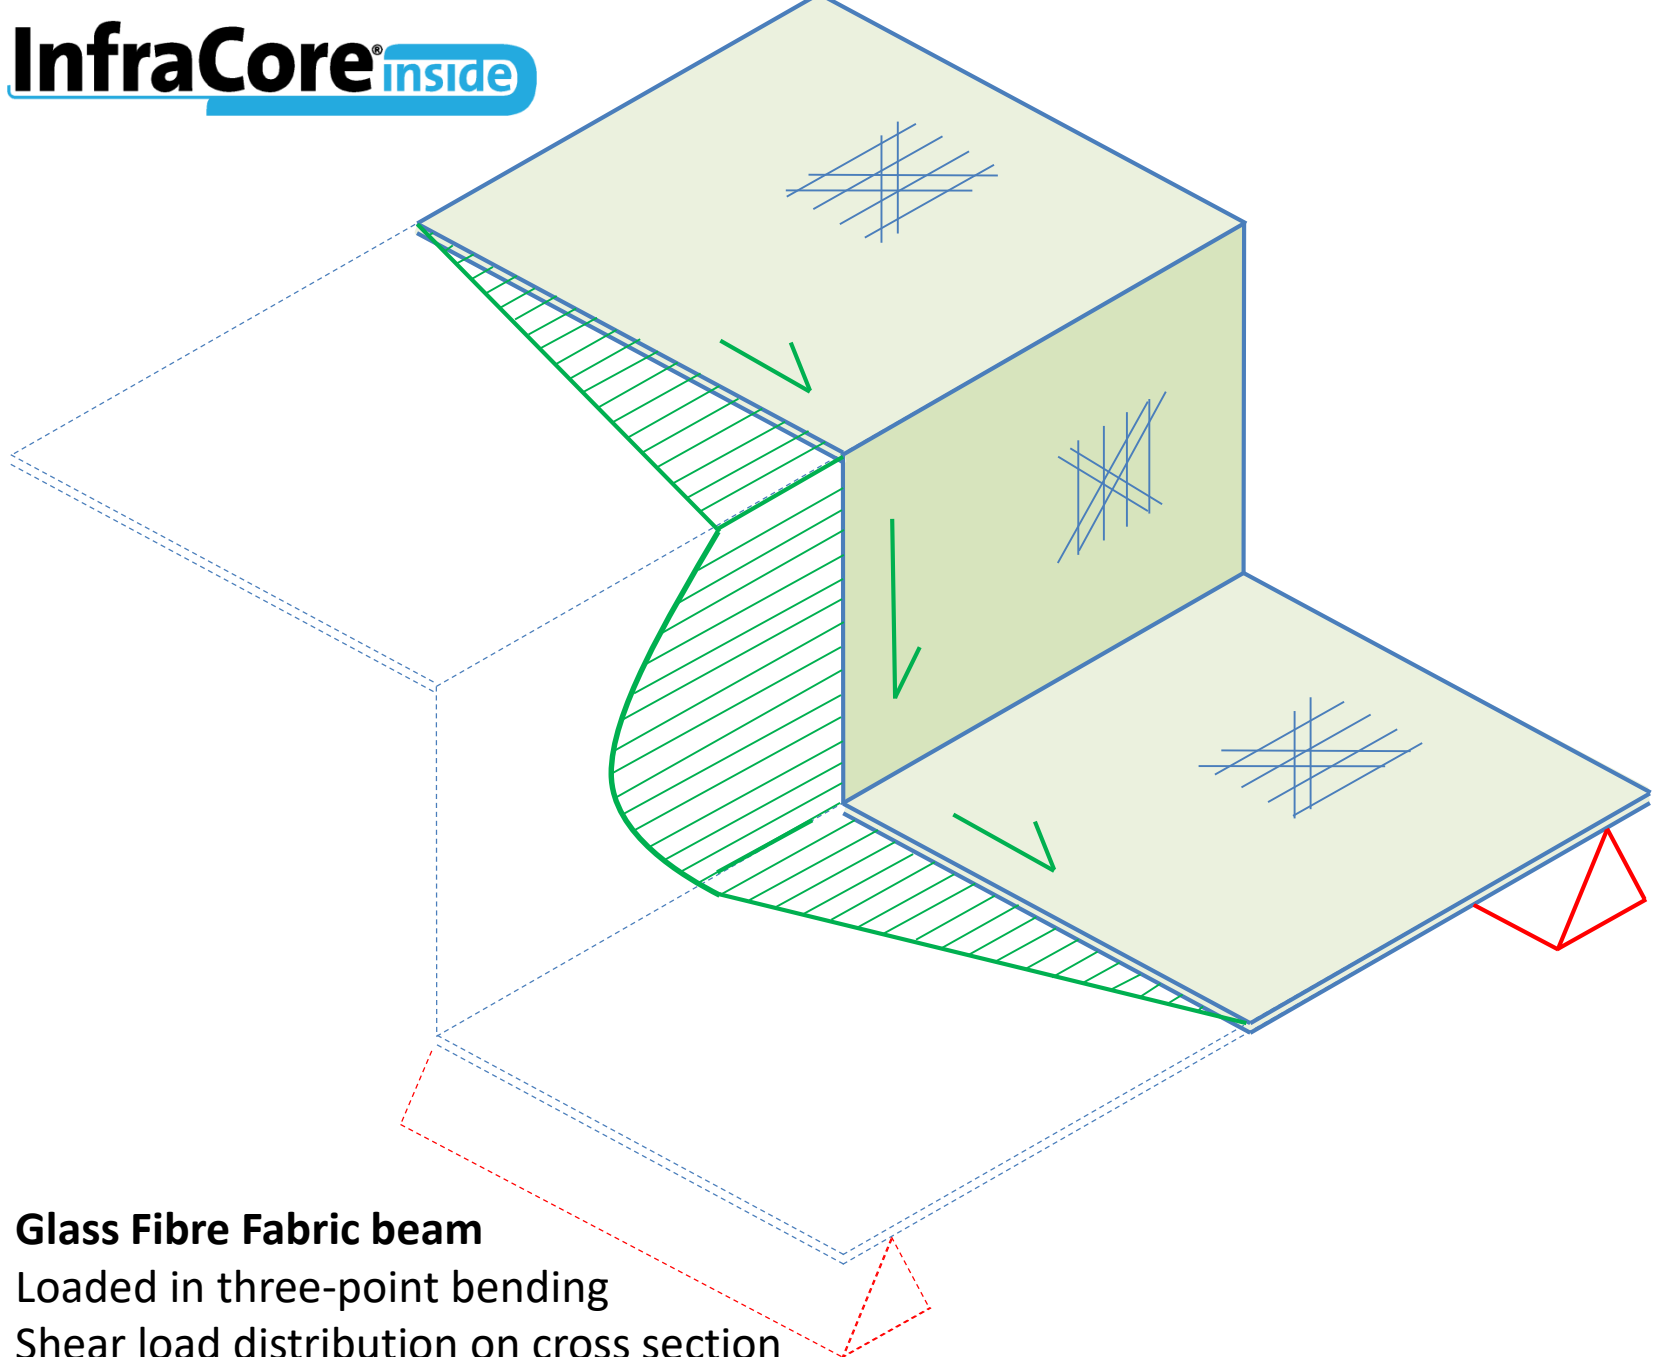
Glass Fibre Fabric beam

Loaded in three-point bending

Shear load distribution on cross section

Continuous transfer of shear loads

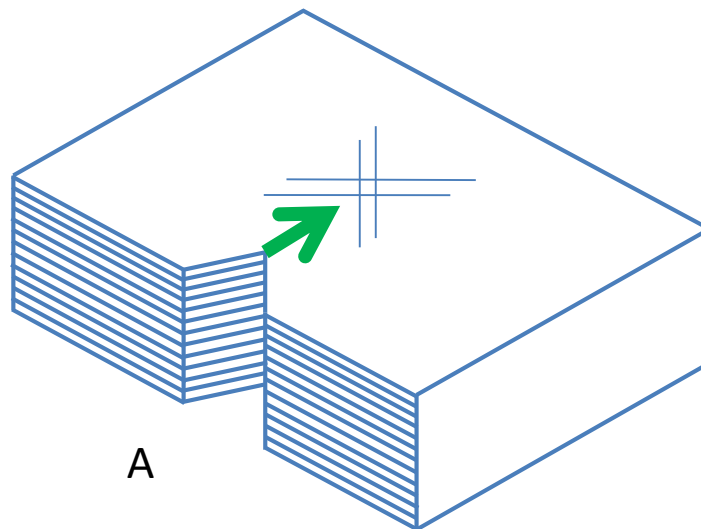
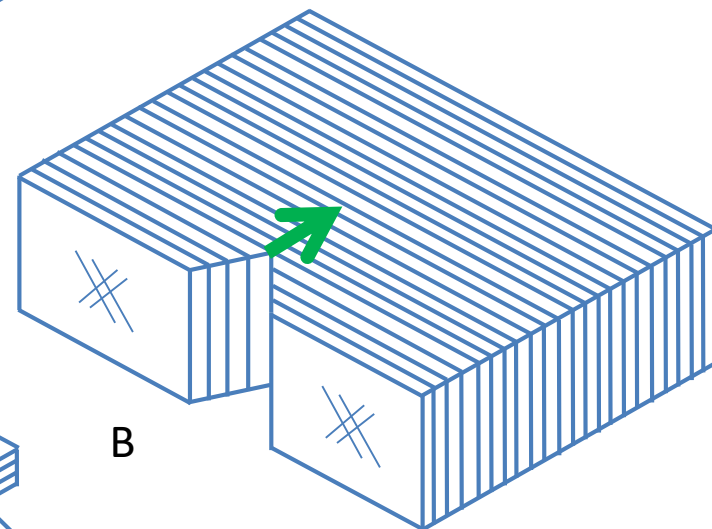
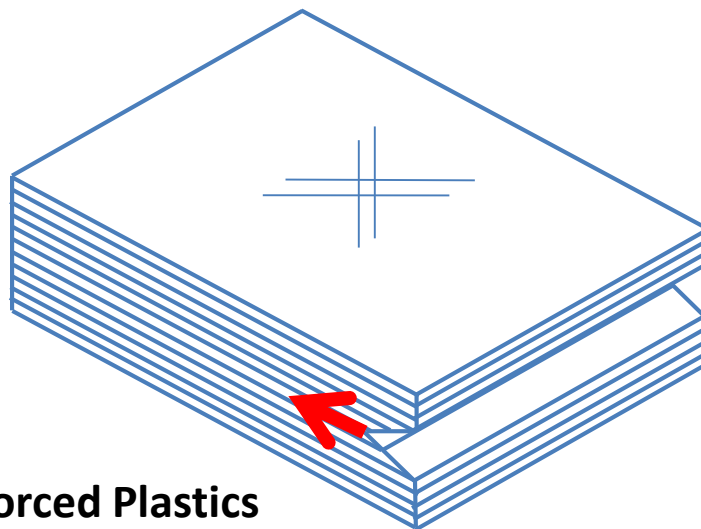
Fibre Reinforced Plastics

Non-homogeneous, layered material

Fibres act as crack arrestors

Vulnerable to cracking between fibre layers (“interlaminar cracking”)

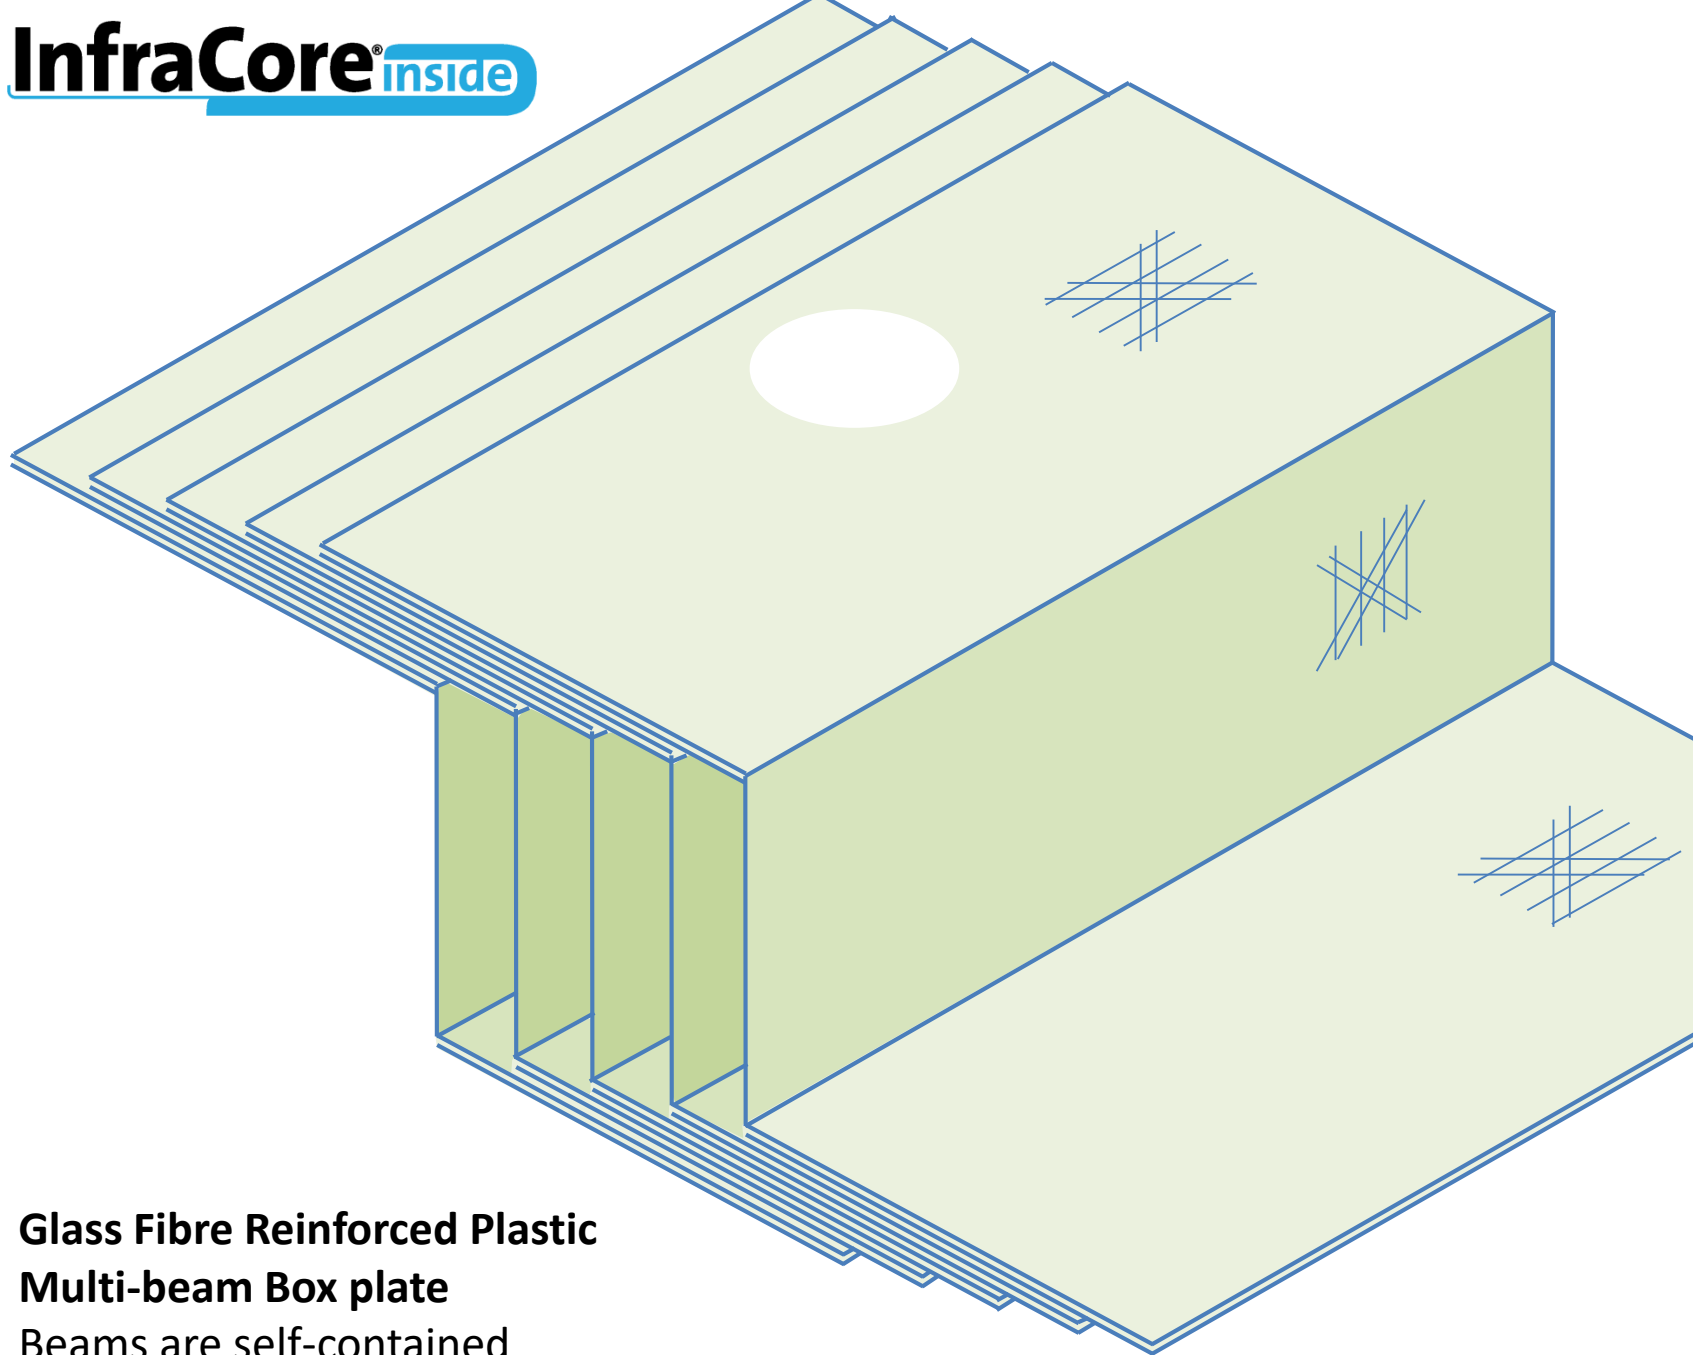
Glass Fibre Reinforced Plastic Multi-beam Box plate

Beams are self-contained

Little shear transfer between beams

Impact damage may occur: local delamination

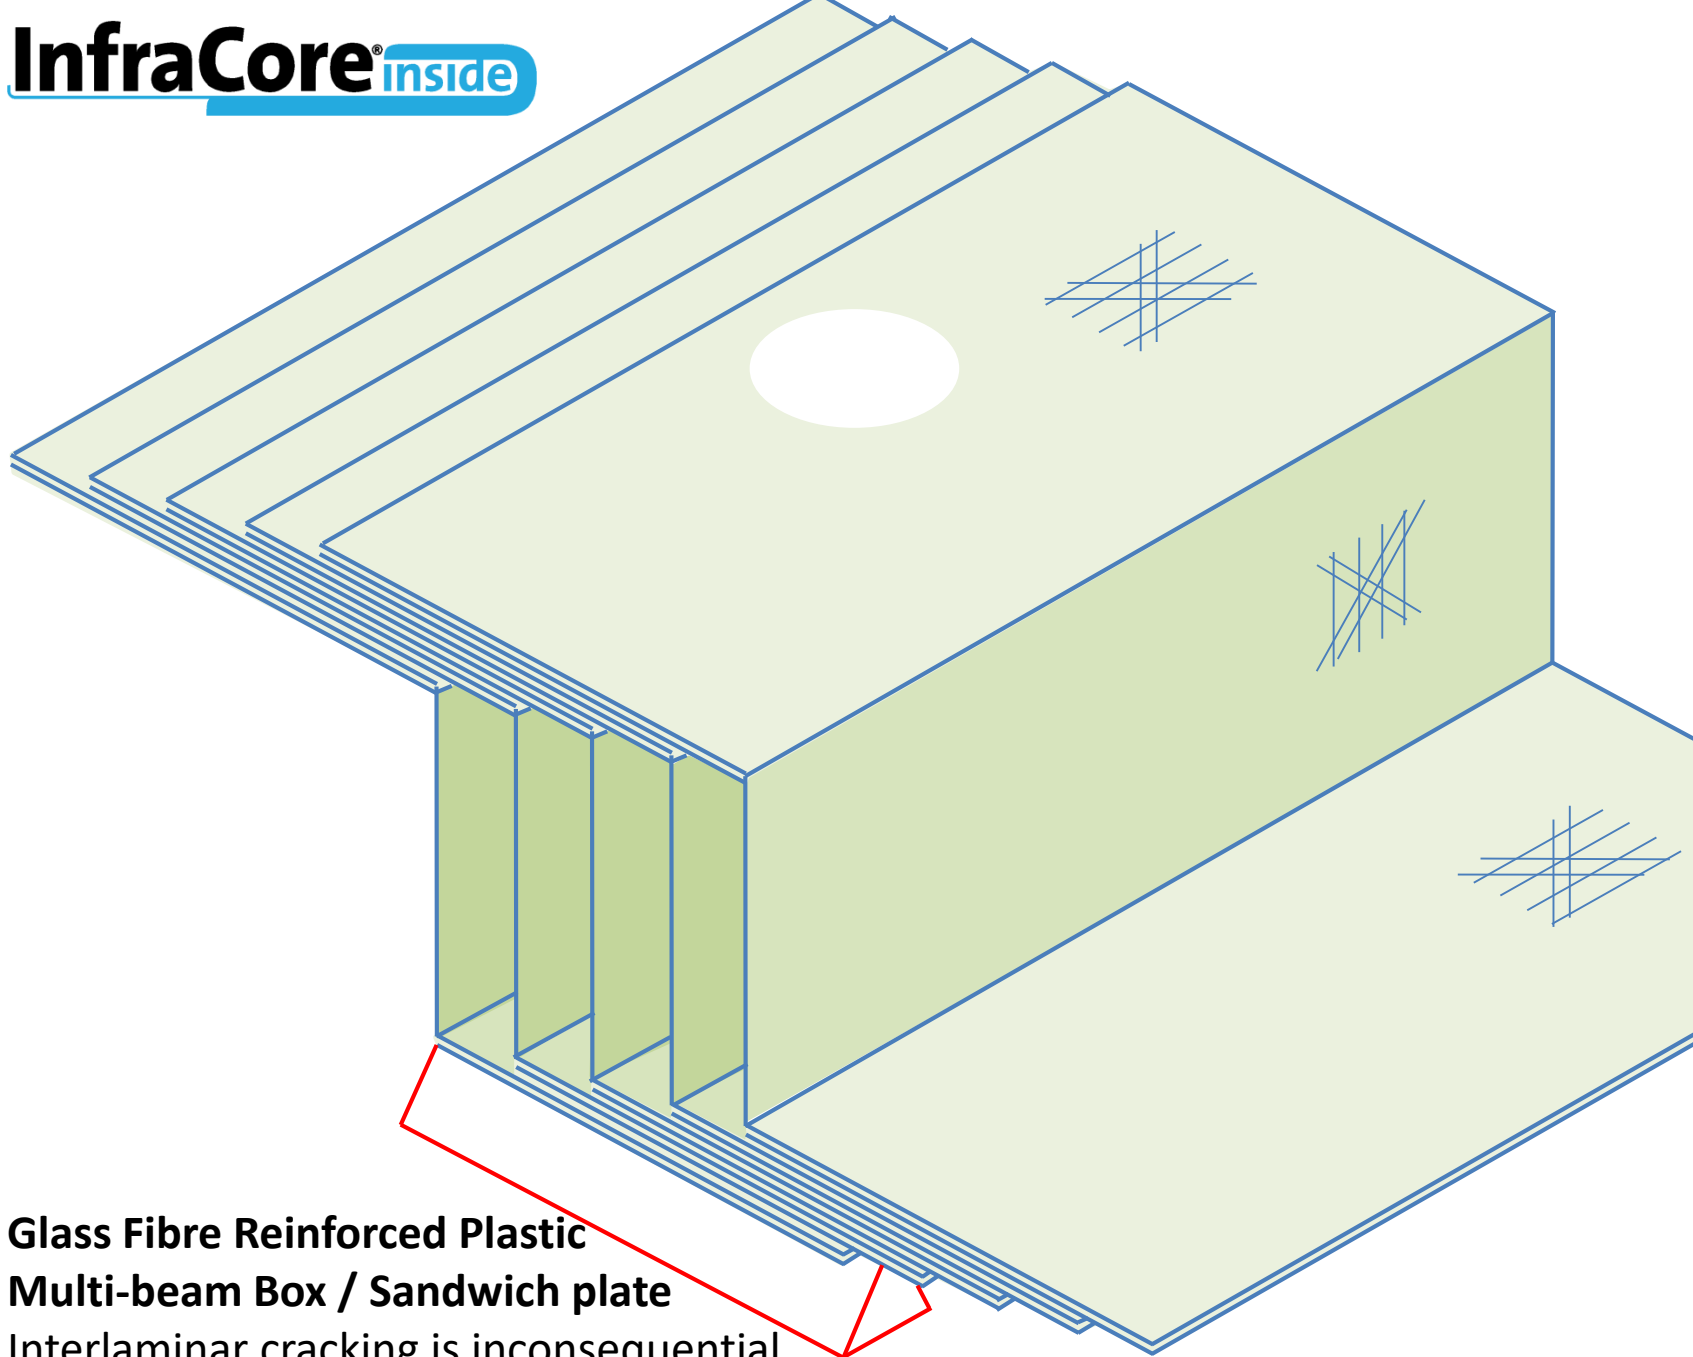
Glass Fibre Reinforced Plastic Multi-beam Box / Sandwich plate

Interlaminar cracking is inconsequential

No skin-core debonding, no damage growth

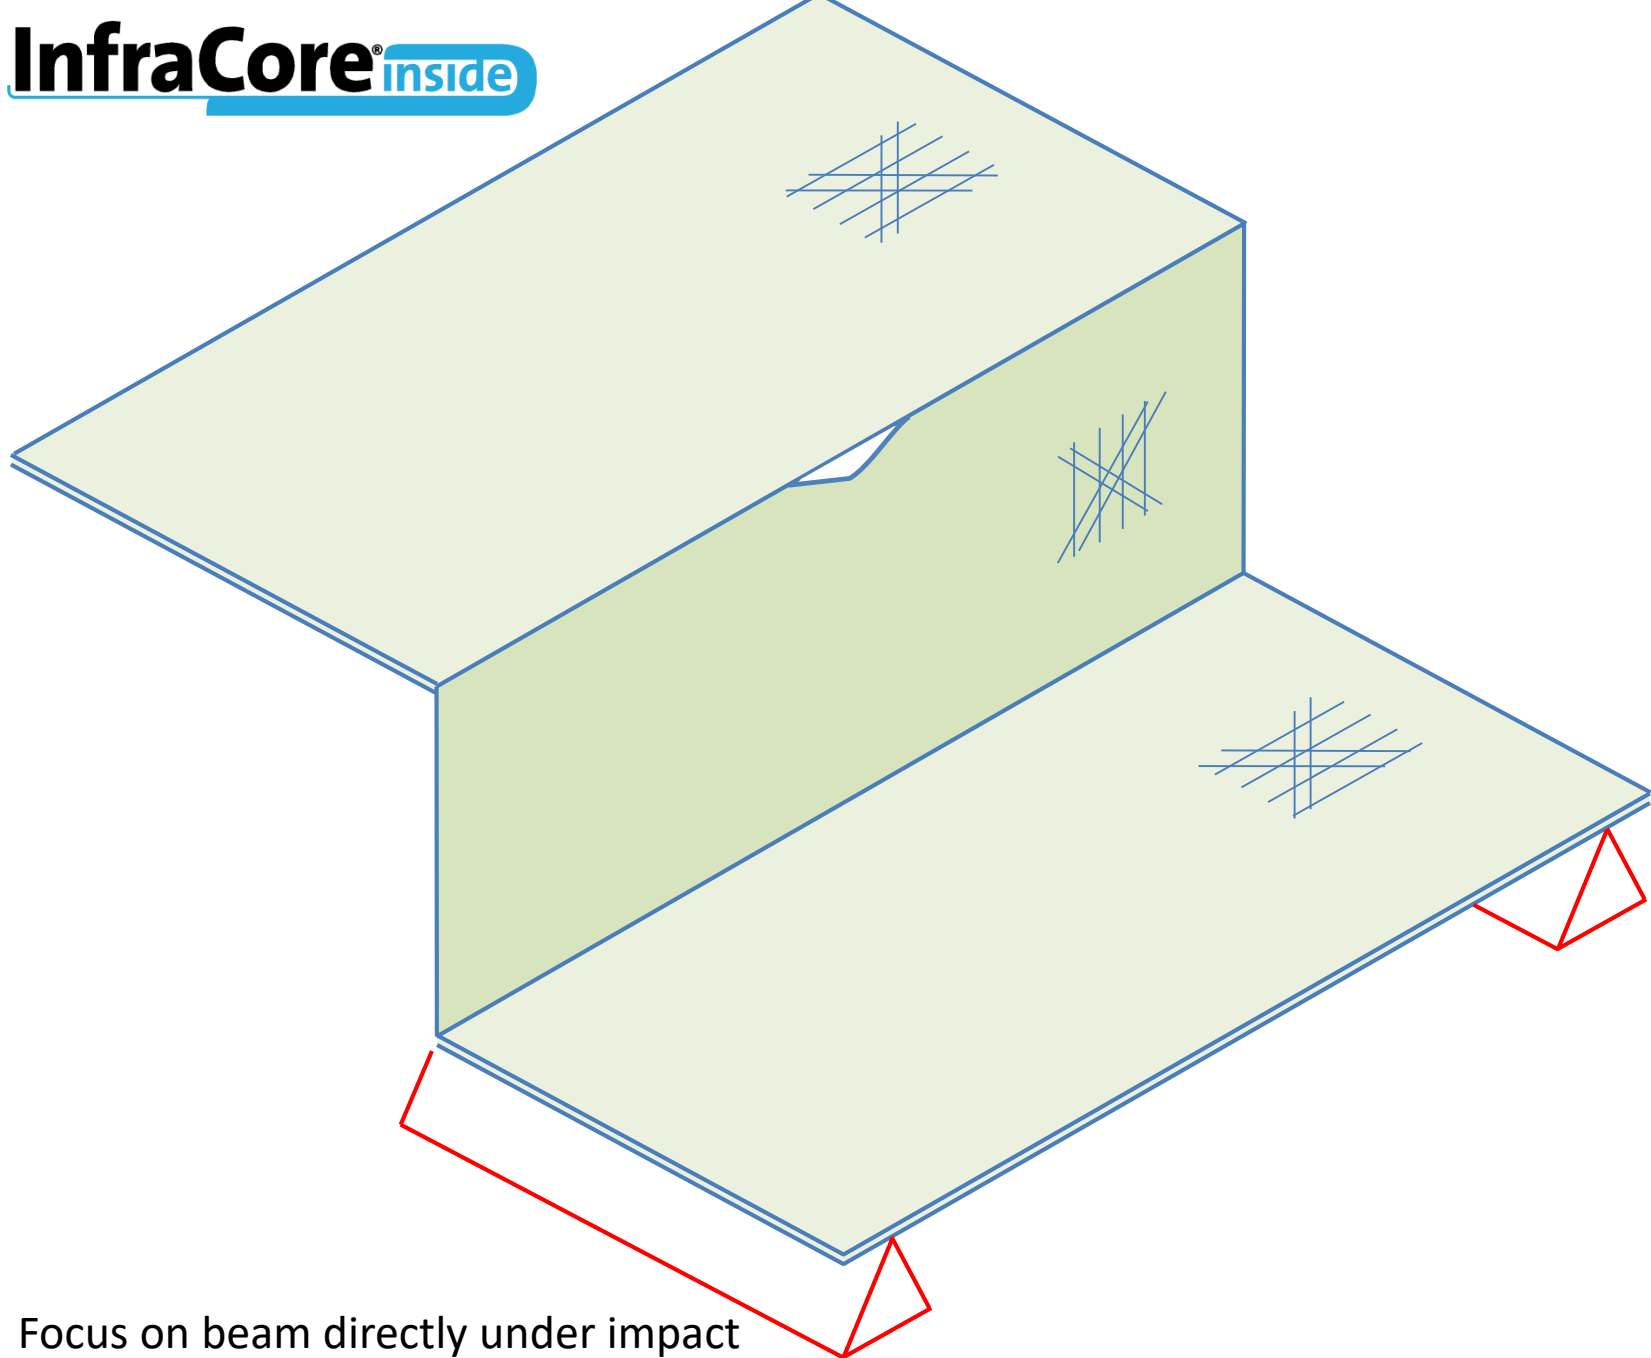
Focus on beam directly under impact
A crack in flange-web zone may occur

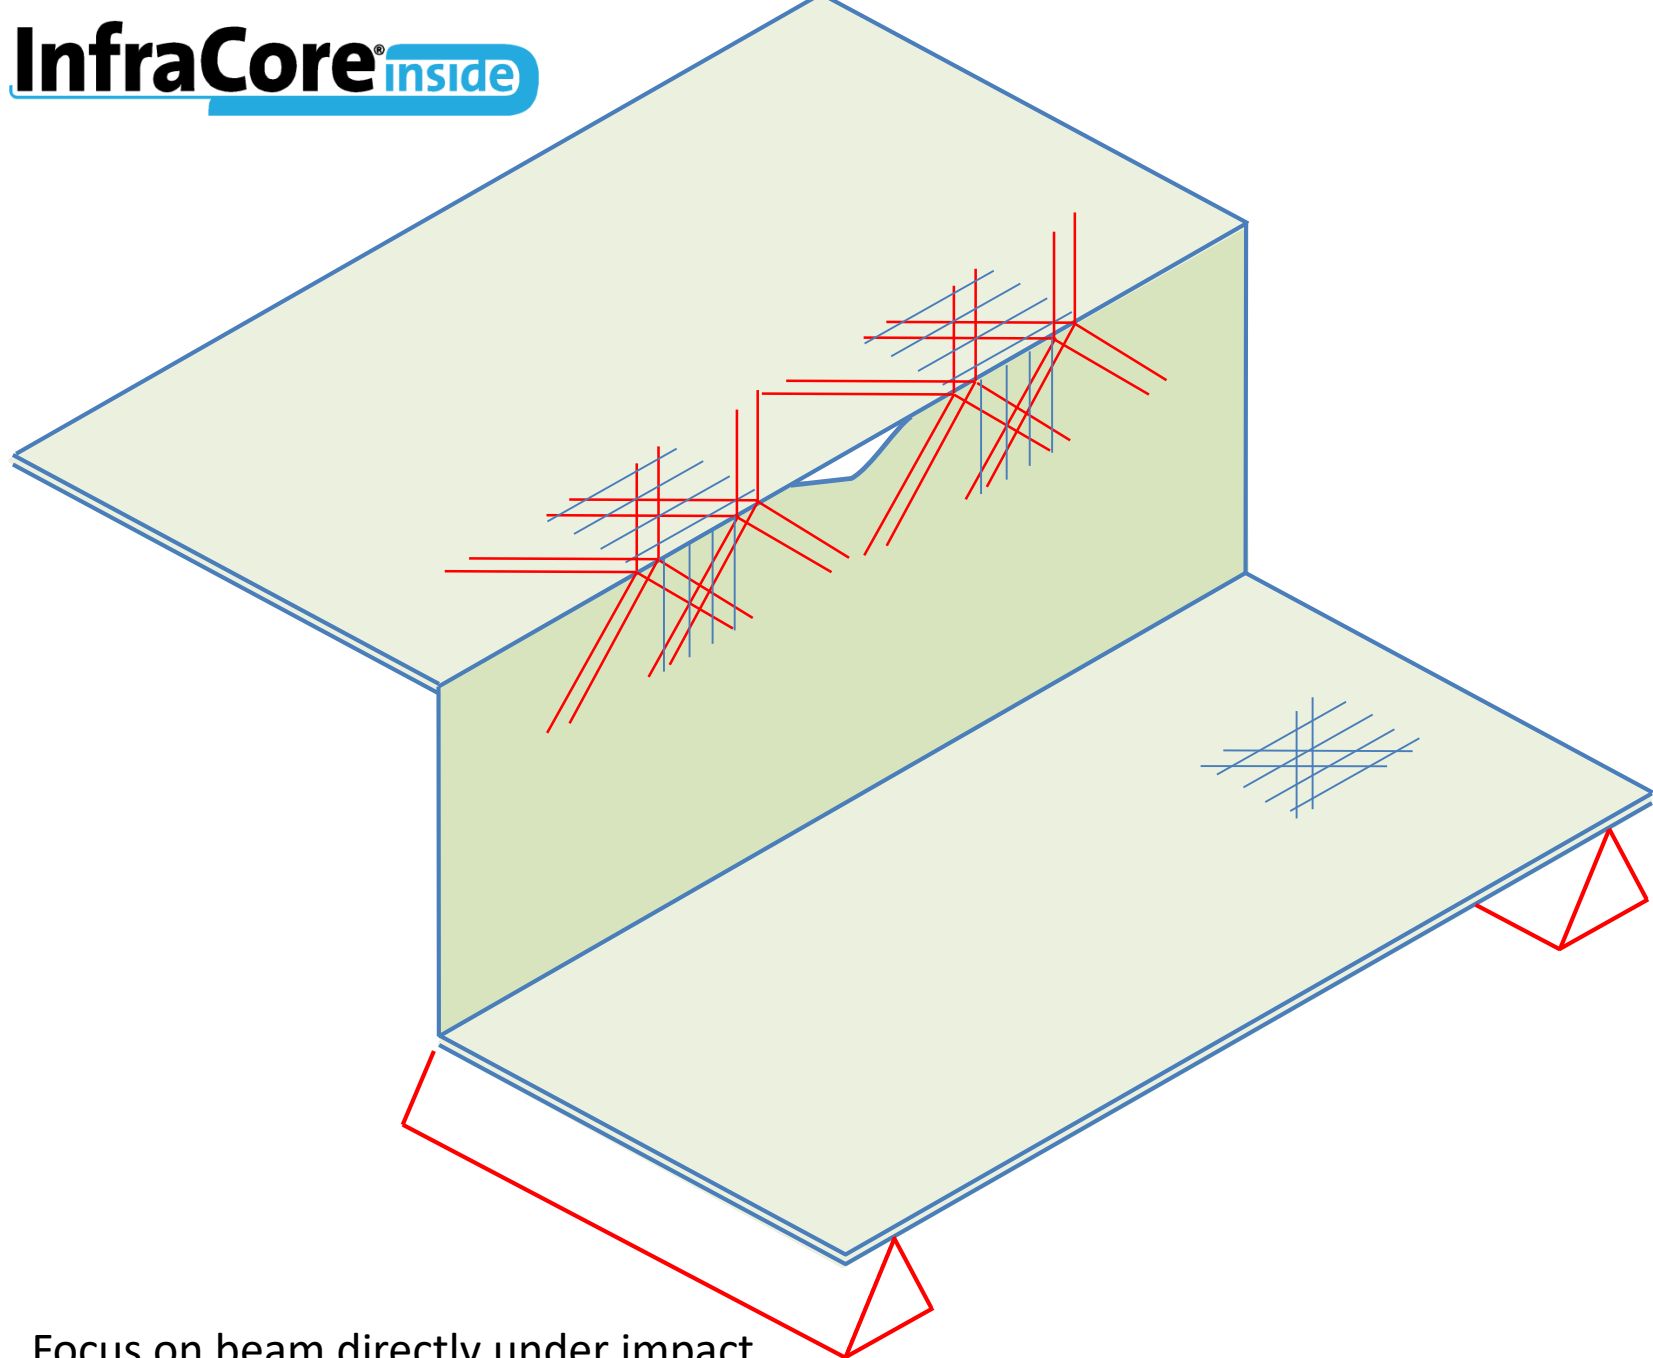
Focus on beam directly under impact
Crack will not grow, constricted by fibres

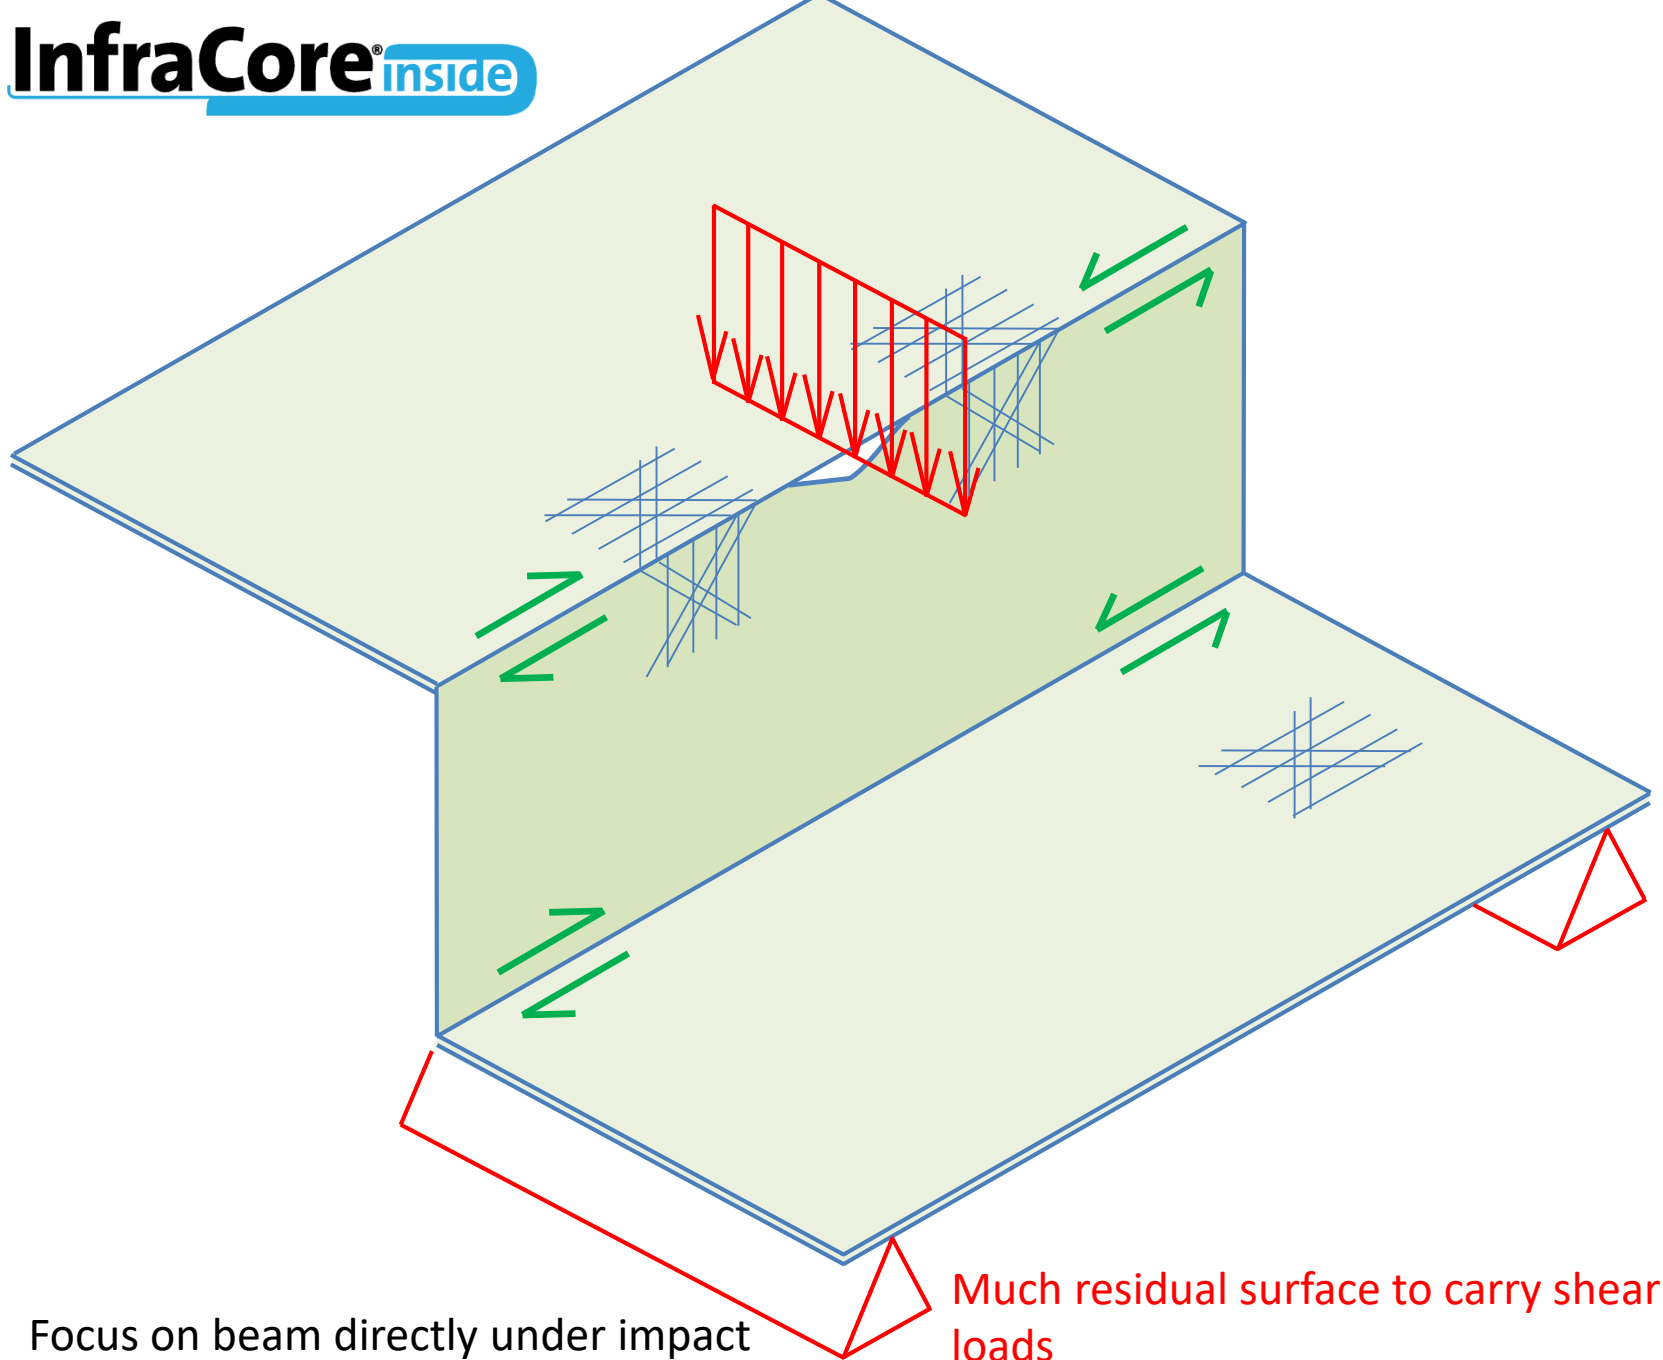
Focus on beam directly under impact
Beam can carry load despite crack

Much residual surface to carry shear loads
Stable situation

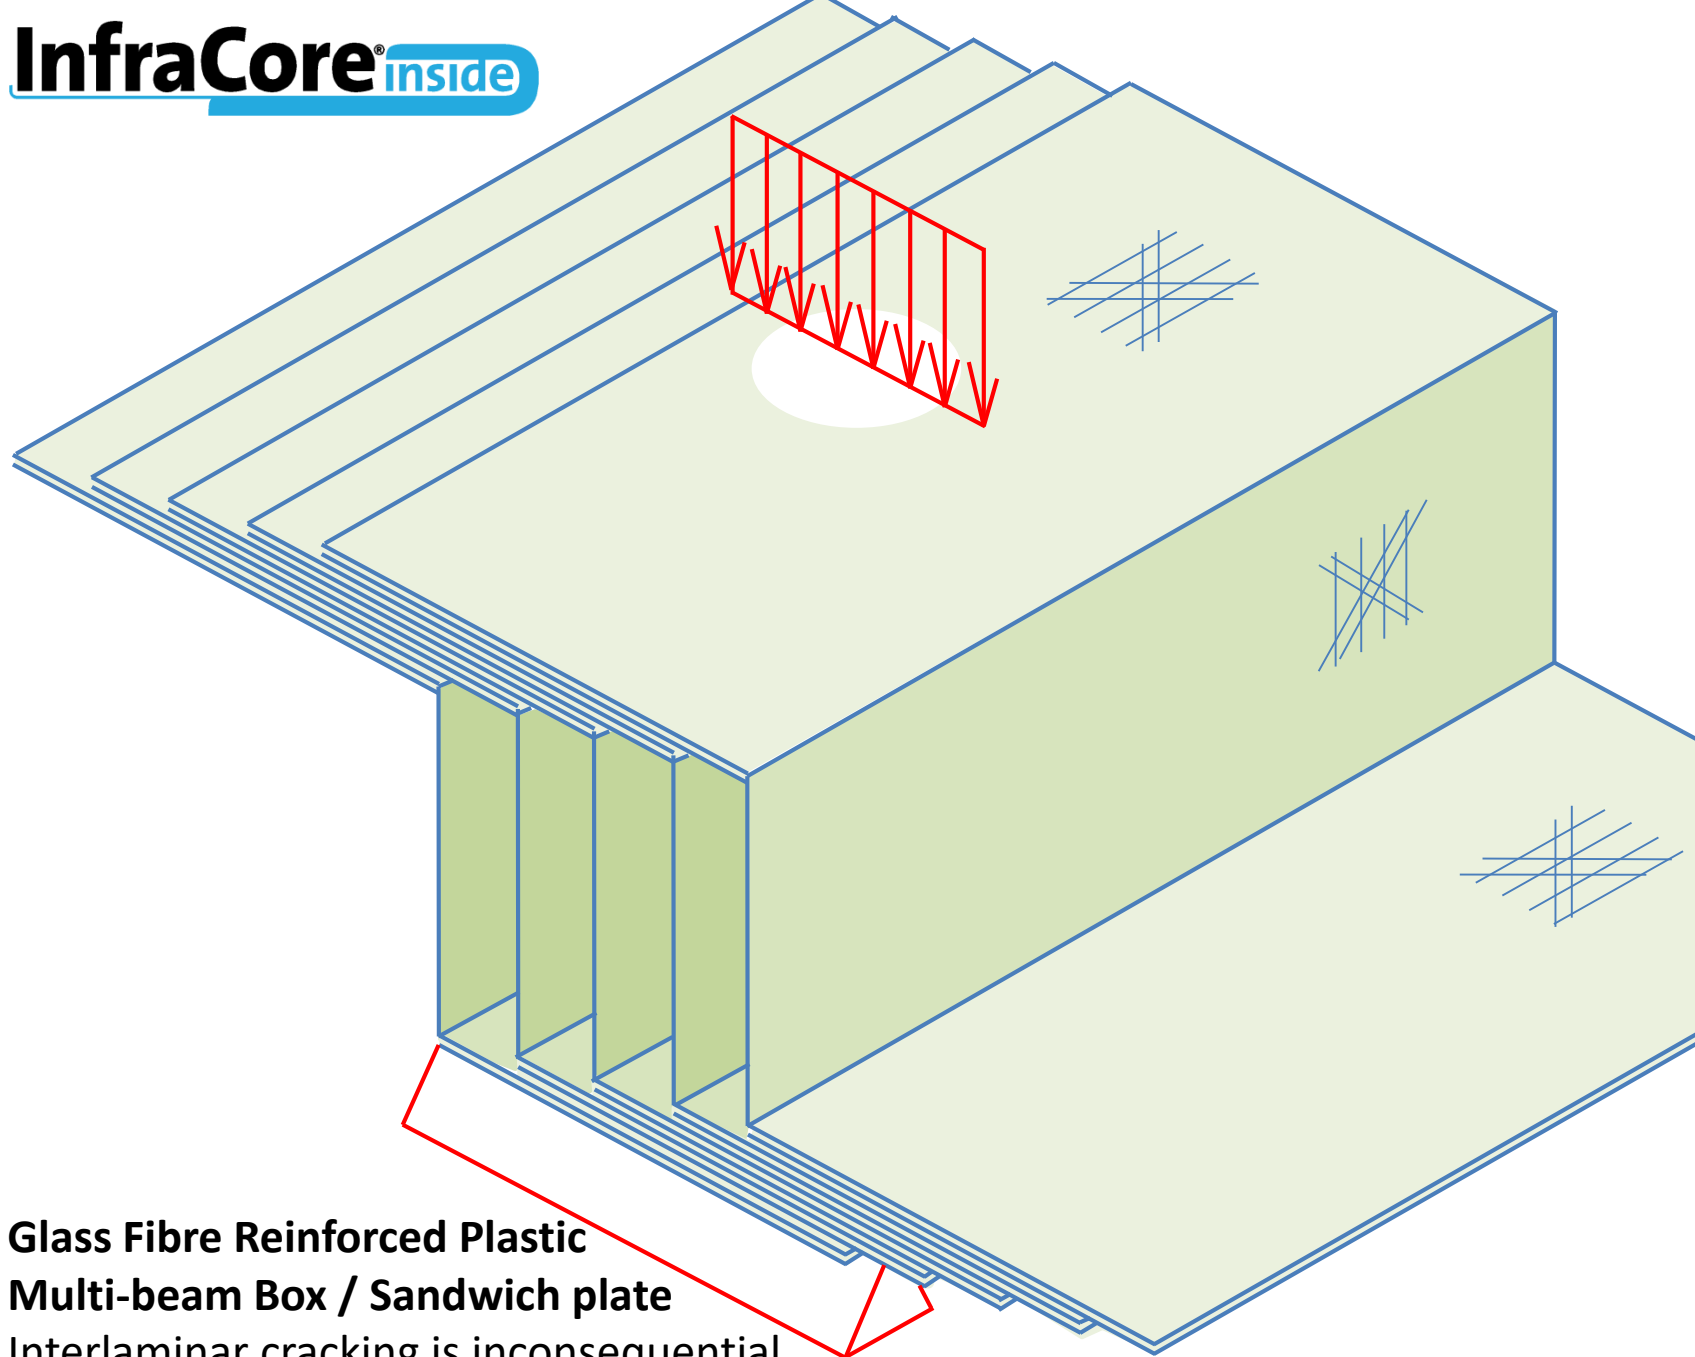
Glass Fibre Reinforced Plastic Multi-beam Box / Sandwich plate

Interlaminar cracking is inconsequential

No skin-core debonding → EXTREMELY ROBUST

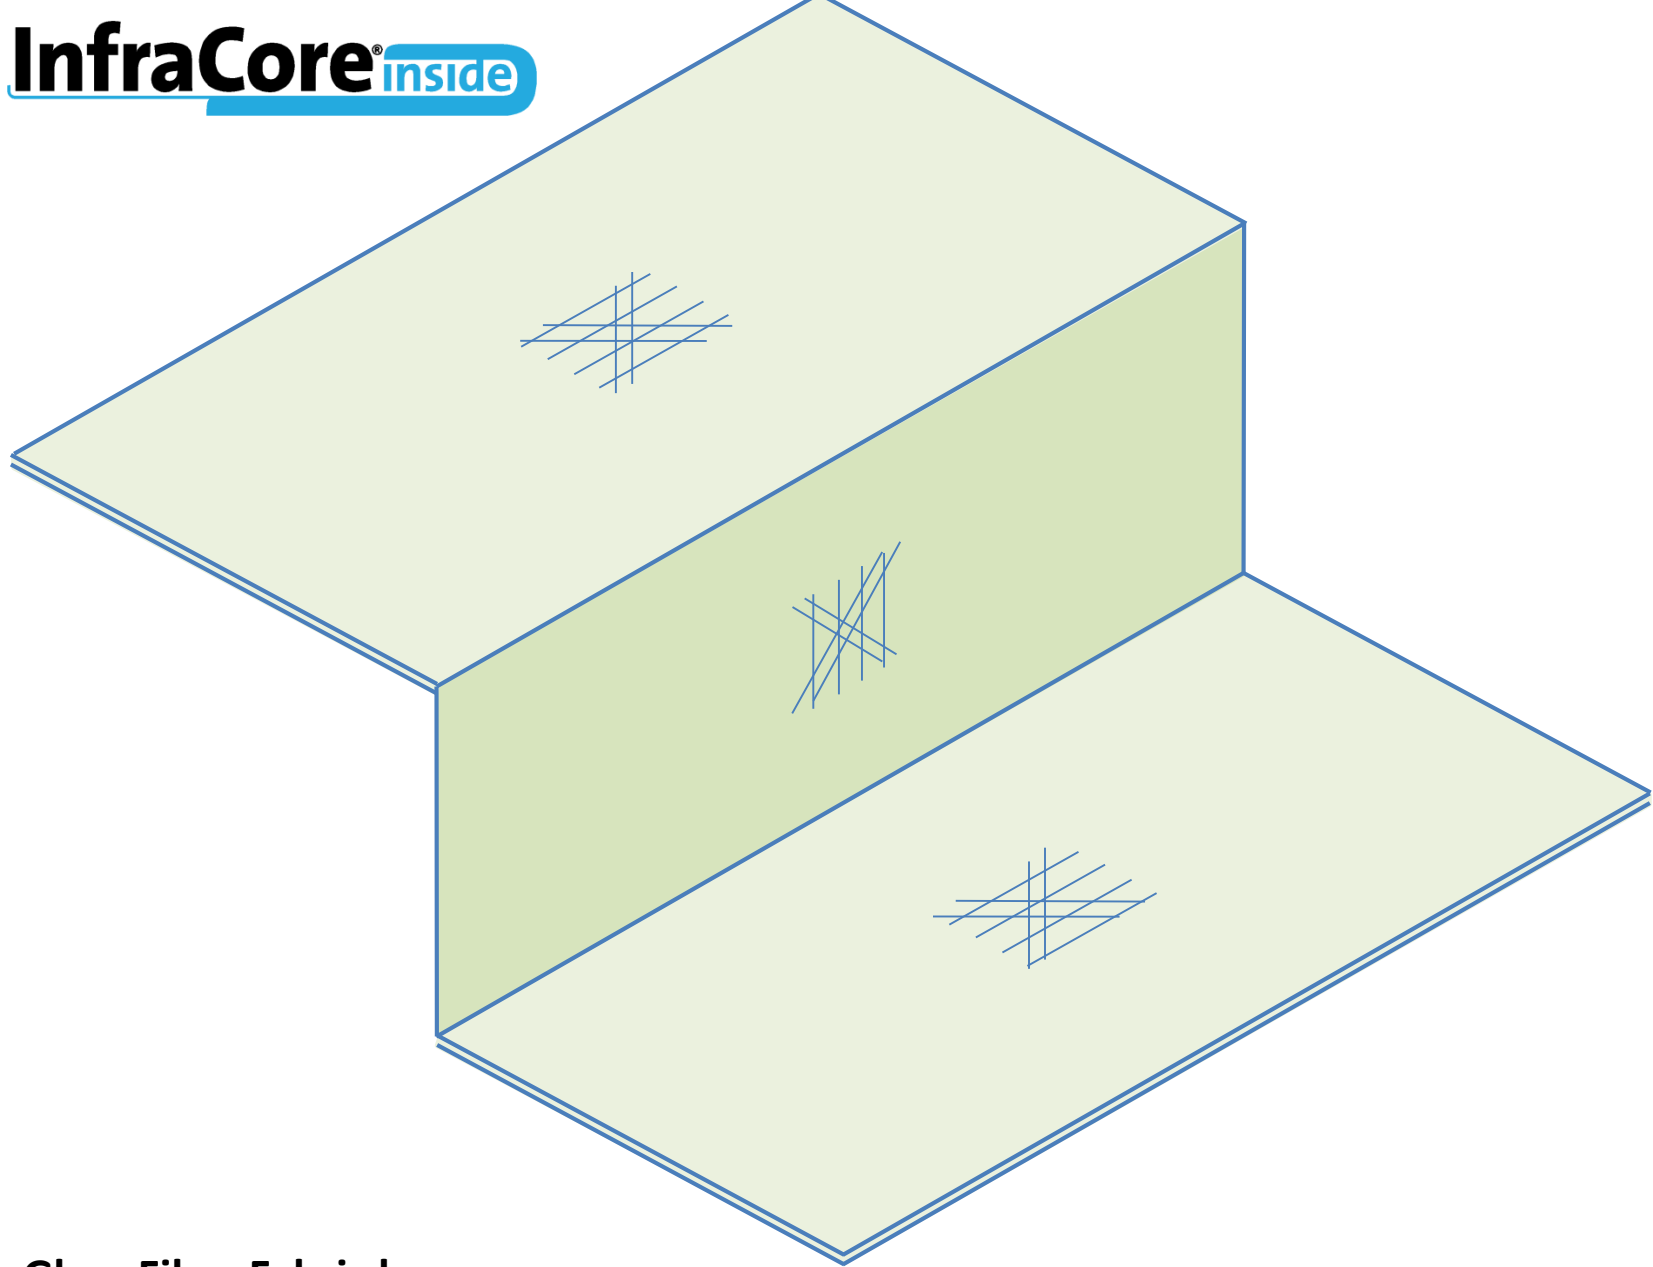
Glass Fibre Fabric beam:

Two flanges, connected by a web

Flanges 0°/ ±45° fabric, web 90°/±45° fabric
