The essence of InfraCore Inside[®]

A brief introduction

InfraCore Inside looks and feels like a sandwich structure, but it has a more direct descent from beams, in fact multi-beam plates.

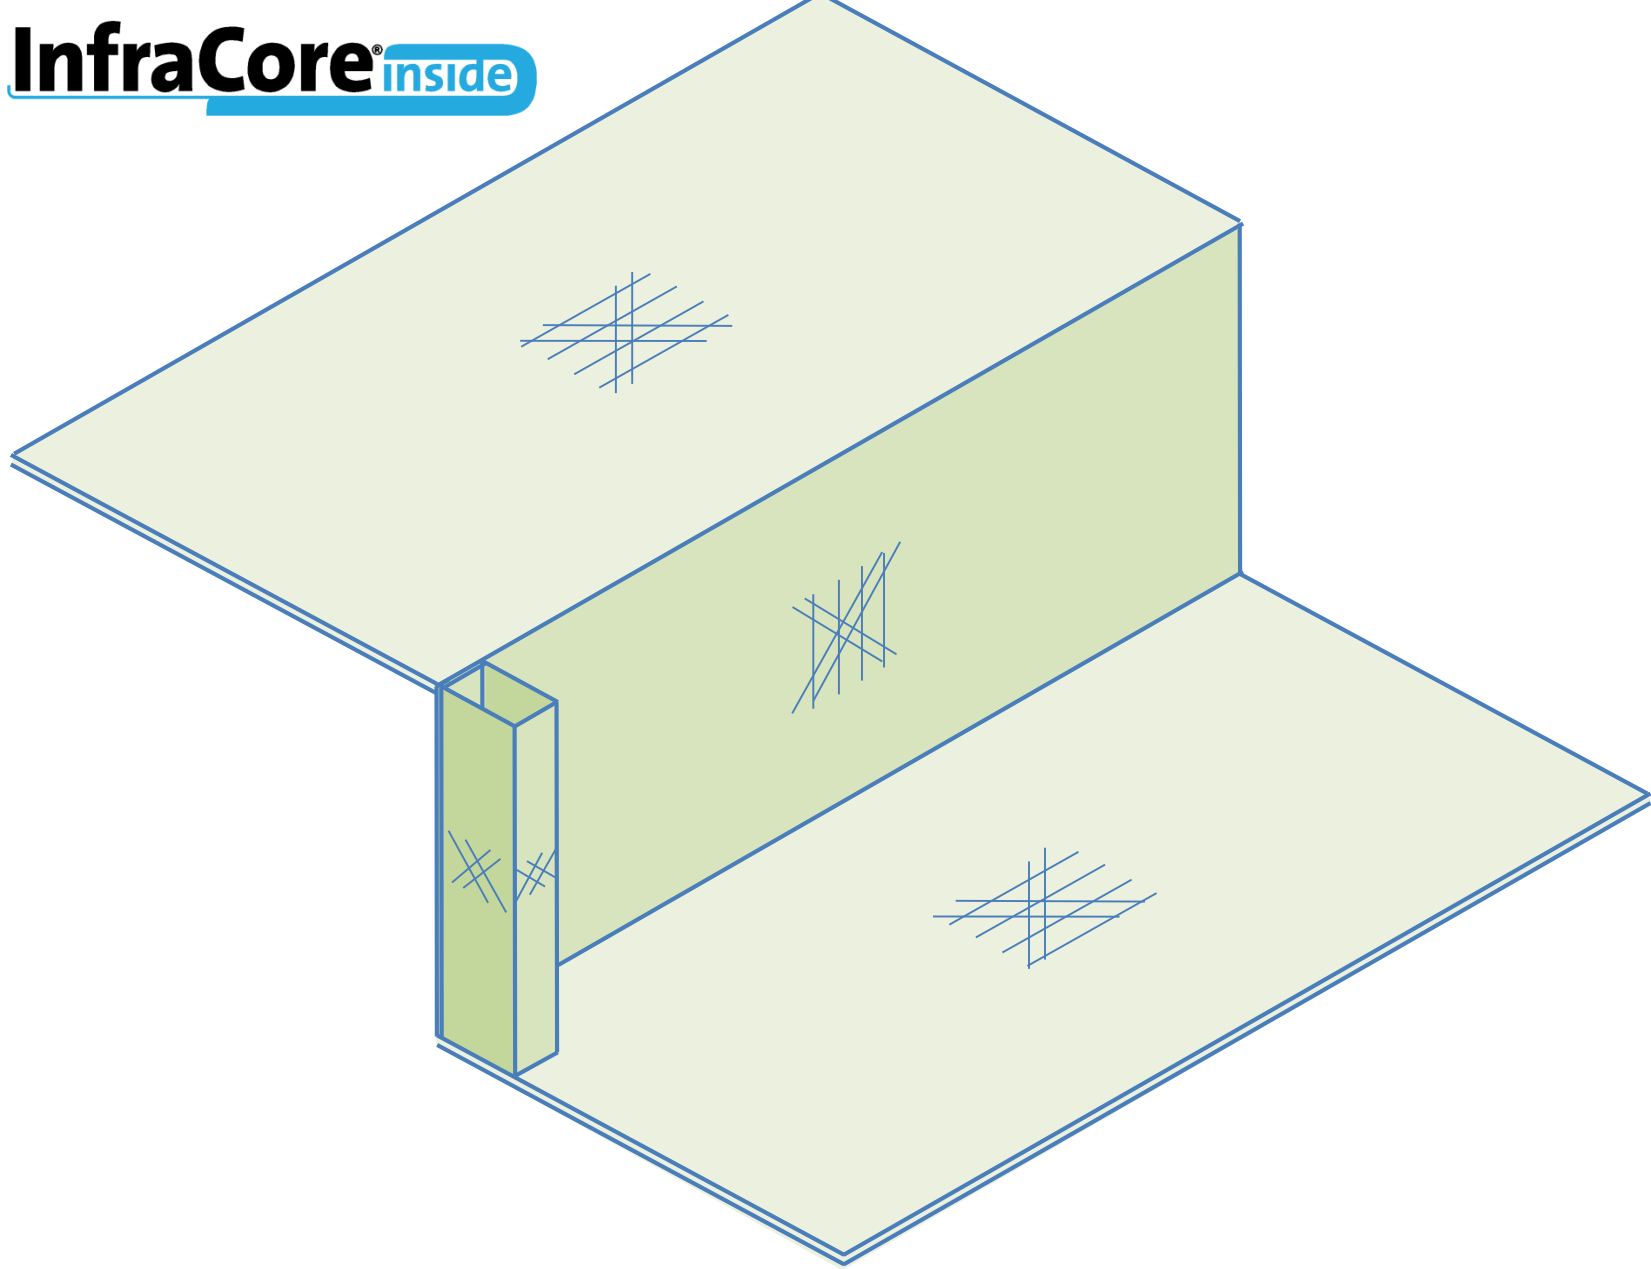
Glass Fibre Fabric beam:

Add shear webs perpendicular to main webs

Made of $\pm 45^\circ$ fabric in box configuration

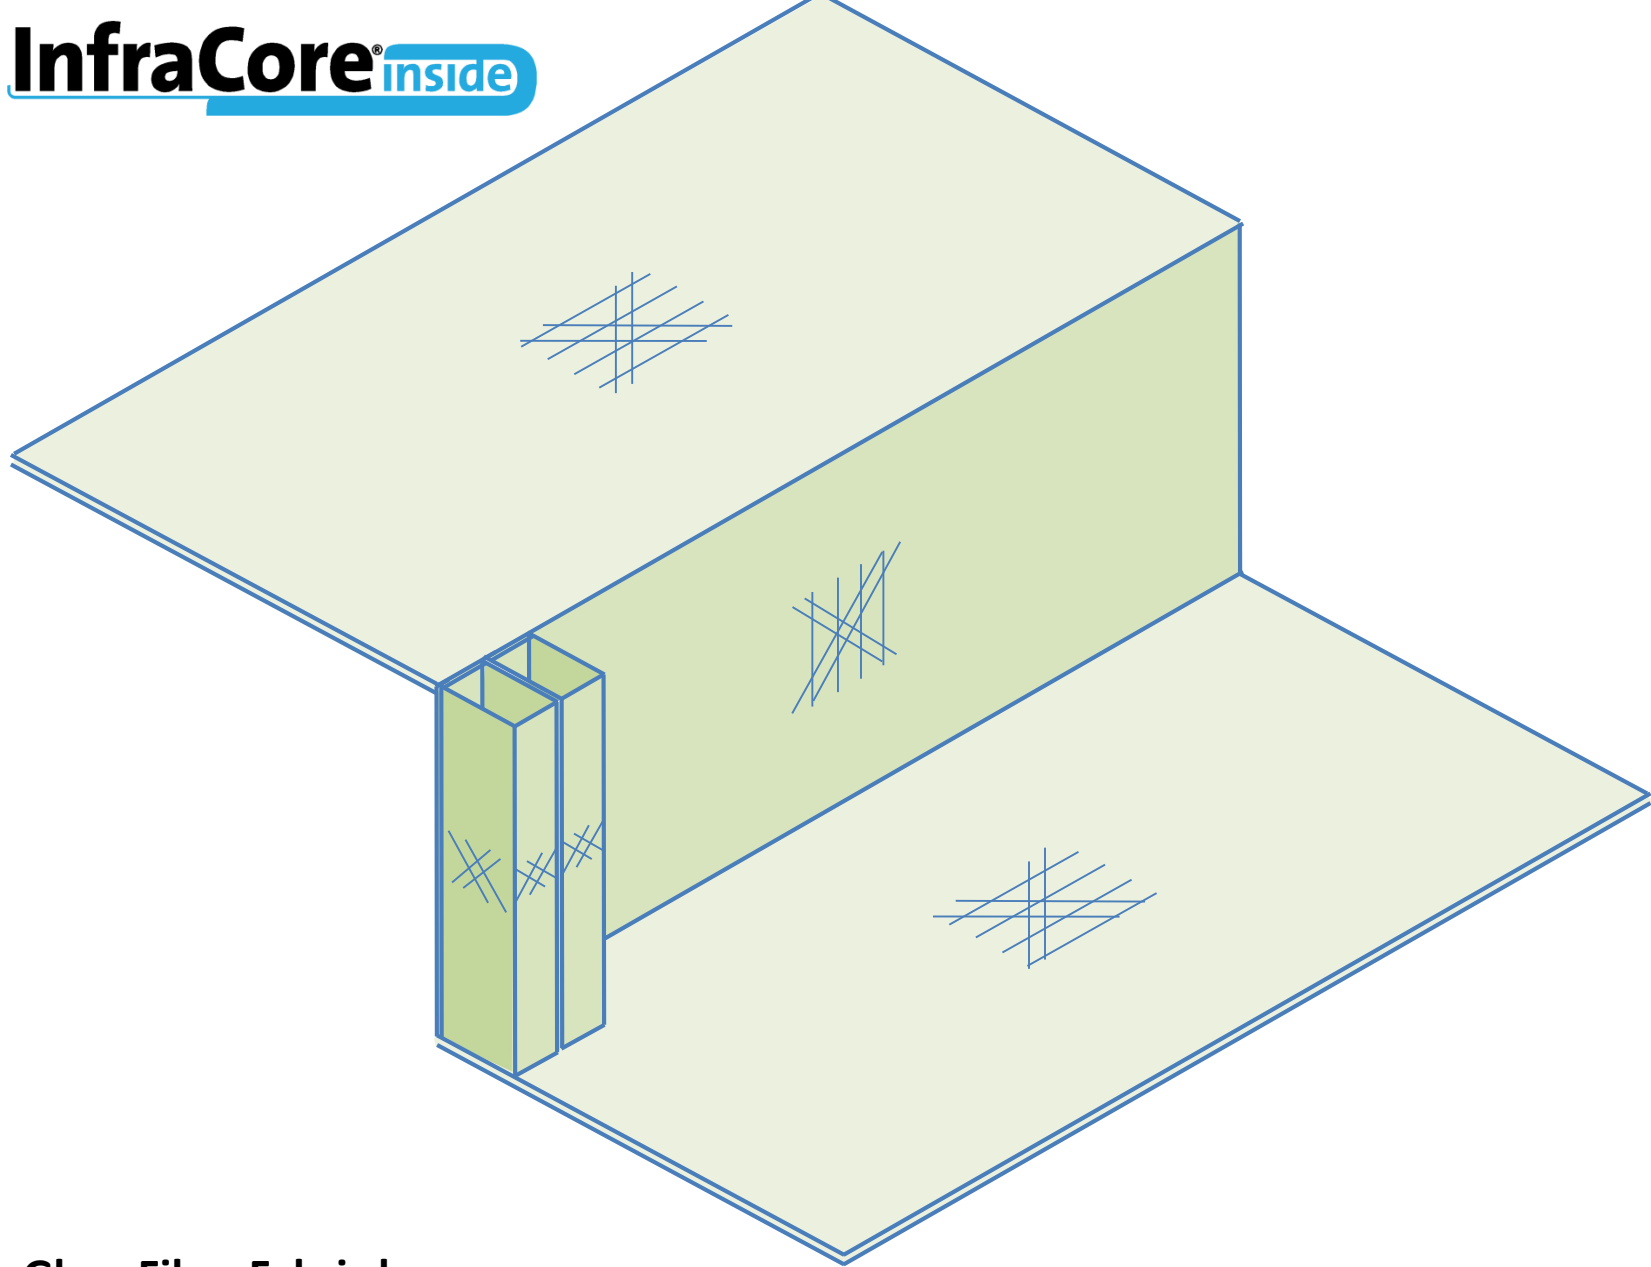
Glass Fibre Fabric beam:

Add shear webs perpendicular to main webs

Made of $\pm 45^\circ$ fabric in box configuration

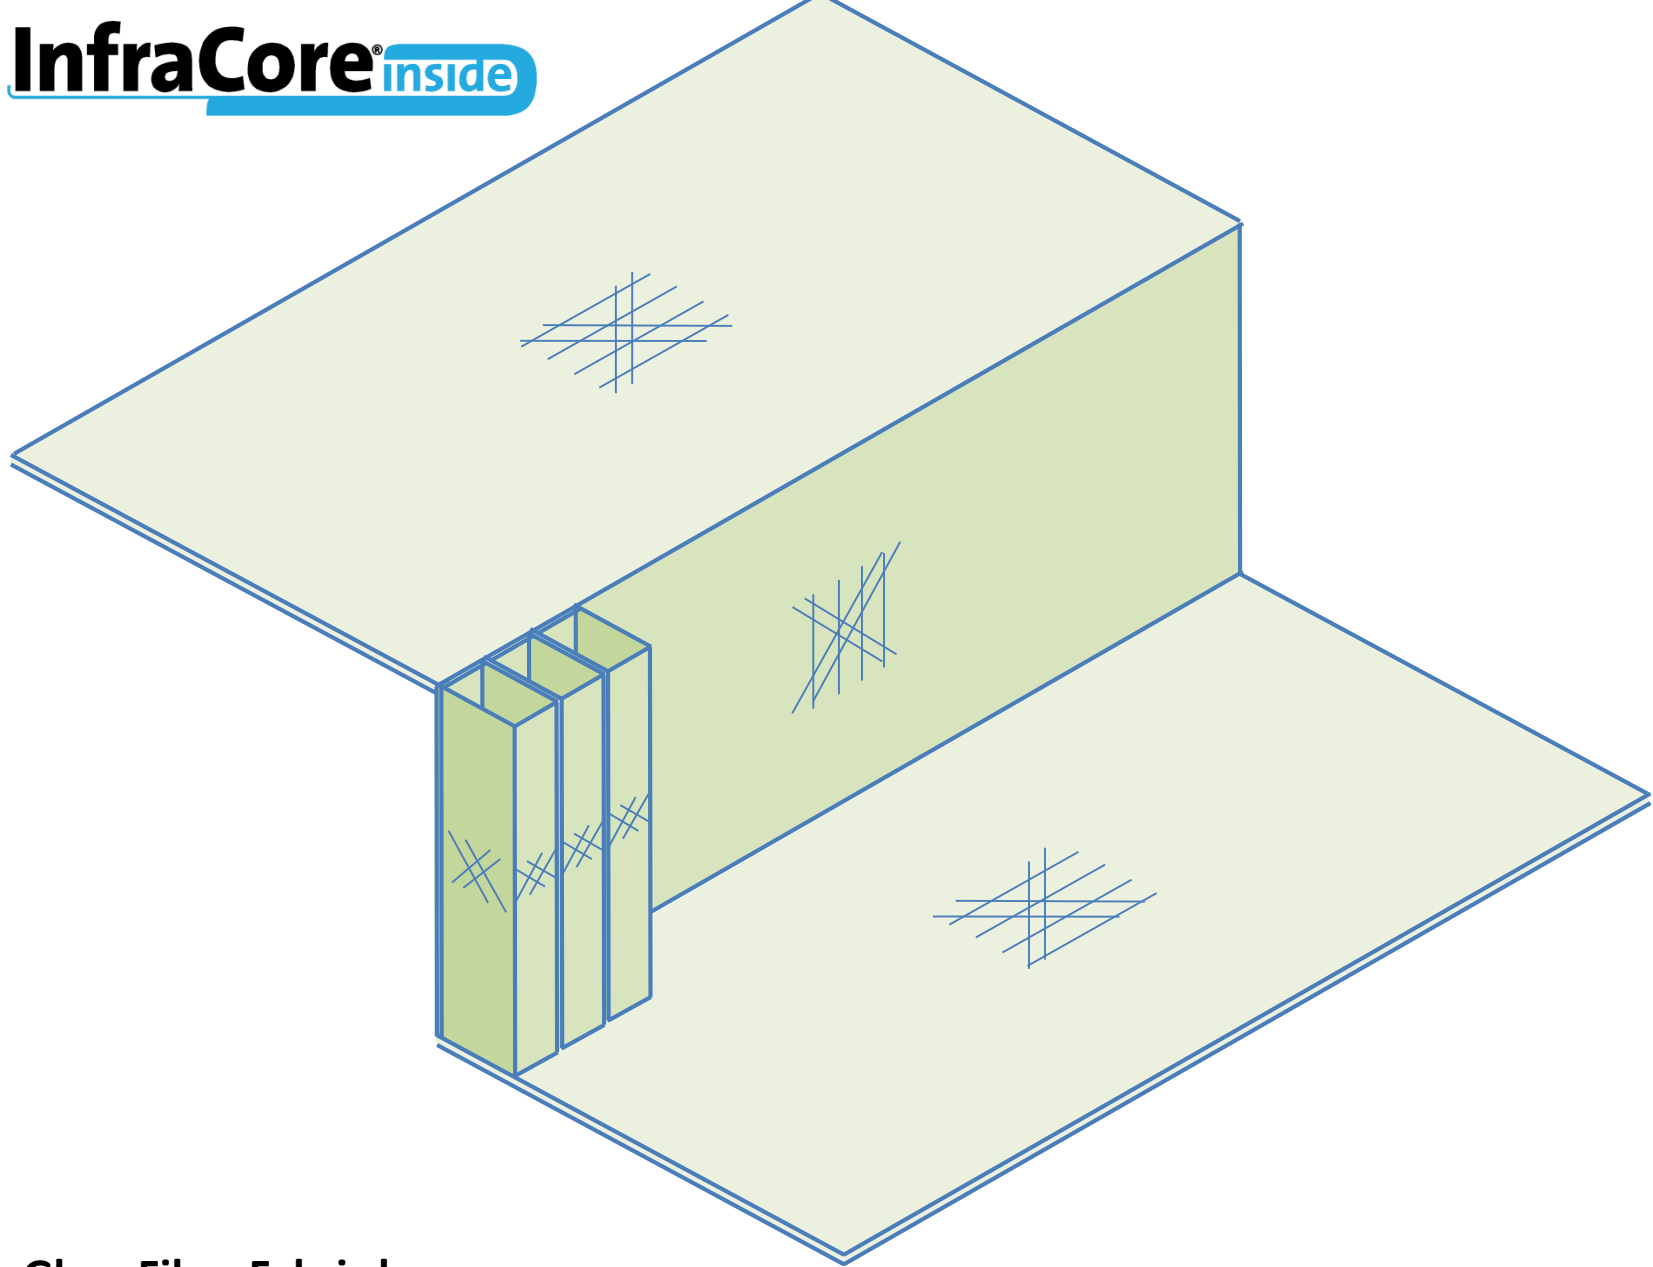
Glass Fibre Fabric beam:

Add shear webs perpendicular to main webs

Made of $\pm 45^\circ$ fabric in box configuration

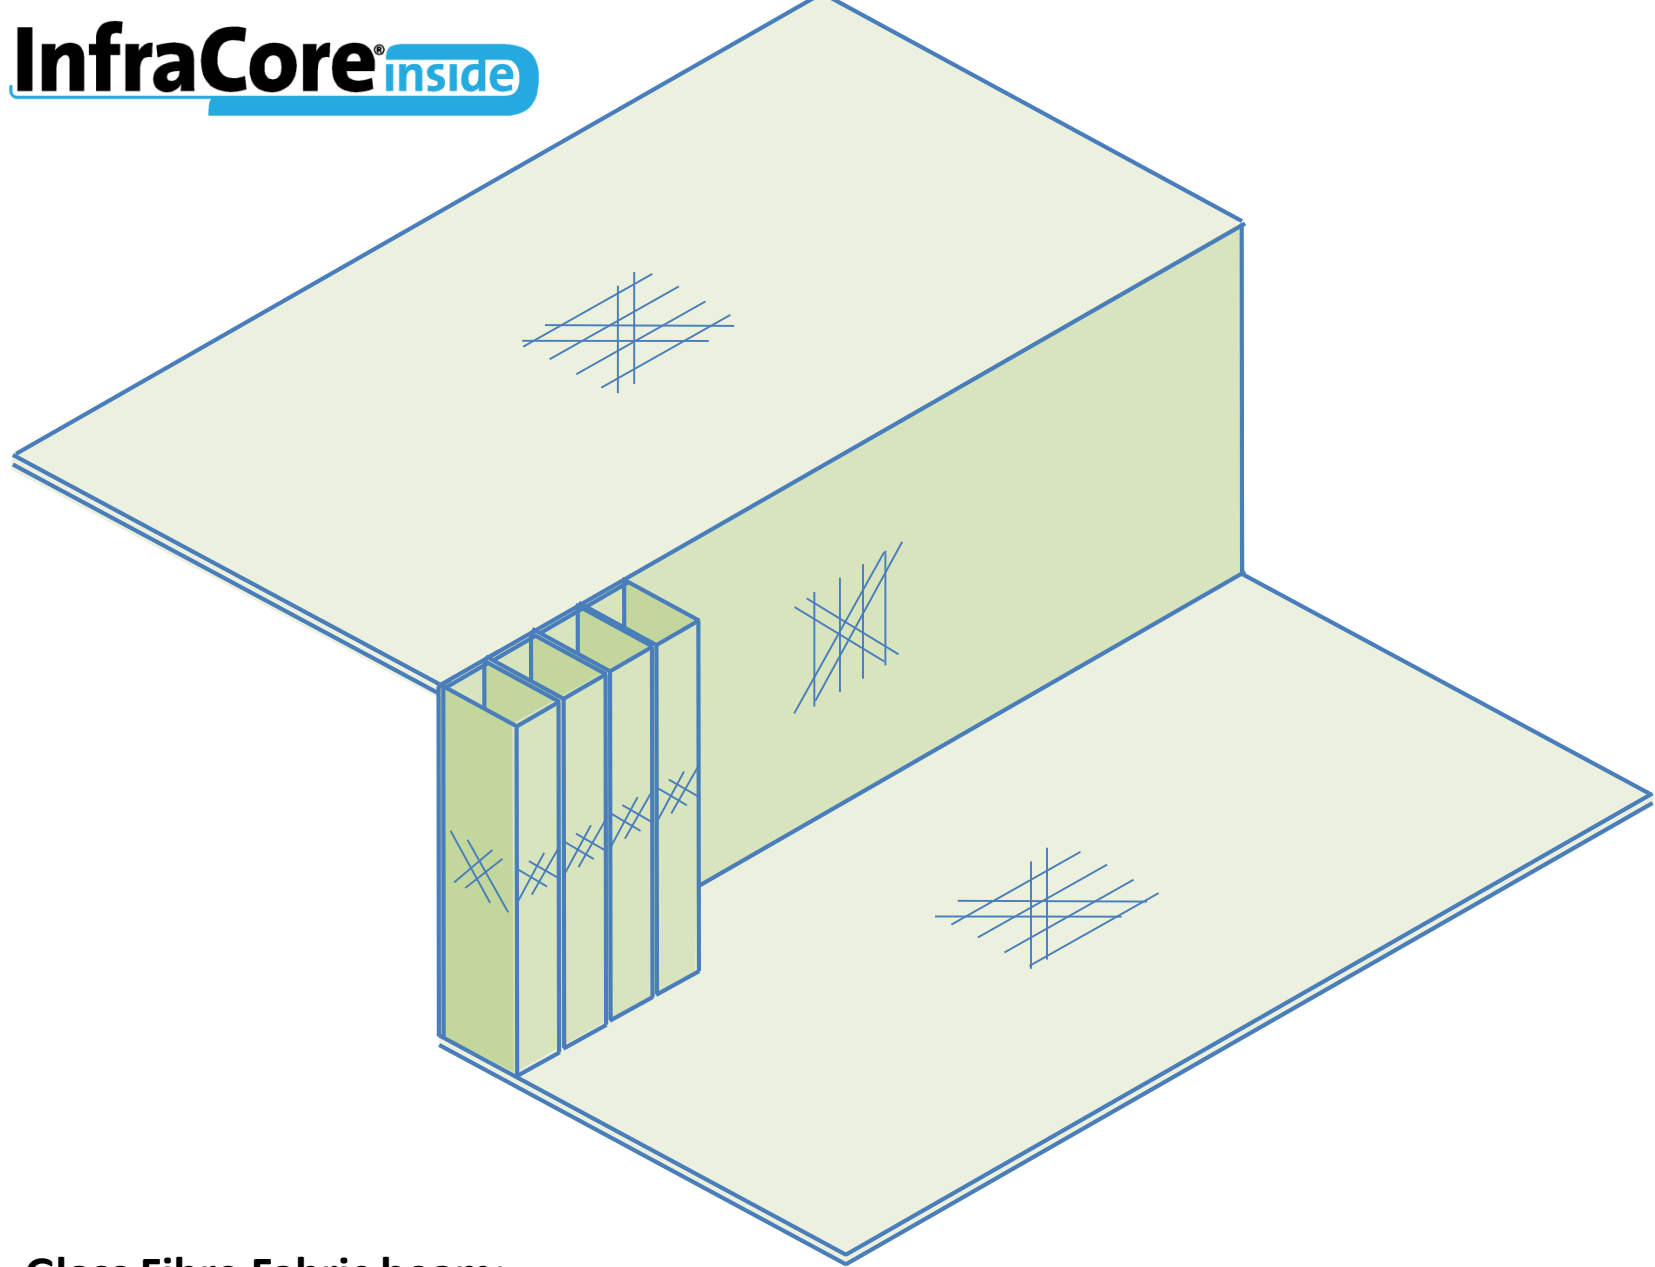
Glass Fibre Fabric beam:

Add shear webs perpendicular to main webs

Made of $\pm 45^\circ$ fabric in box configuration

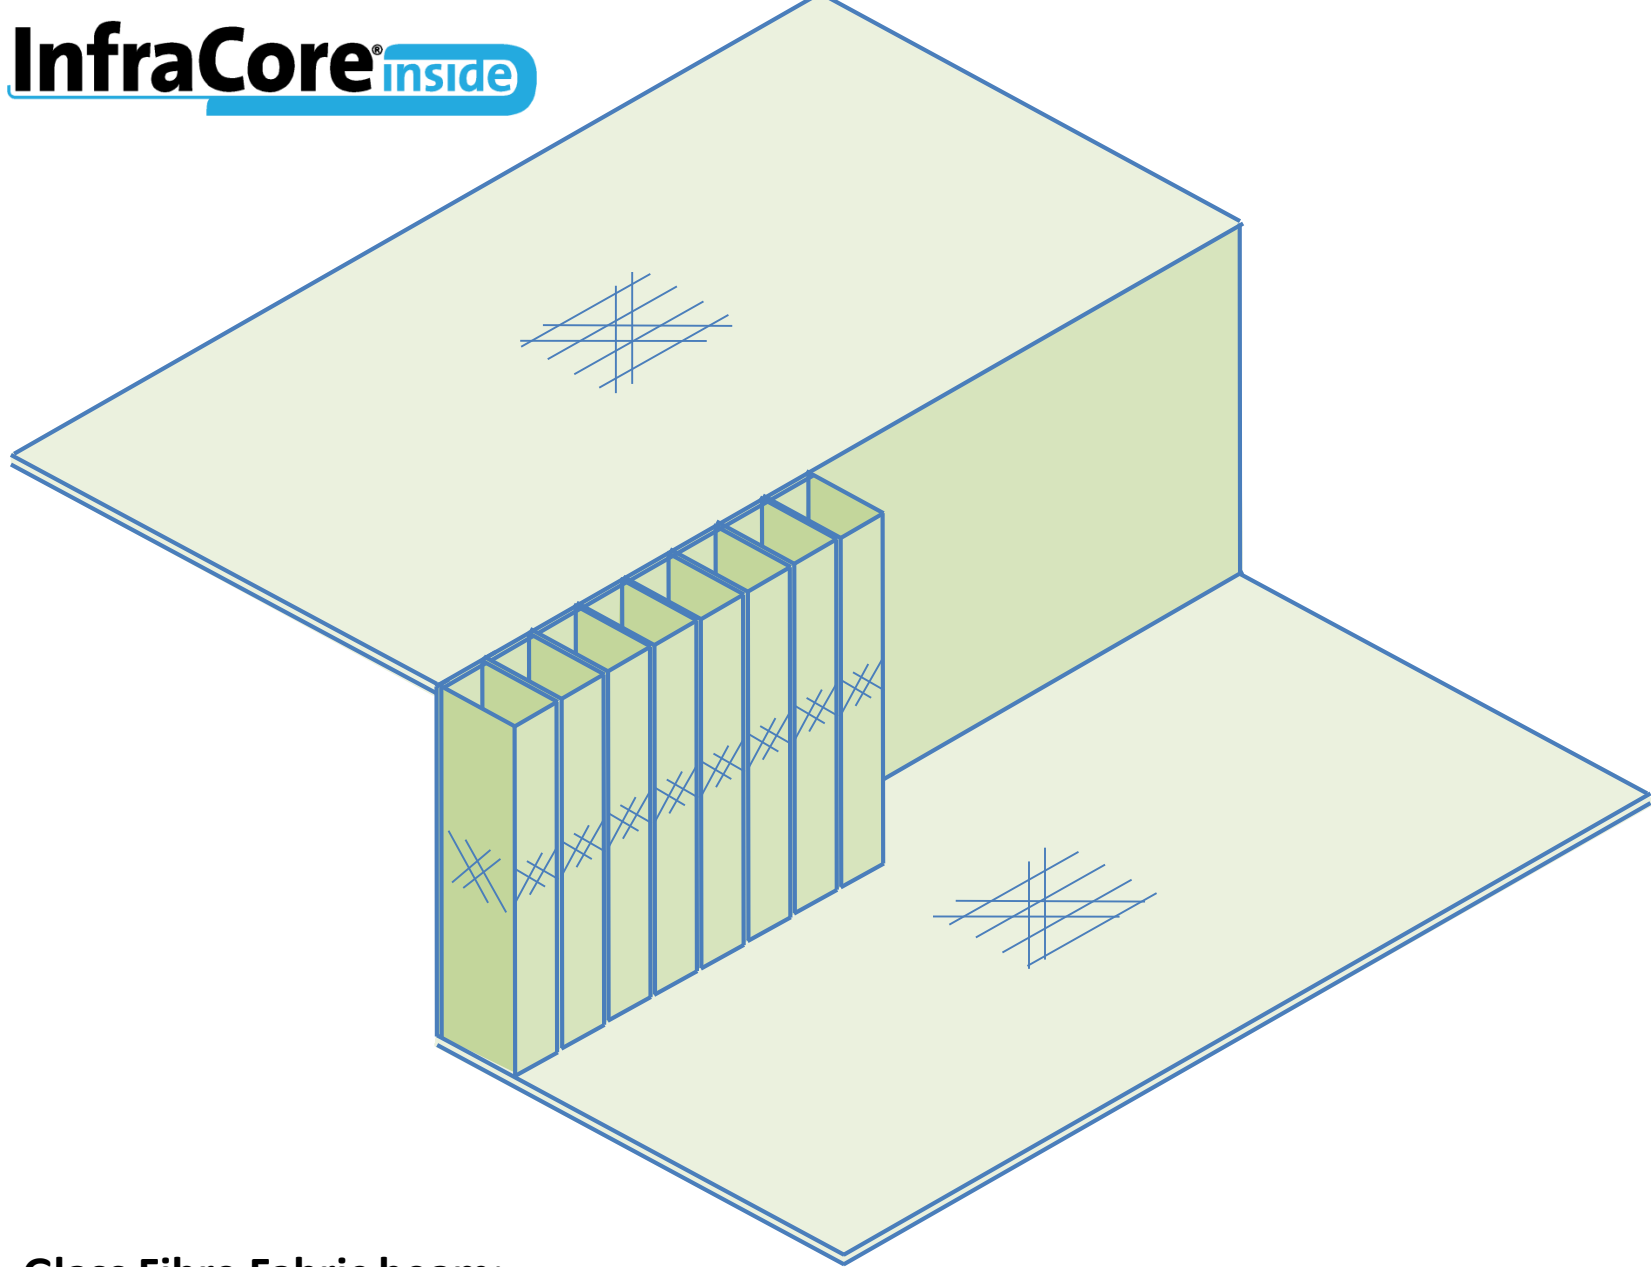
Glass Fibre Fabric beam:

Add shear webs perpendicular to main webs

Made of $\pm 45^\circ$ fabric in box configuration

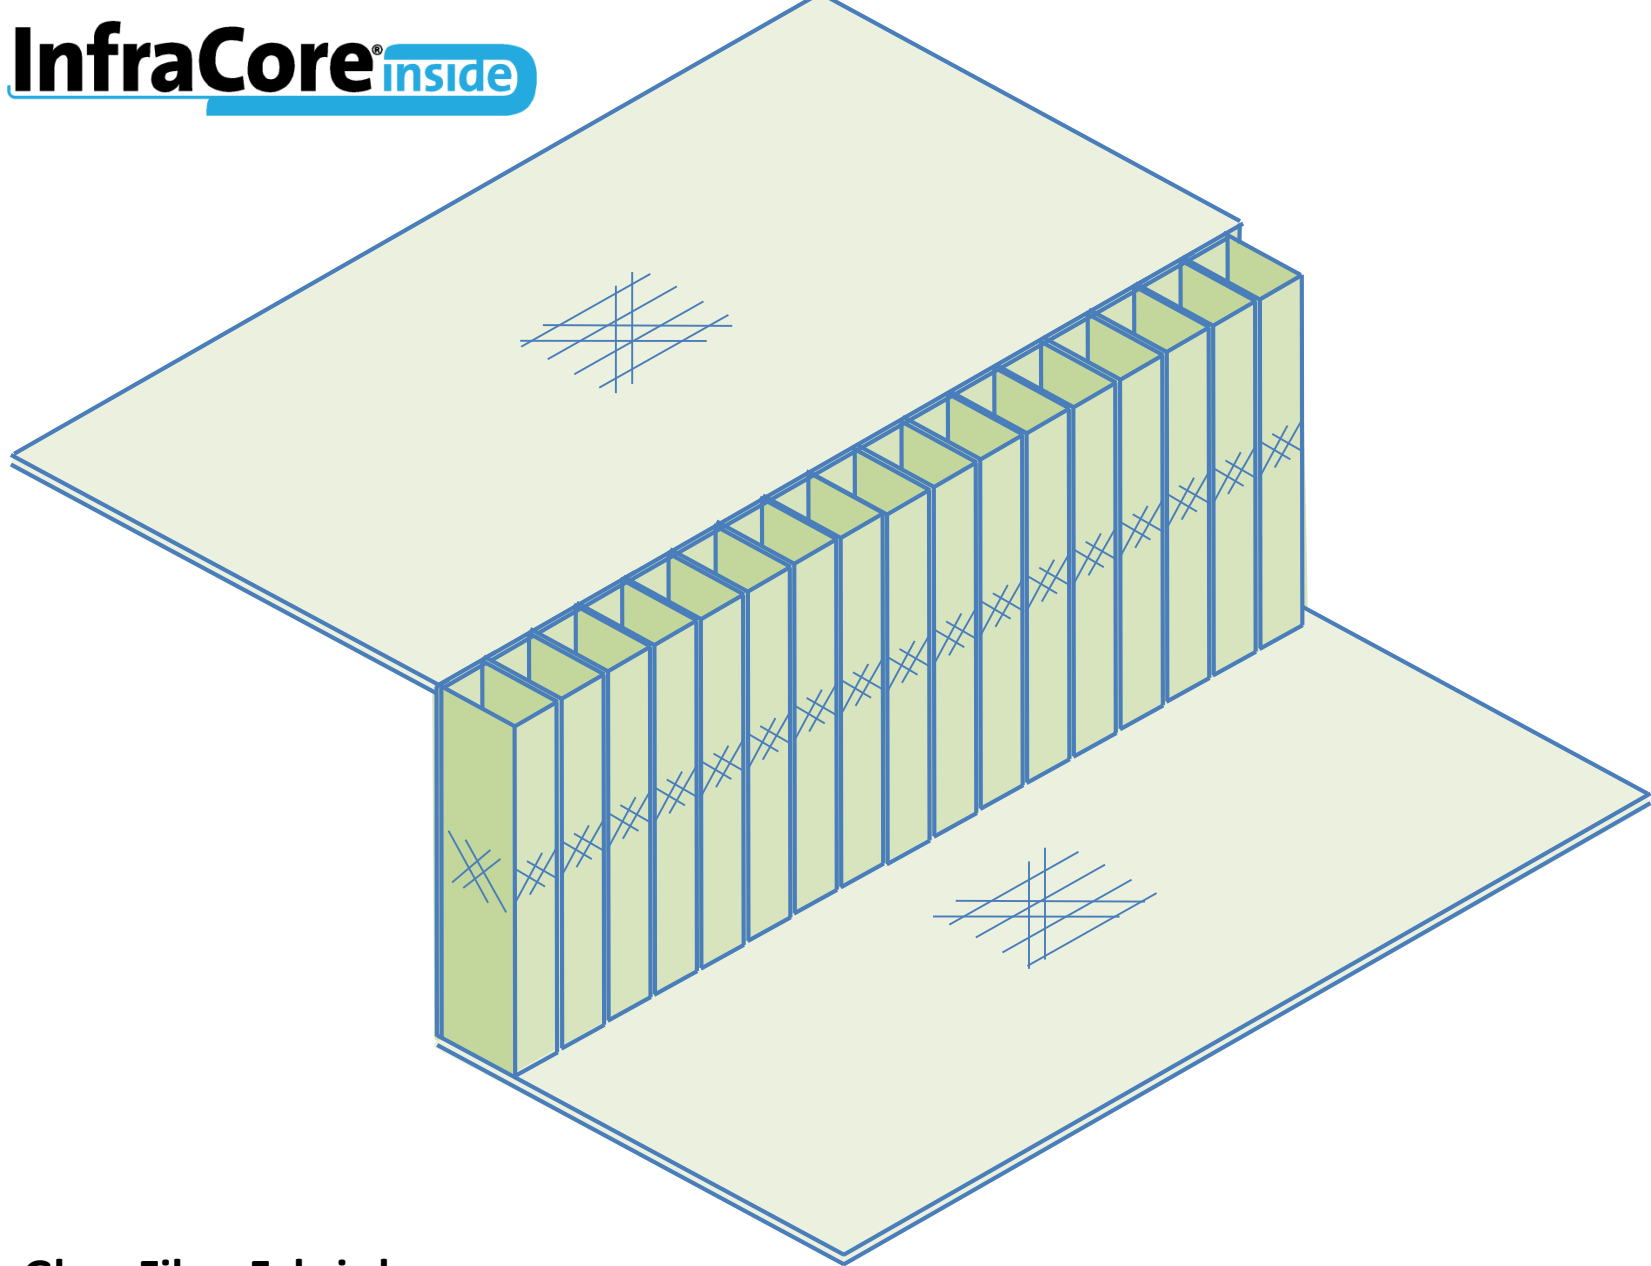
Glass Fibre Fabric beam:

Add shear webs perpendicular to main webs

Made of $\pm 45^\circ$ fabric in box configuration

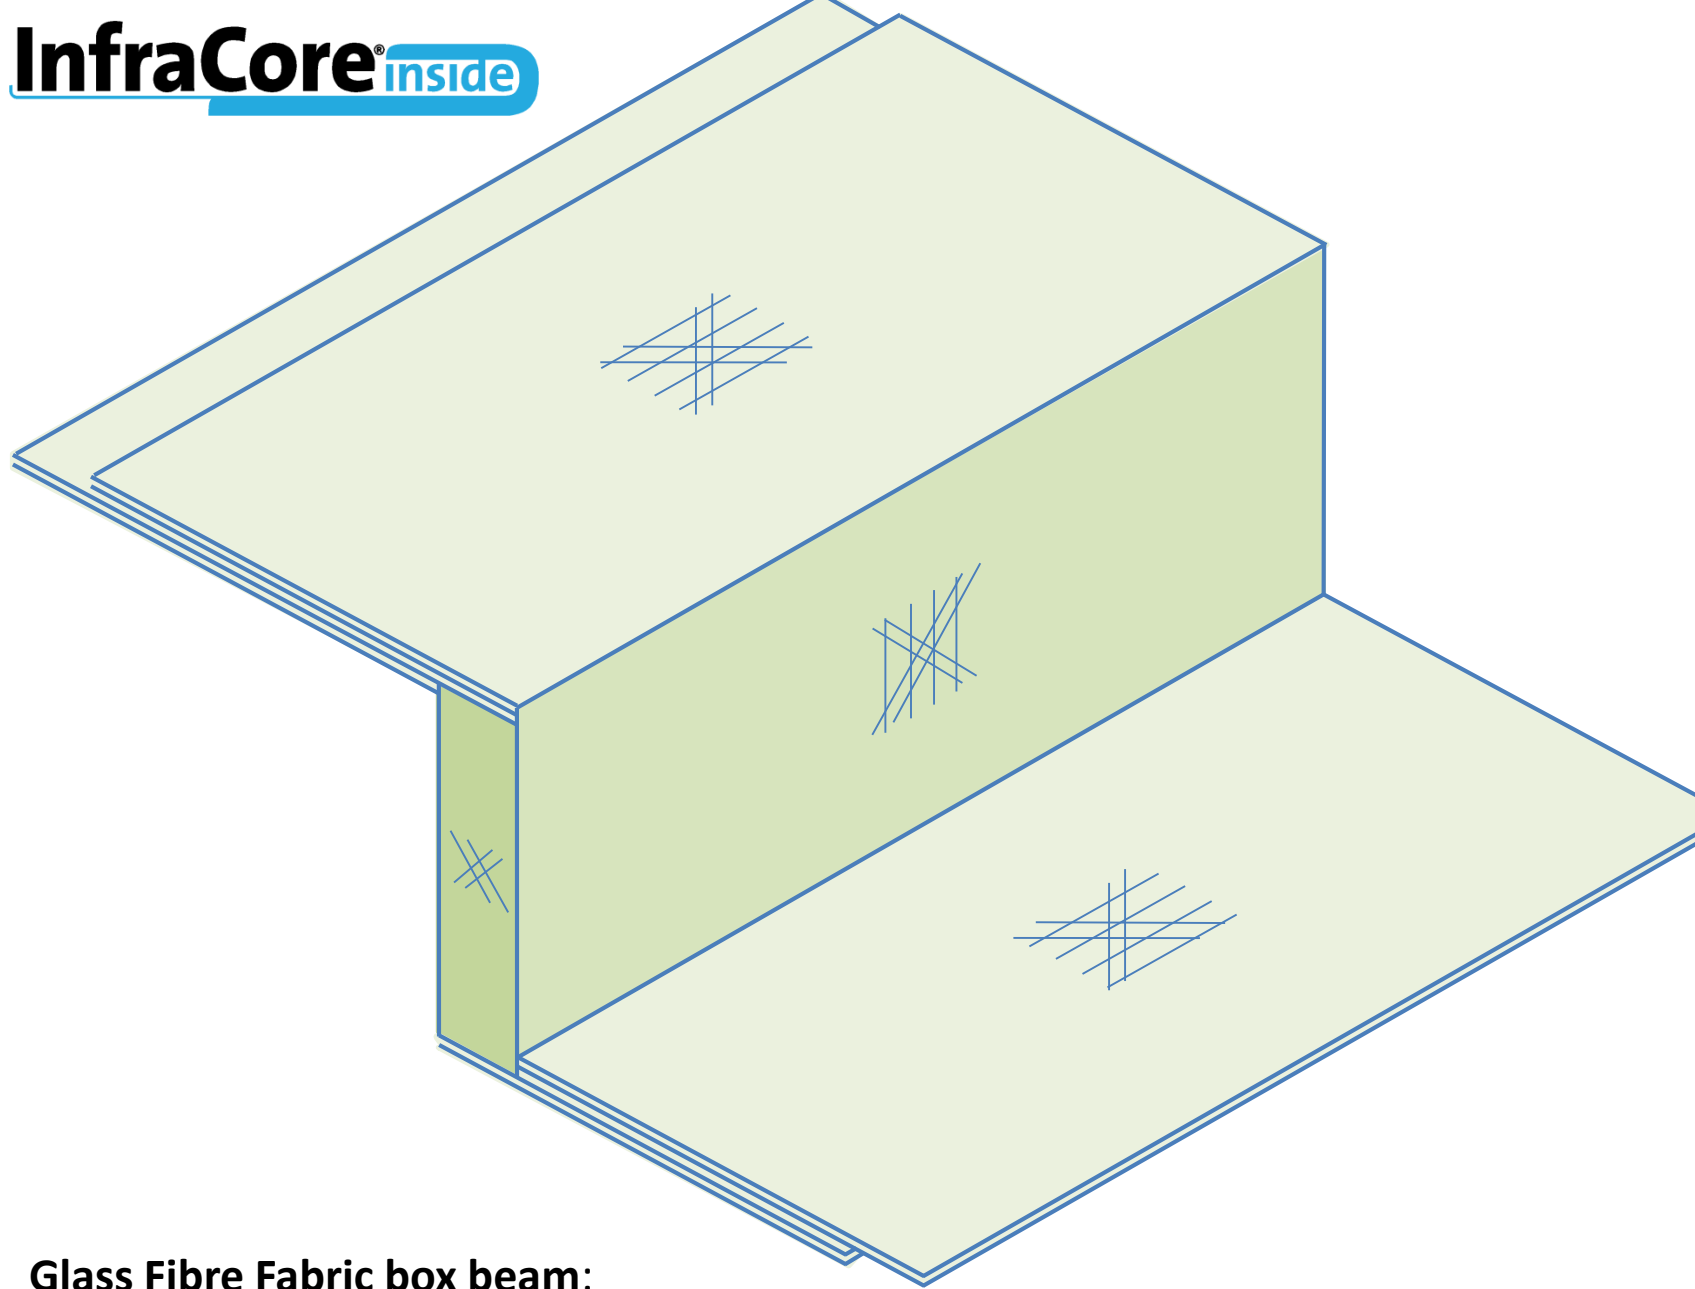
Glass Fibre Fabric box beam:

Flanges, connected by webs

Flanges 0°/ ±45° fabric, webs 90°/±45° fabric, cross-webs ±45° fabric

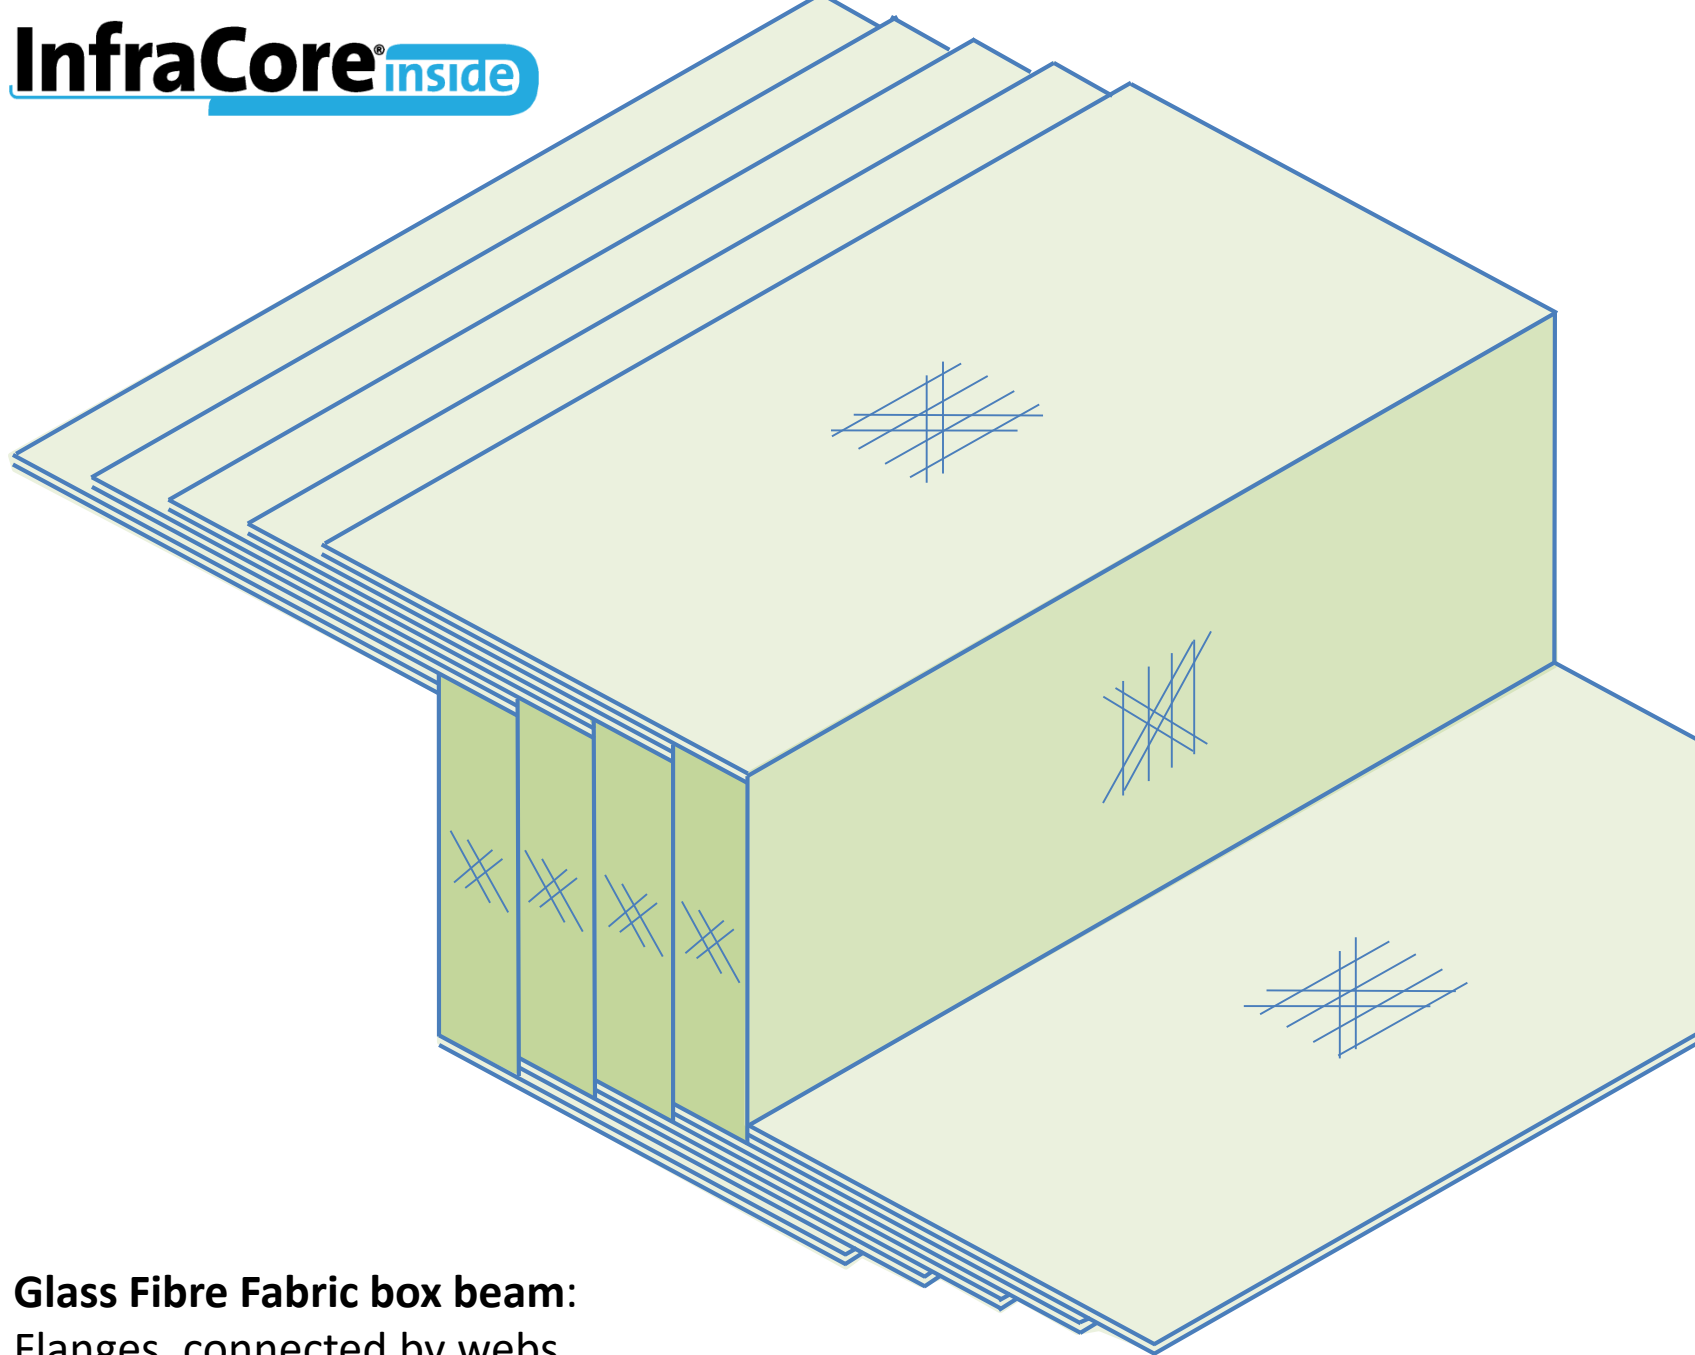
Glass Fibre Fabric box beam:

Flanges, connected by webs

Flanges 0°/ ±45° fabric, webs 90°/±45° fabric, cross-webs ±45° fabric

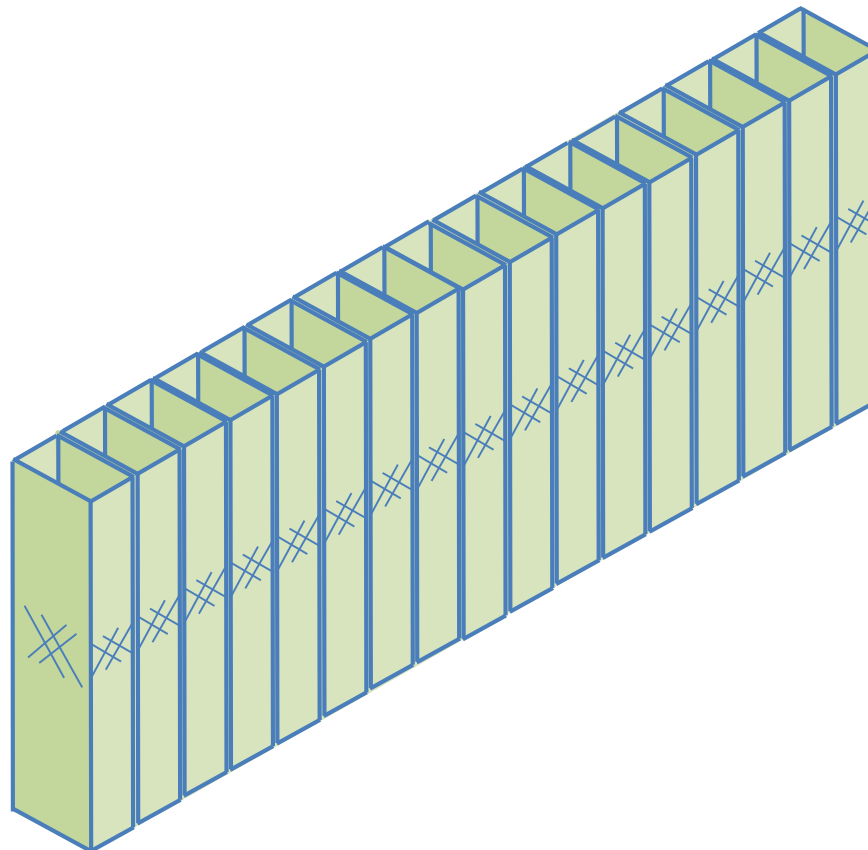
Core configurations:

Multi-box plate

±45° fabric

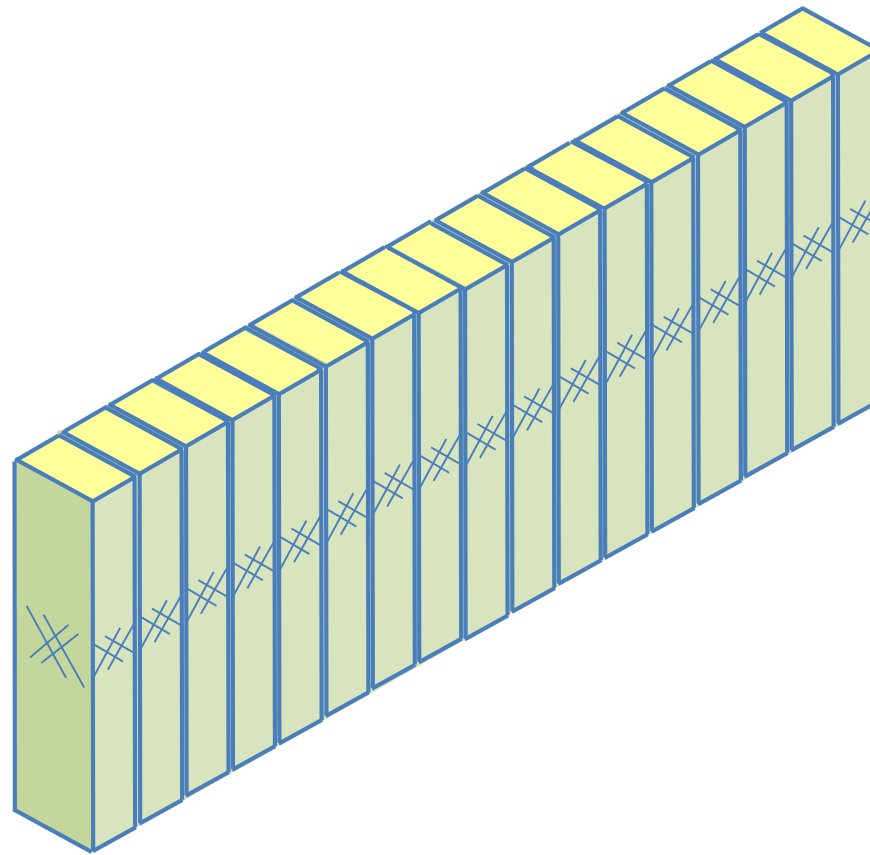
Core configurations:

Multi-box plate

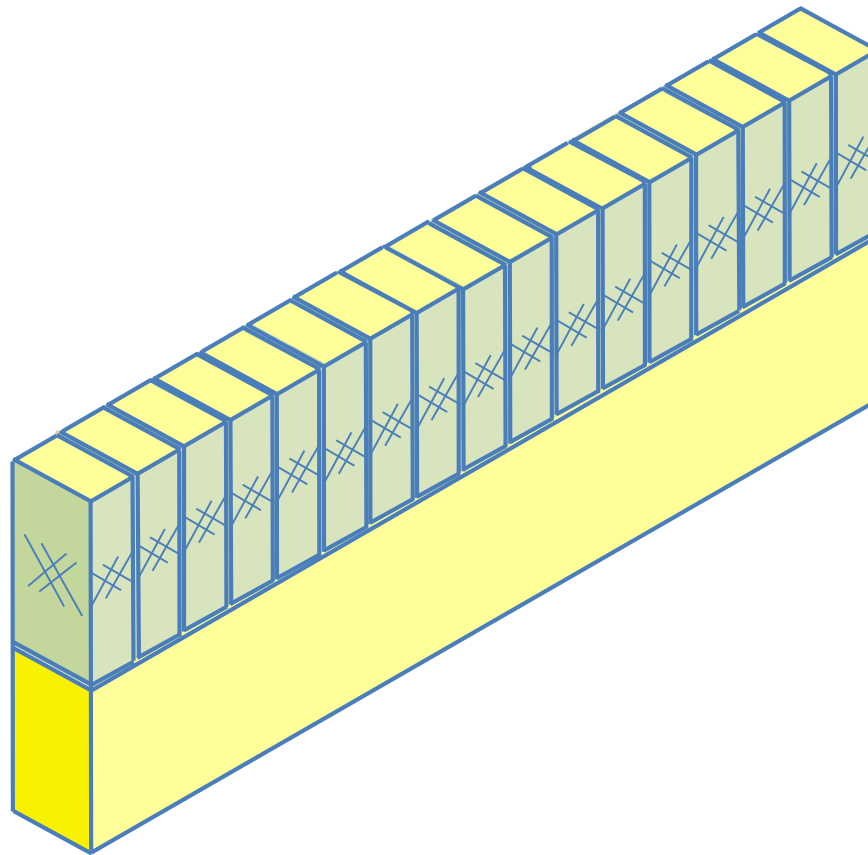
Core configurations:

Multi-box plate

±45° fabric + foam

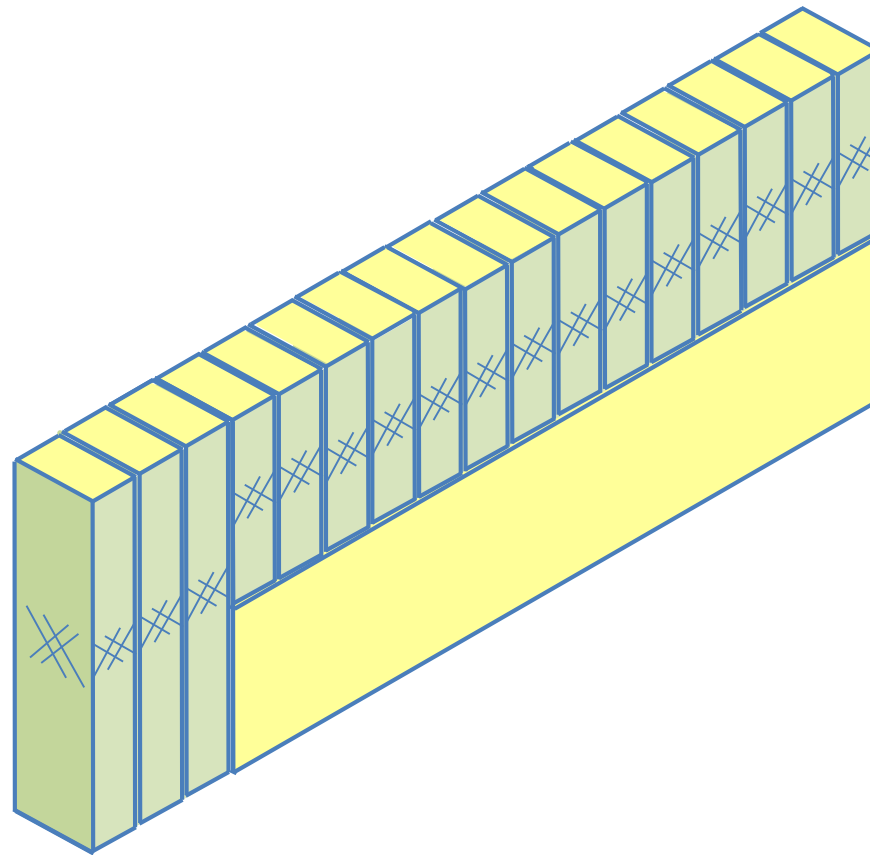
Core configurations:

Multi-box plate

±45° fabric + foam

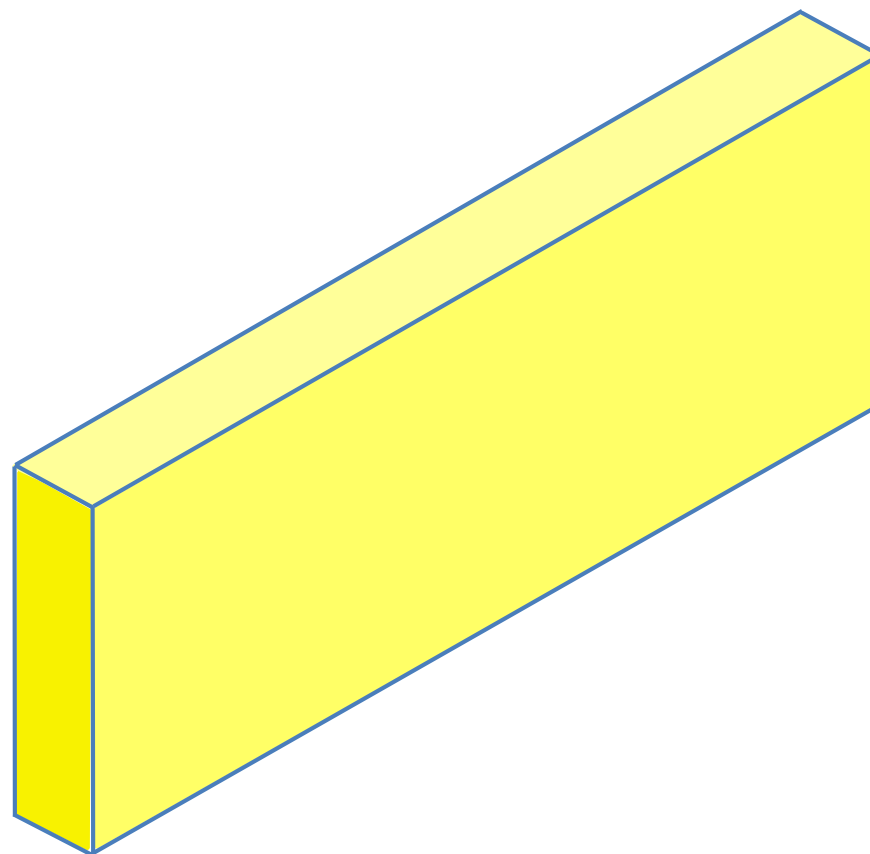
Core configurations:
Foam (lost mould core)

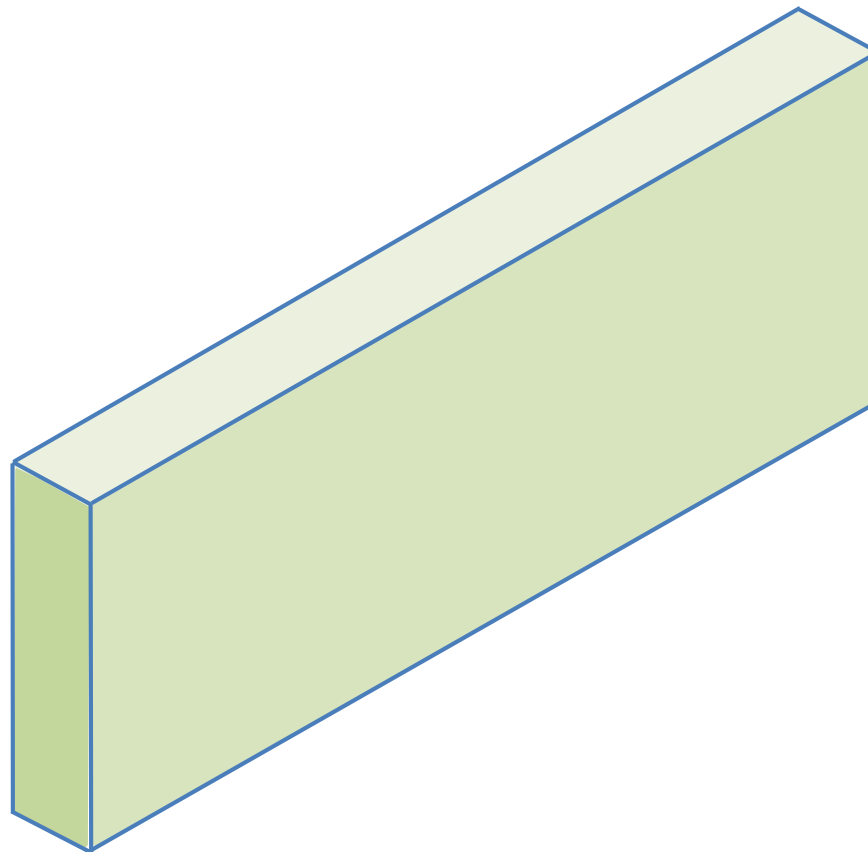
Core configurations:

Massive fibre reinforced plastic plate
