The essence of InfraCore Inside[®]

A brief introduction

InfraCore Inside looks and feels like a sandwich structure, but it has a more direct descent from beams, in fact multi-beam plates.

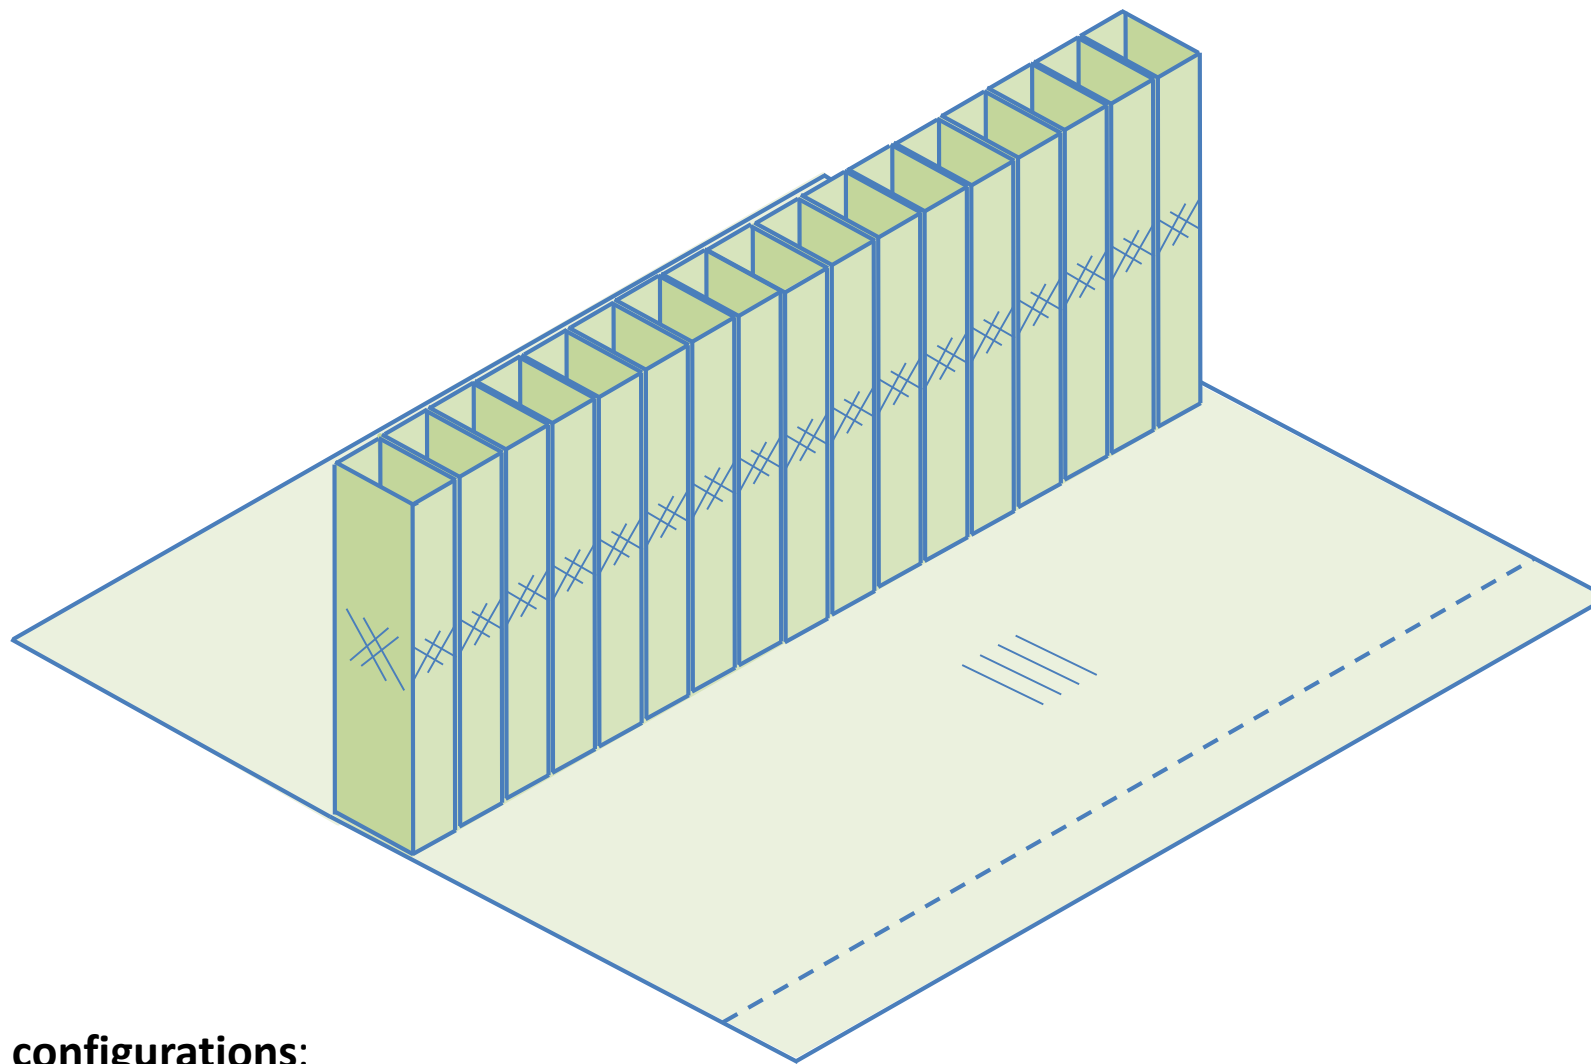
Core configurations:

Multi-box plate

±45° fabric + core wrap of 90° fabric

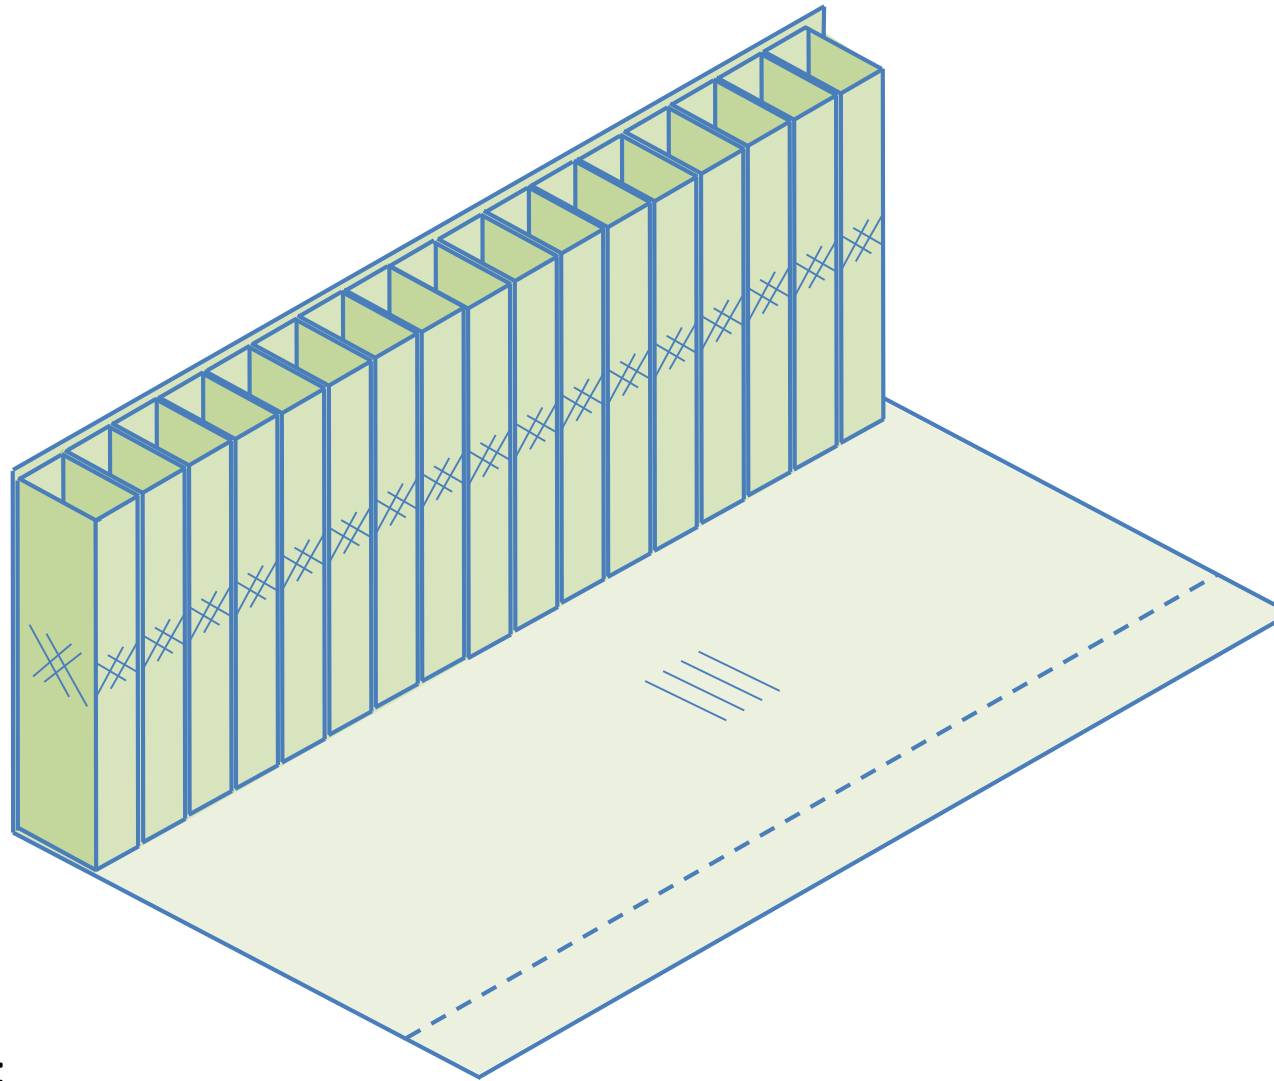
Core configurations:

Multi-box plate

$\pm 45^\circ$ fabric + core wrap of 90° fabric

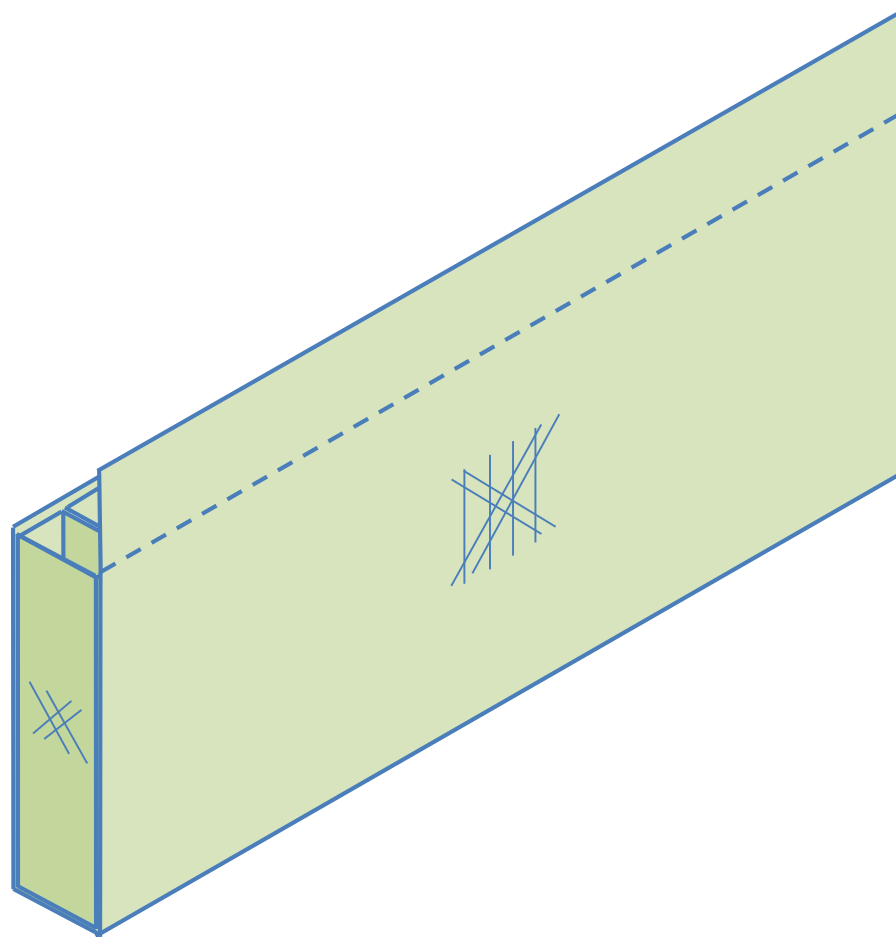
Core configurations:

Multi-box plate

$\pm 45^\circ$ fabric + core wrap of 90° fabric

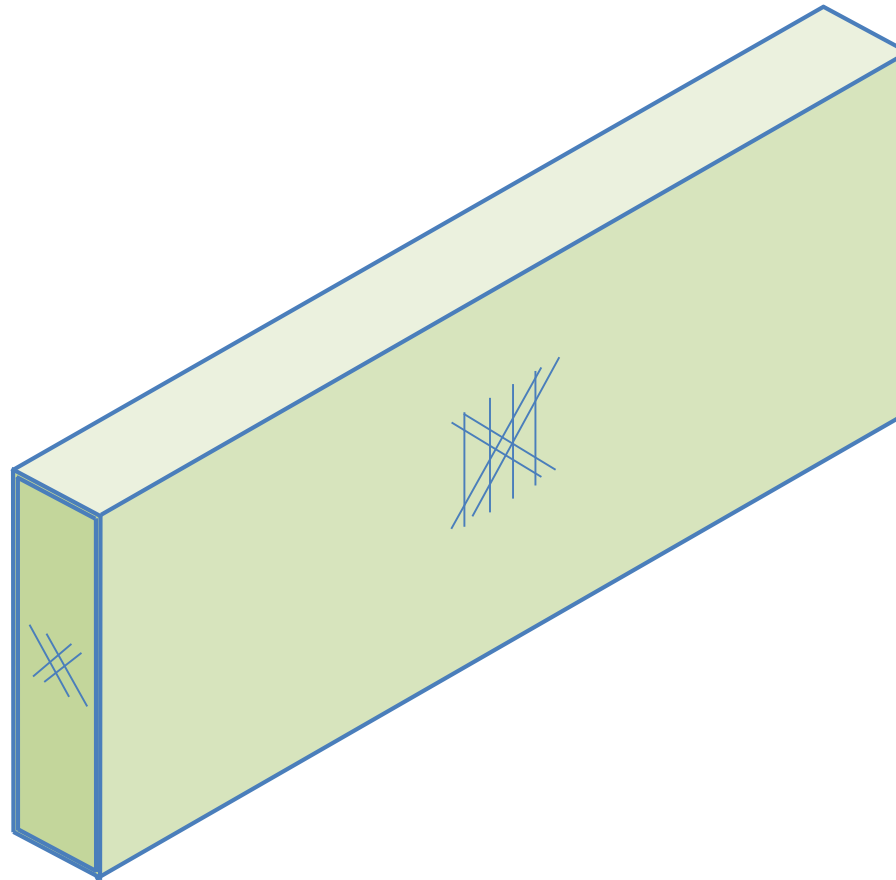
Core configurations:

Multi-box plate

$\pm 45^\circ$ fabric + core wrap of 90° fabric

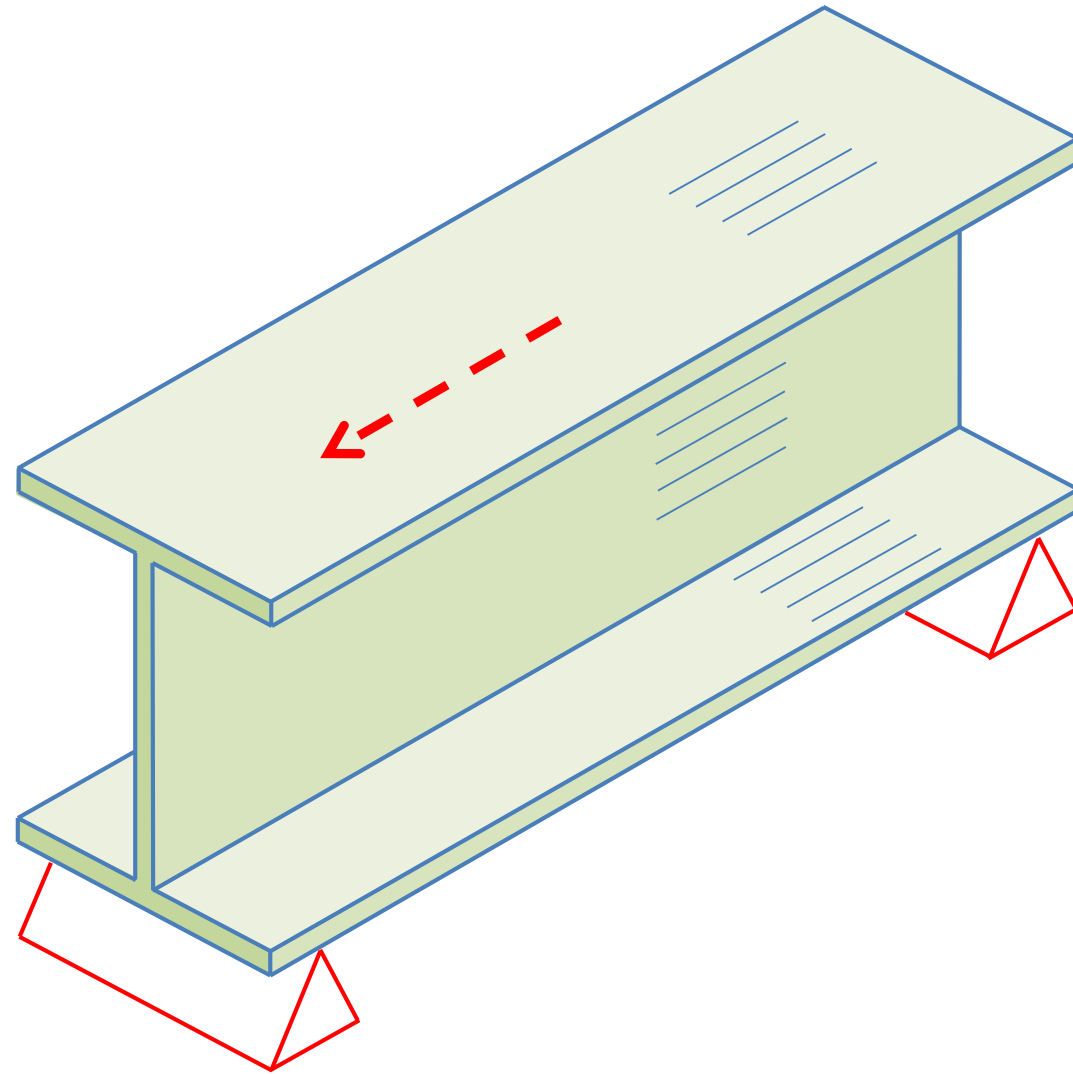
GRP pultruded beam: Achilles heel

Supported in three-point bending

Impacted by hard object → flange-web crack initiation

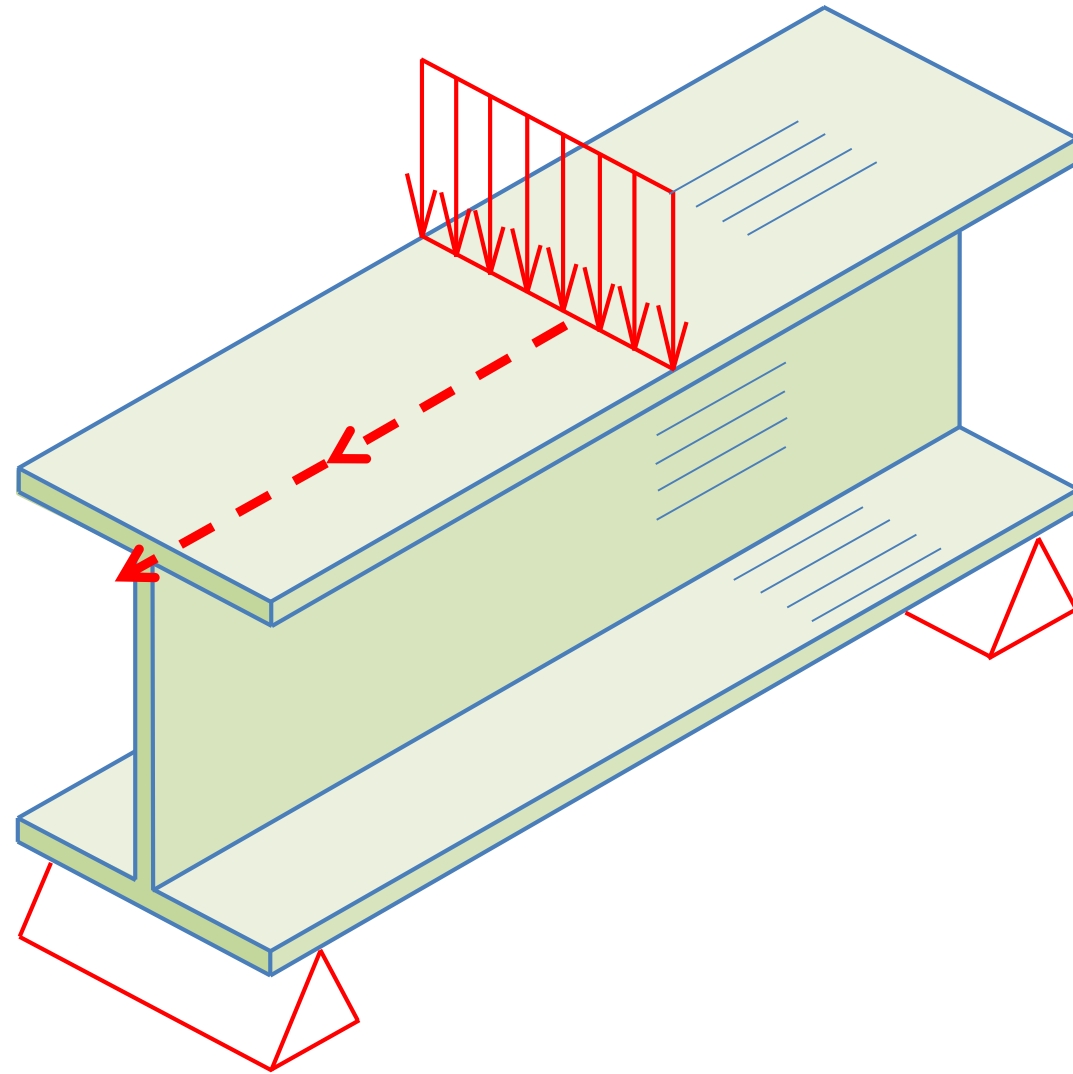
GRP pultruded beam: Achilles heel

Loaded in three-point bending

Unarrested crack growth → catastrophic failure

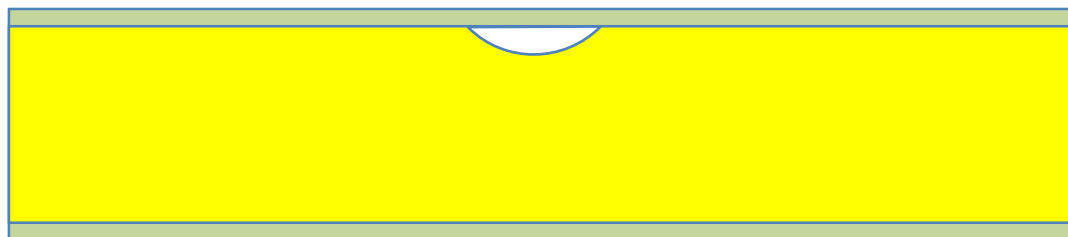
Classic sandwich: Achilles Heel

Two skins bonded on a core

Impacted by hard object → skin-core debonding

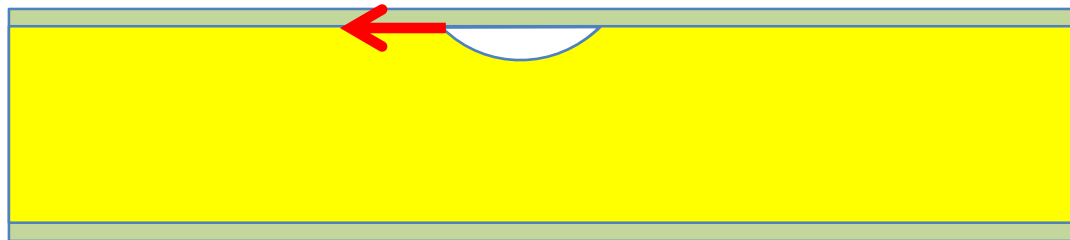
Classic sandwich: Achilles Heel

Two skins bonded on a core

Crack growth caused by rolling loads

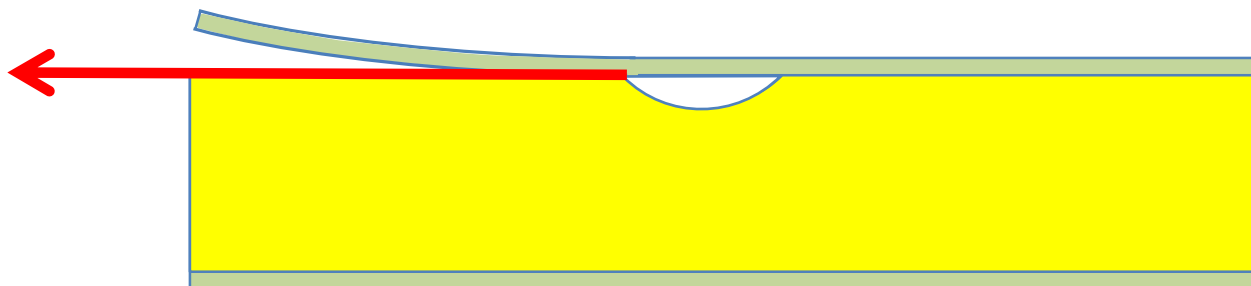
Classic sandwich: Achilles Heel

Two skins bonded on a core

Catastrophic failure, due to unrestricted weak resin dominated fracture path

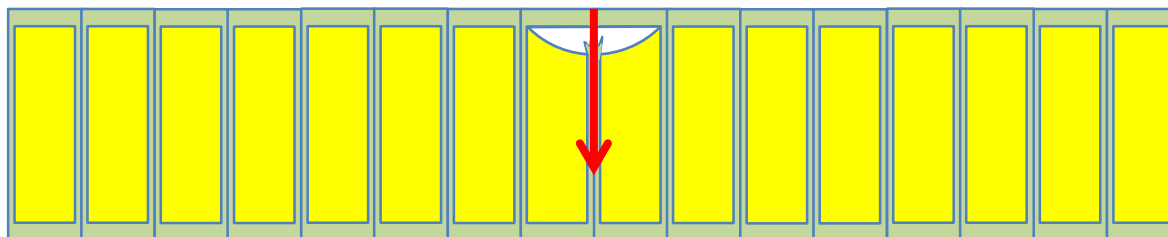
Multi beam plate: Achilles Heel

Many box beams bonded together

Impacted by hard object → crack in and between webs

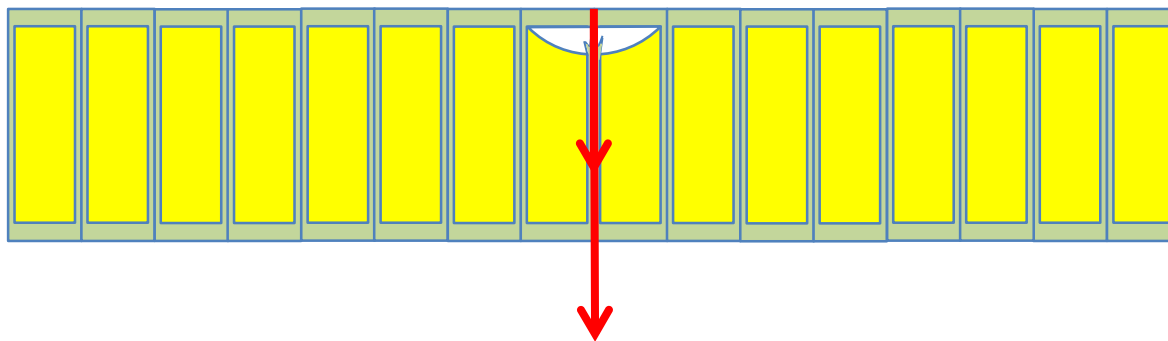
Multi beam plate: Achilles Heel

Many box beams bonded together

Crack growth caused by rolling loads

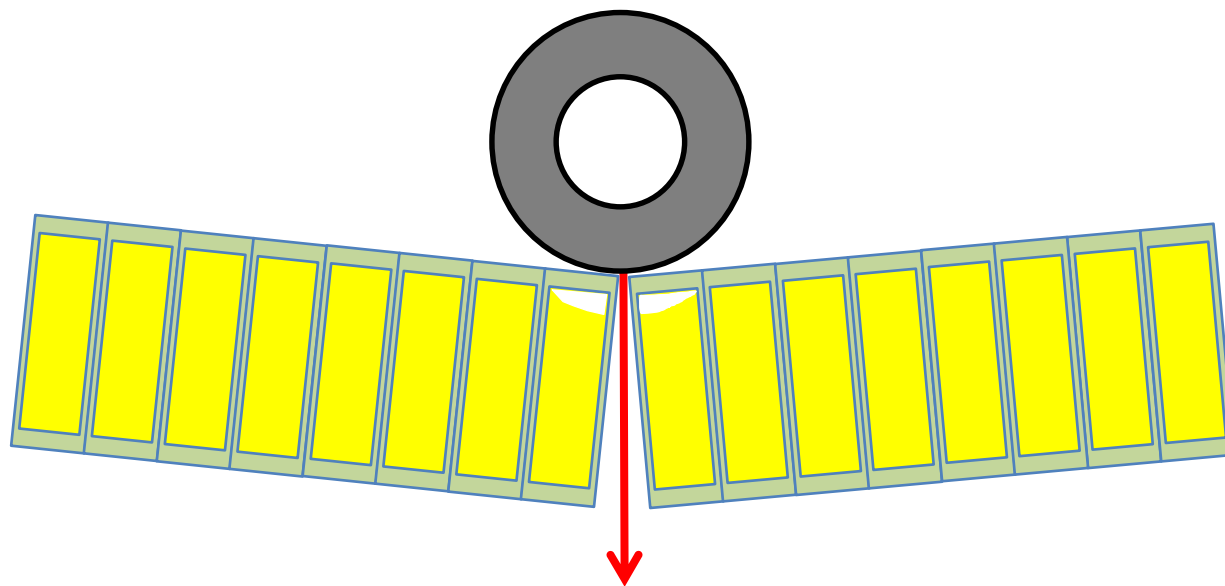
Multi beam plate: Achilles Heel

Many box beams bonded together

Failure, due to unrestricted weak resin dominated fracture path

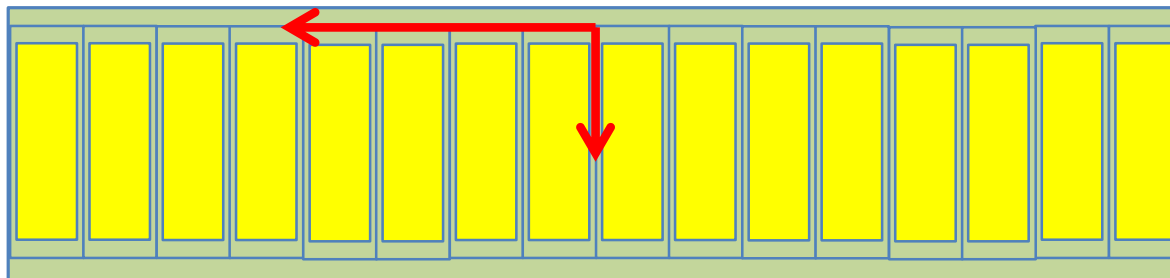
Multi beam plate: Achilles Heel

Many box beams bonded together, with additional deck layers

Impacted by hard object → two weak resin dominated fracture paths

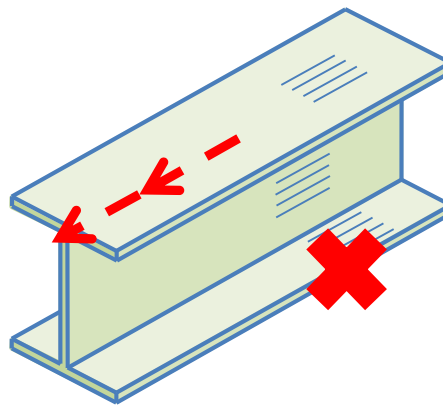
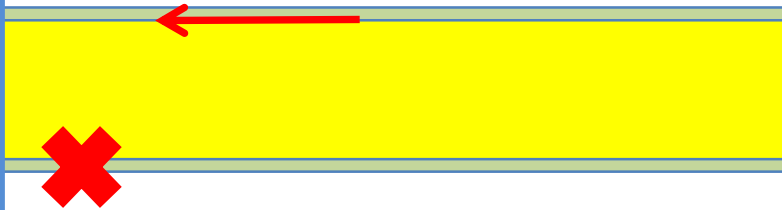
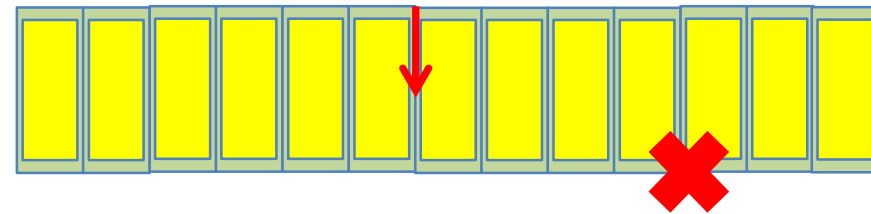
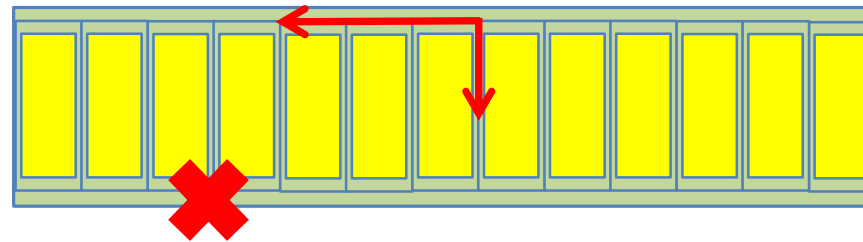
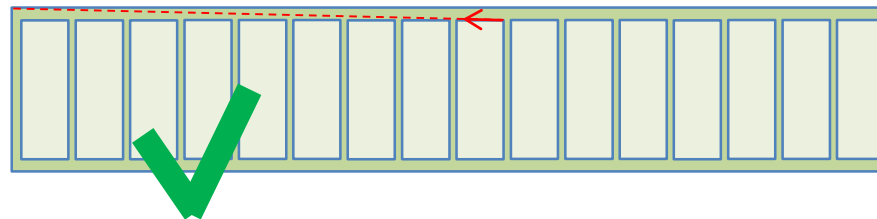
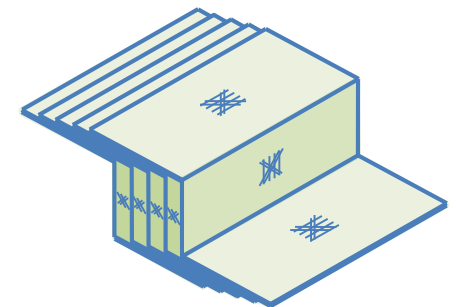
Glass Fibre Fabric box beam:
Extreme robustness

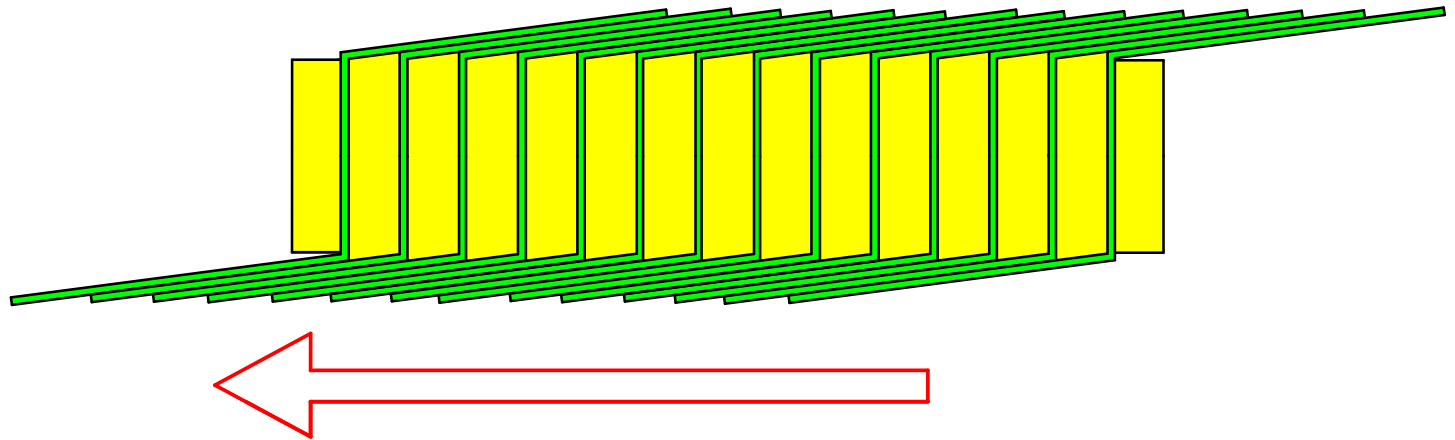
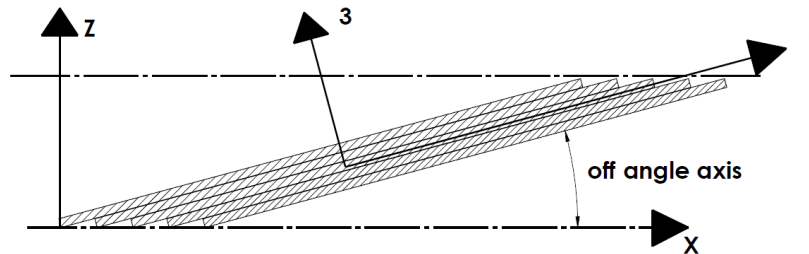
InfraCore Inside

- skin = in essence a new material
- through-the-thickness off-axis
- new name coined:

“oblique layered composites”

- complete filled 6x6 compliance matrix
- to be fully modelled...

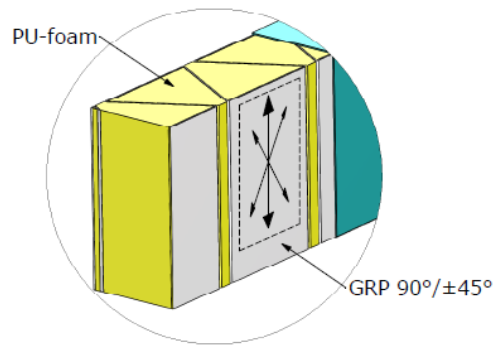
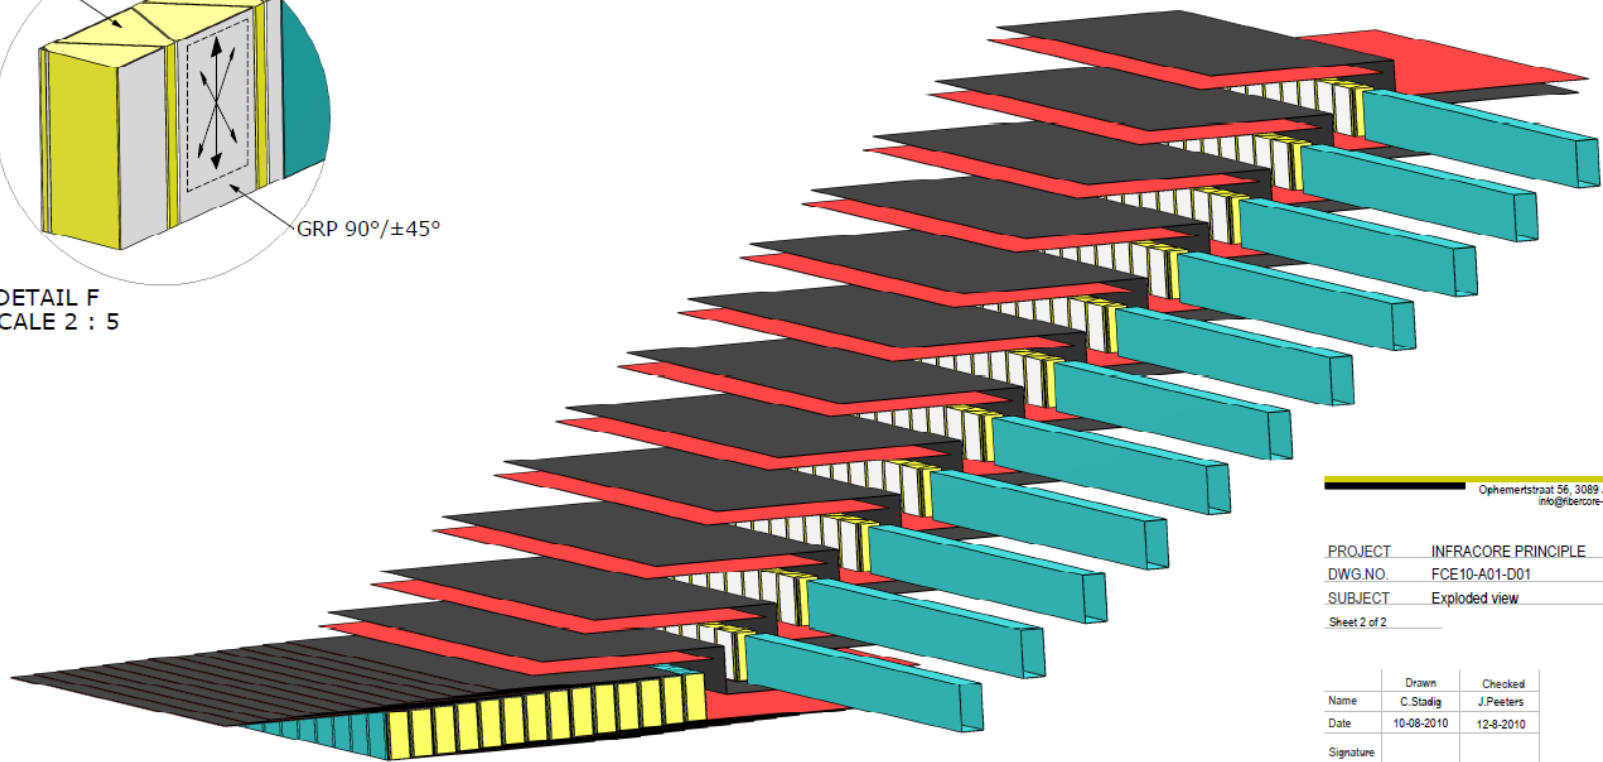
DWG NO. FCE10-A01-D01

DETAIL F
SCALE 2 : 5

PROJECT INFRACORE PRINCIPLE

SUBJECT Exploded view

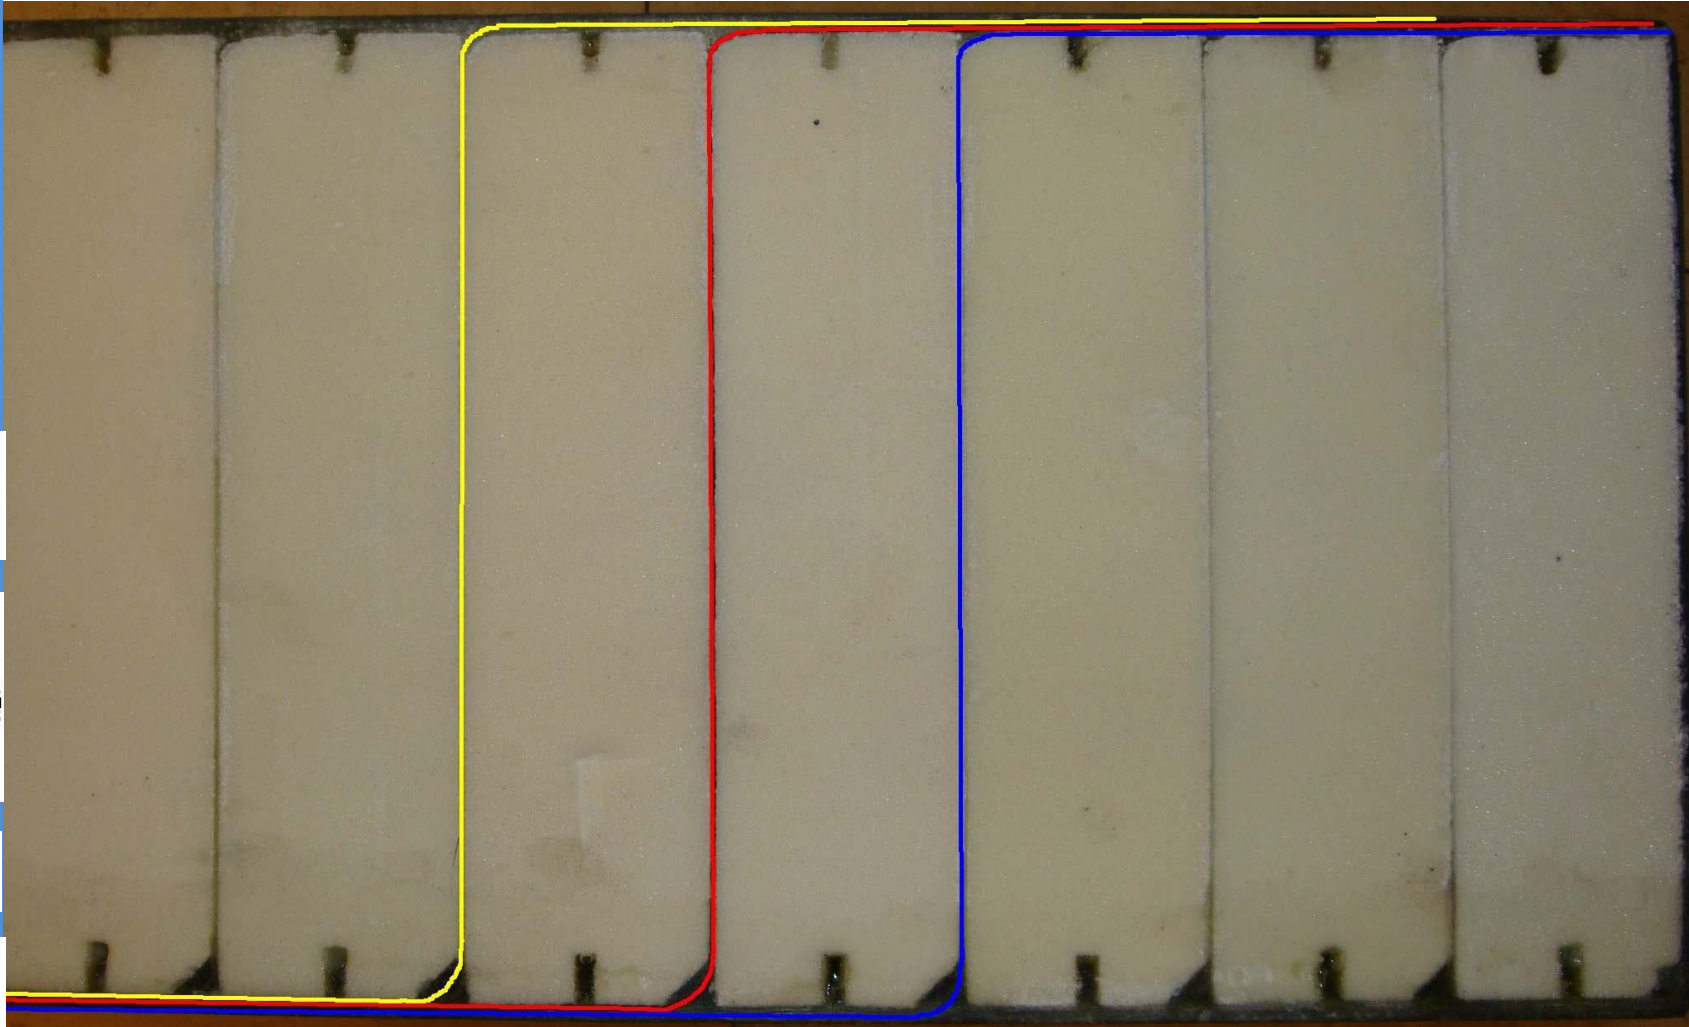
Cross section InfraCore light

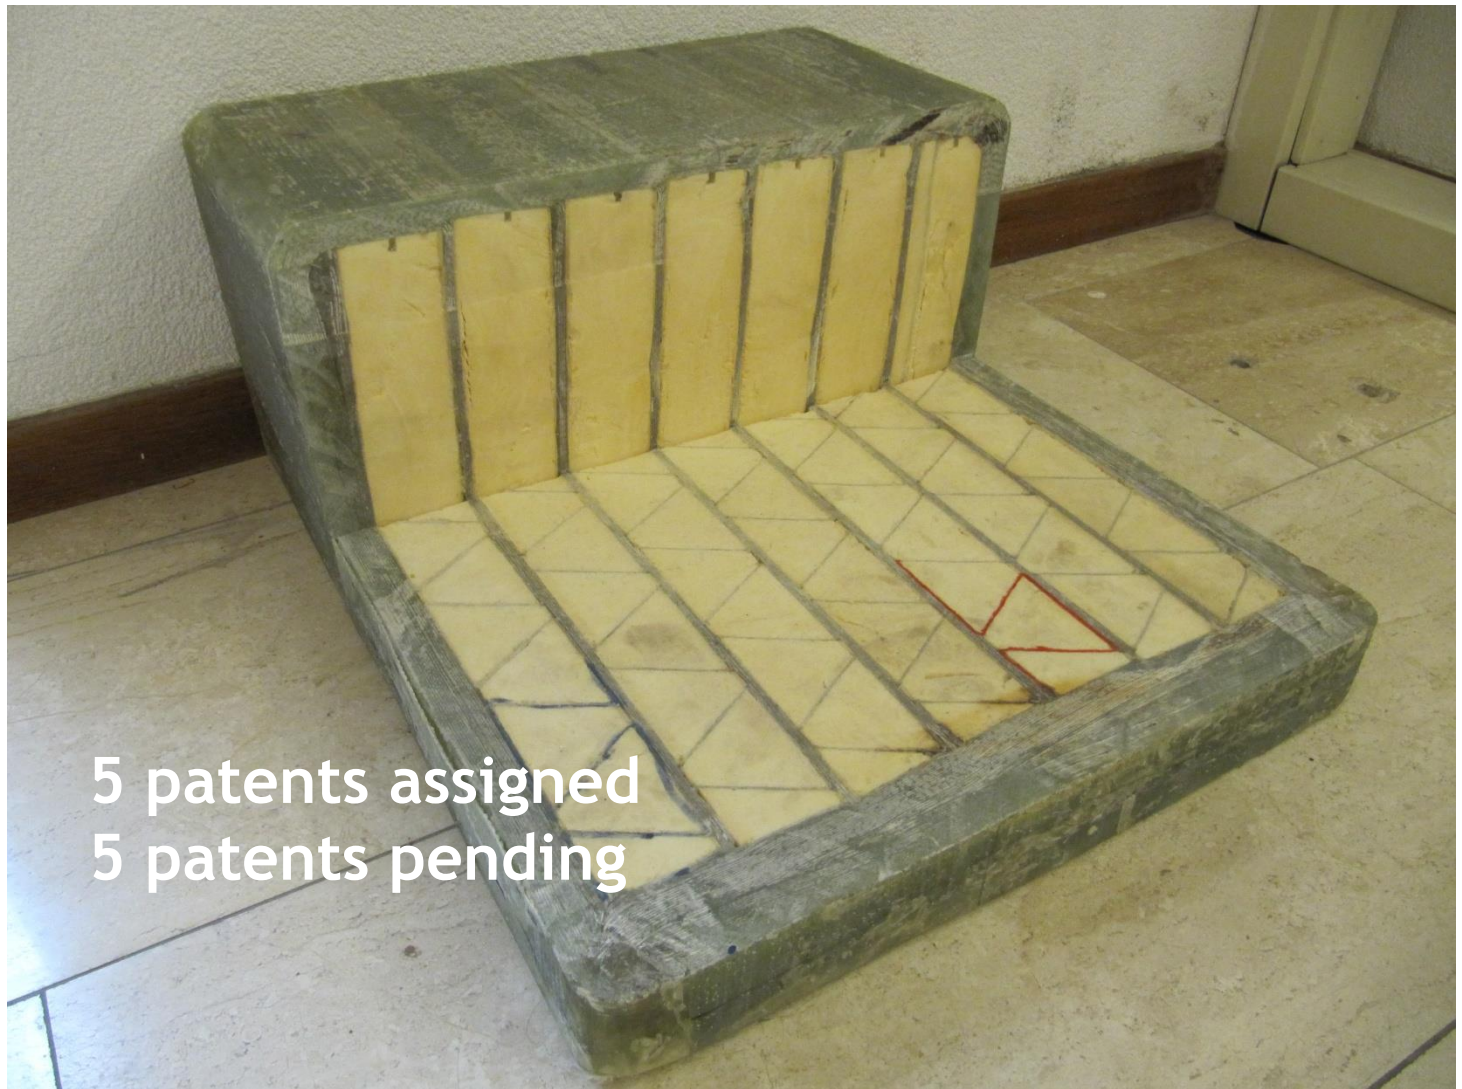
Cross section InfraCore heavy

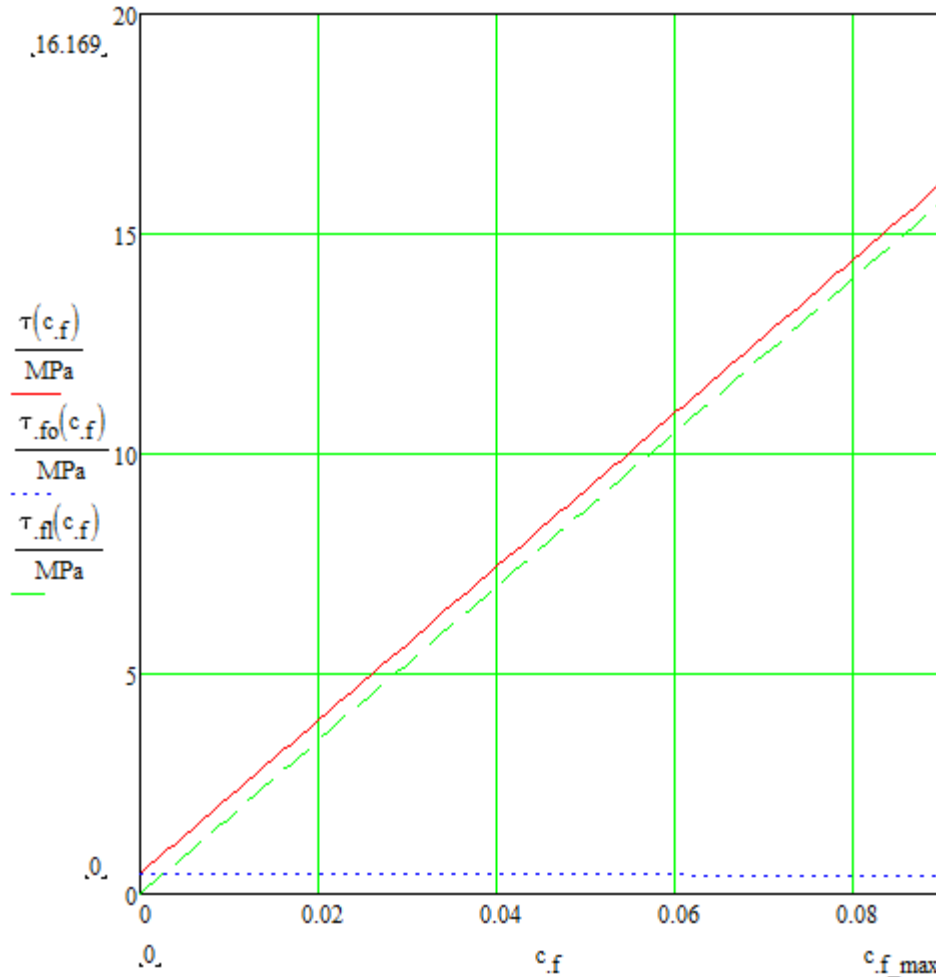
Foam contribution to InfraCore

InfraCore Inside, with
Airex T90 65 kg/m³
constructive PET-foam

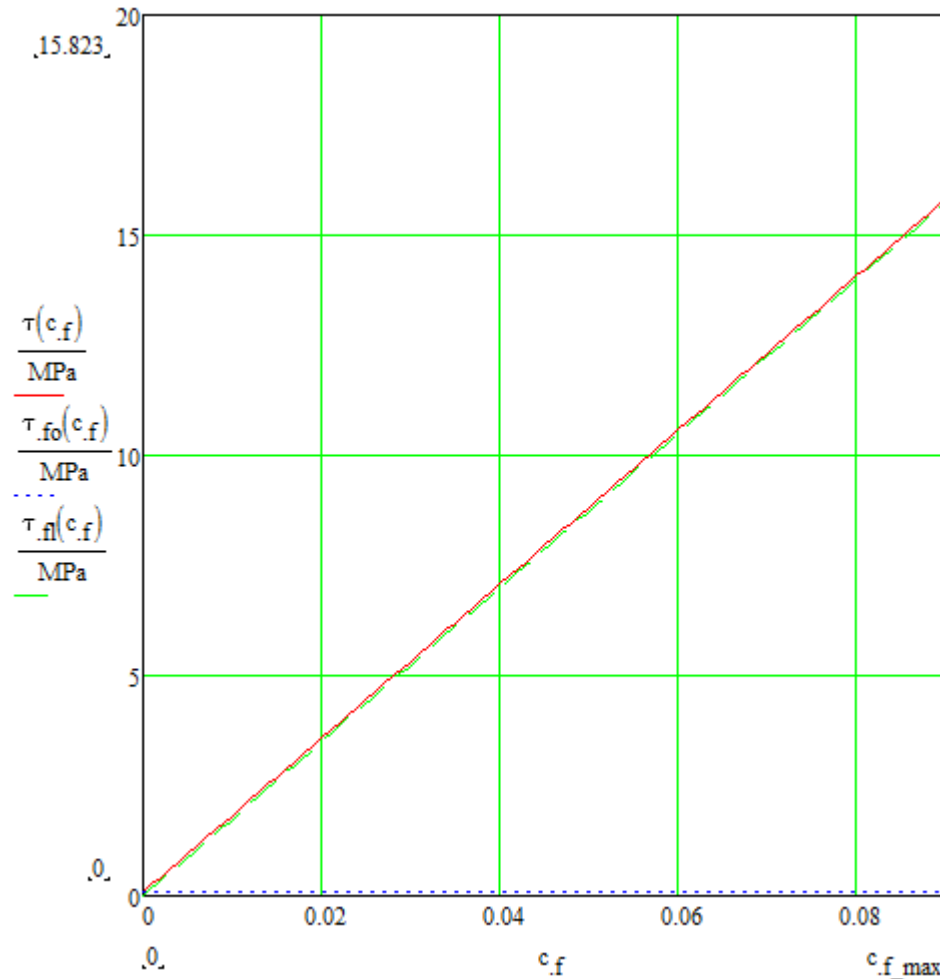
Foam contribution to InfraCore

InfraCore Inside, with
PU 35 kg/m³ Nestaan,
foam
